Report No. CDOT-DTD-R-2001-20

SHRP CHIP SEAL

William (Skip) Outcalt

December 2001

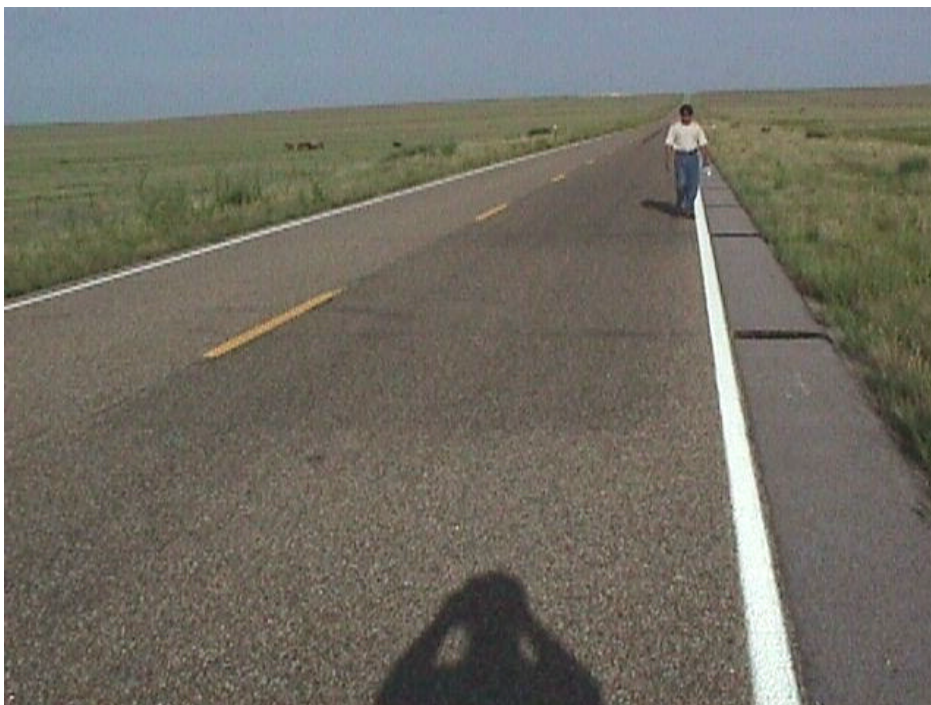
Figure 2. The fog seal section starts where the pavement is darker. The dark stripes on the shoulder are seals applied to transverse cracks before the chip seals were placed.

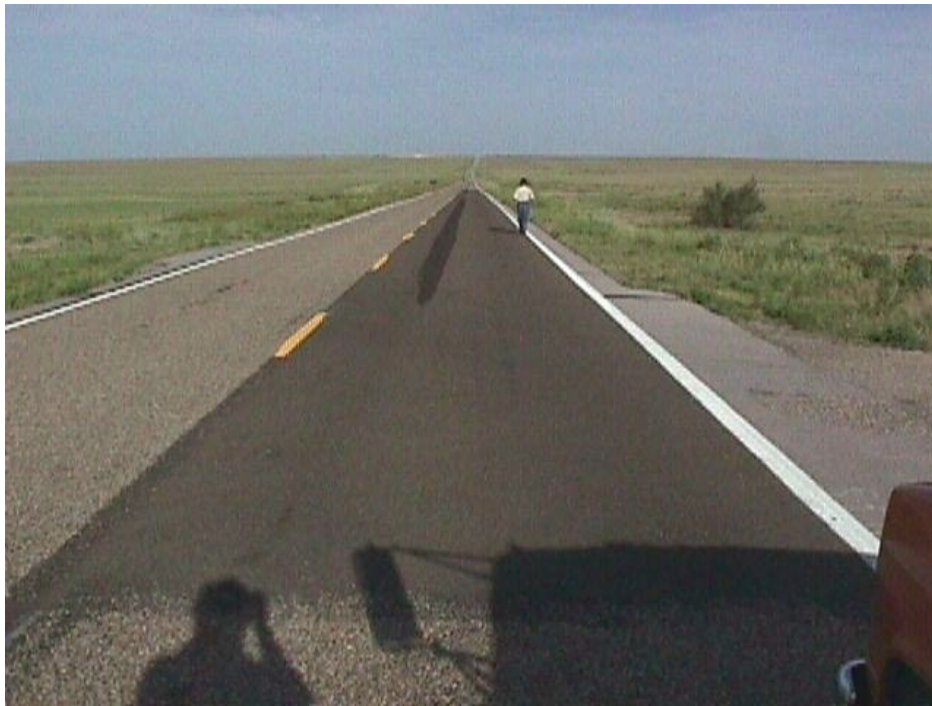
Figure 3. The light weight chip section at the east end of the site.
The right lane is the light weight chip seal. The dark patch in the left wheel path is water left by the skid testing equipment.

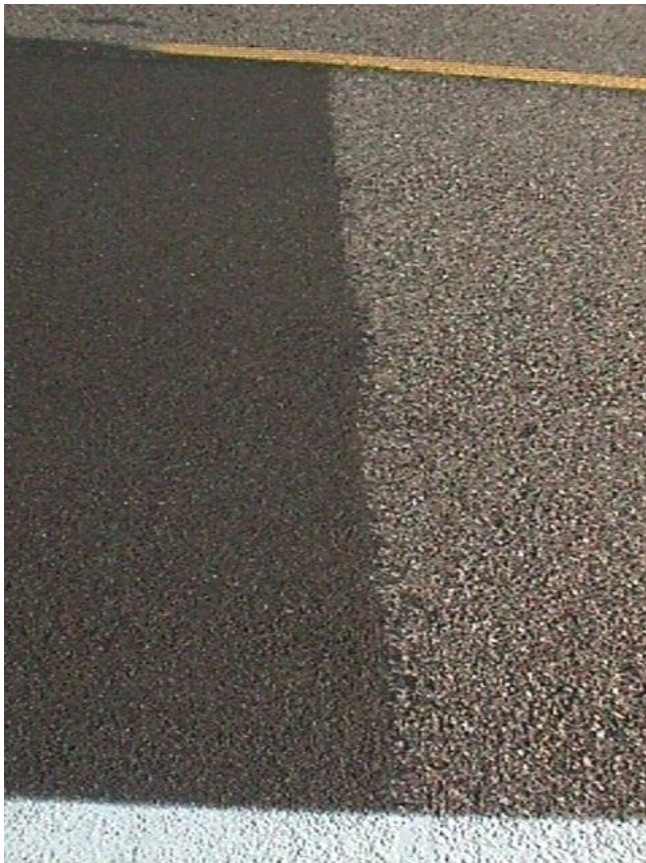
Figure 4. The transition from light weight to standard weight chips.
Light weight chips are the dark area on the left of the picture. To the right side and in the far lane are standard chips.
