Re: Colorado State Capitol

Dome
Bi-Annual Review
Project #200014.027

Re: Colorado State Capitol Dome
WJE No. 2008.0718

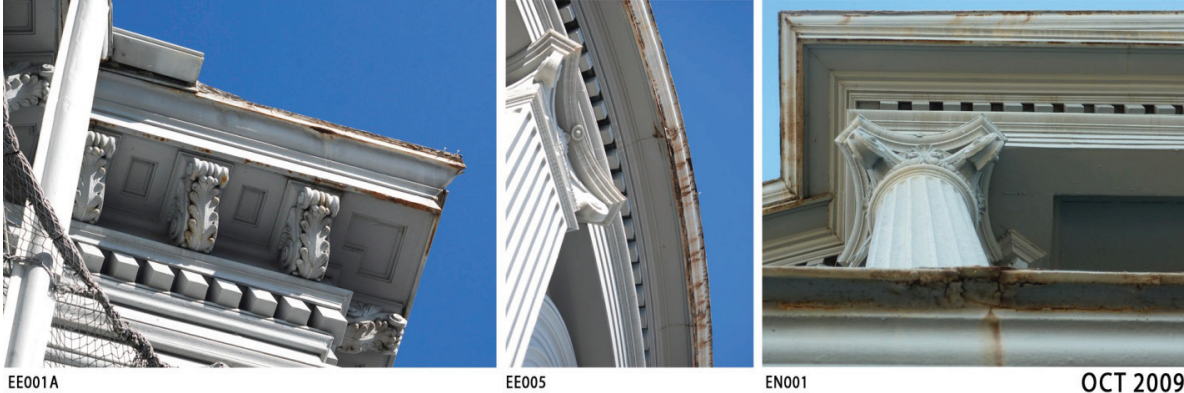
IMAGE EE001A, EE005, EN001

EE001A EE005 EN001 **OCT 2009**
The perimeter of the Lower Entablature is stained and rusting due to water infiltration in the cast iron.
A new crack can be seen in EE005.

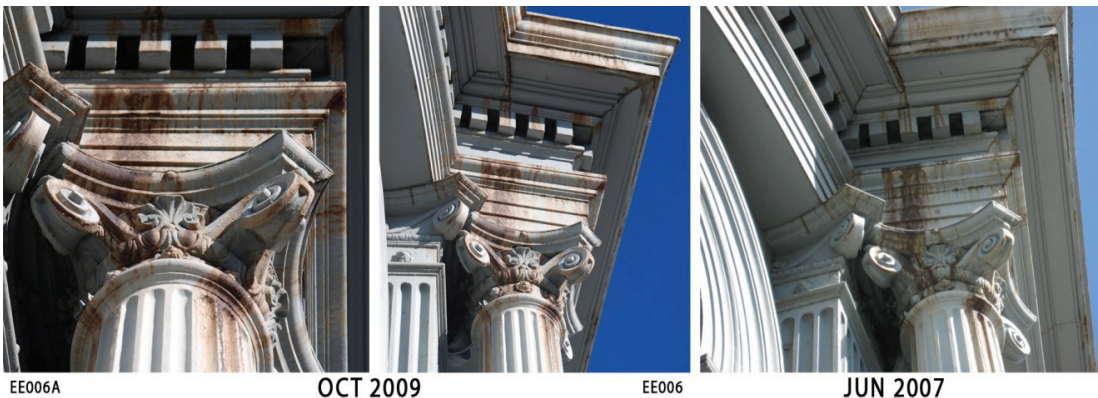
IMAGE EE006

EE006A **OCT 2009** EE006 **JUN 2007**
Additional staining is seen on EE006 and EE006A compared to the June 2007 photograph

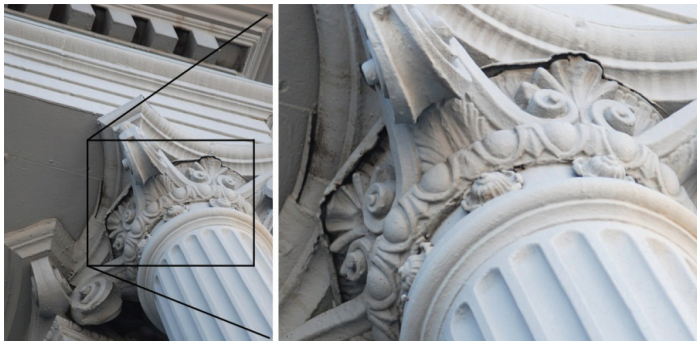
IMAGE EN002

The column is separating from the Corinthian capital. Eventually pieces could break off and fall. Water will begin to migrate into this crack. Additional corrosion can be seen in the column flutes. See #EN008.
JPG on the contact sheet.

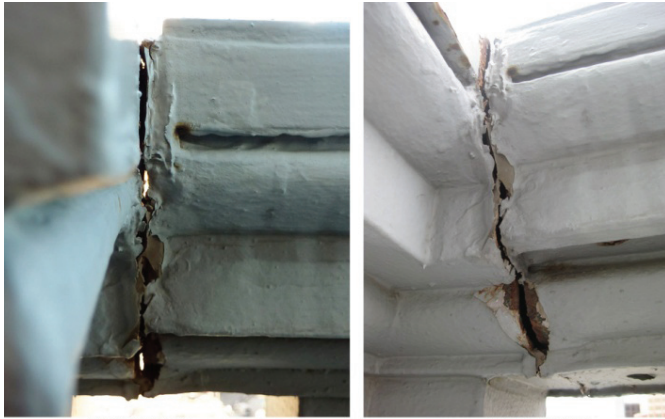
IMAGE UN001A

This condition at the balustrade has gotten worse since March 2009. You can now see daylight through the separation.

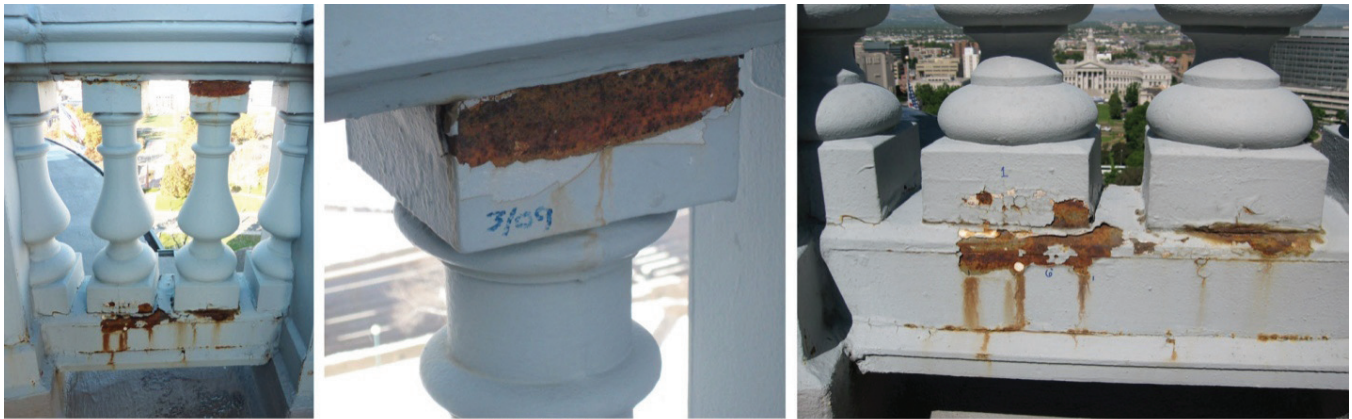
IMAGE UN003

Coating failure has gotten worse since March 2009 on the balustrade railing

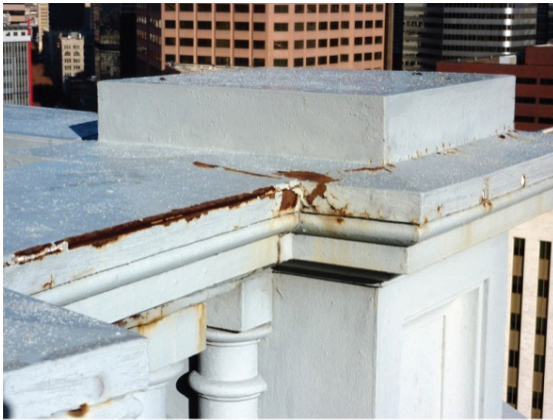
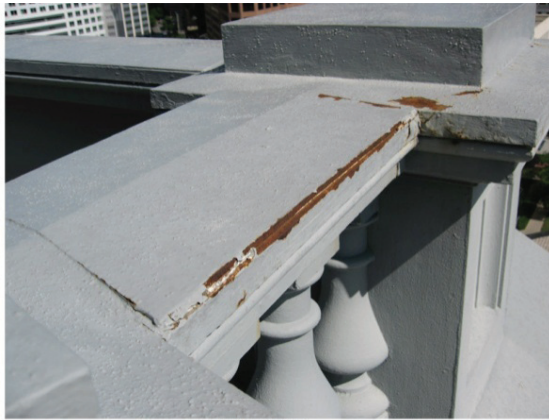
IMAGE UN006

Rusting and coating failure has gotten worse since 2007 on the balustrade railing cap

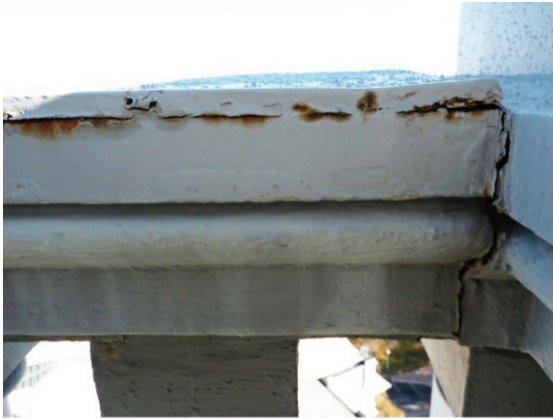
IMAGE UN008

The top of balustrade railing cap is starting to separate. Fasteners are starting to pop.

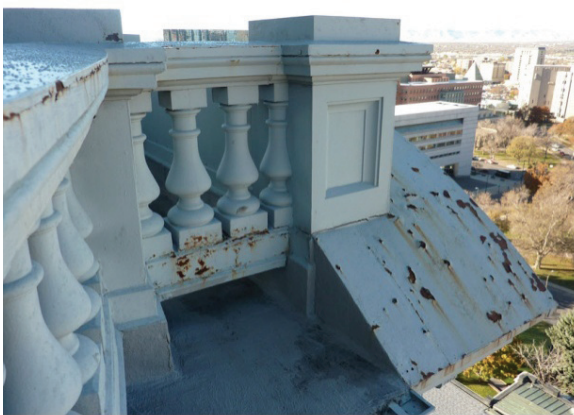
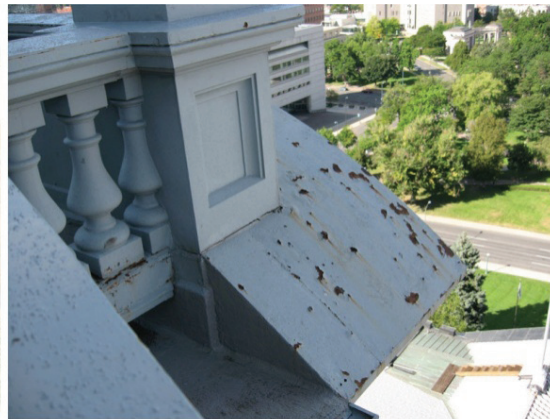
IMAGE UW003

Coating failure and rusting has gotten worse since 2007 on the arched roof.

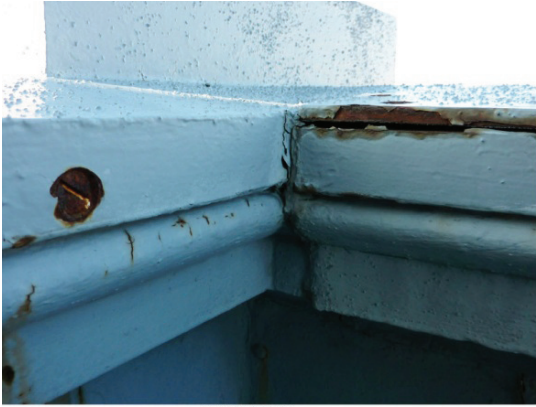
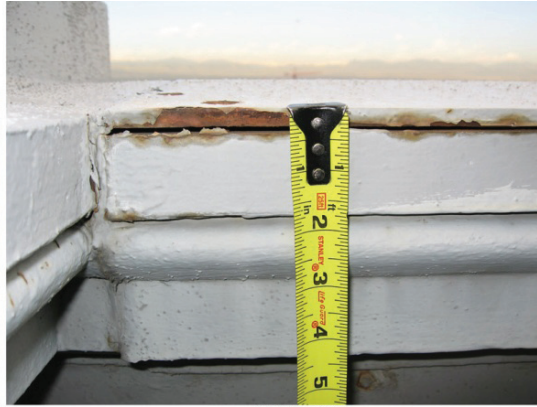
IMAGE UW005B

A detail of the separation and rusting at the balustrade railing cap shows increased separation since 2008. Photo above shows a rusted fastener.

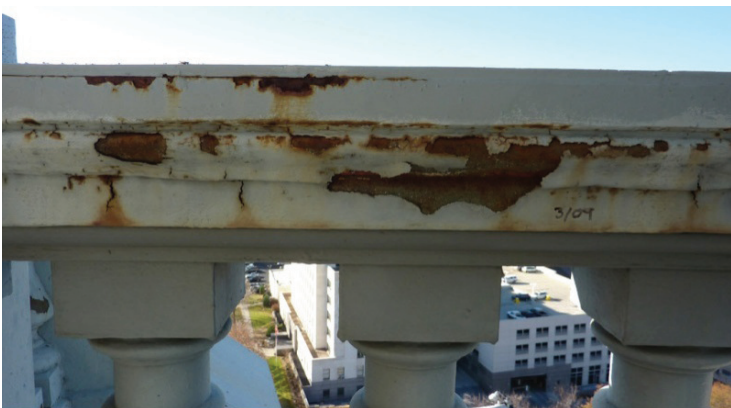
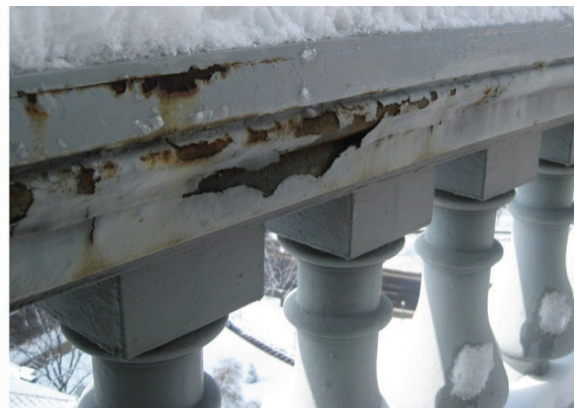
IMAGE US002

Coating failure, cap separation and rusting has gotten worse since March 2009.

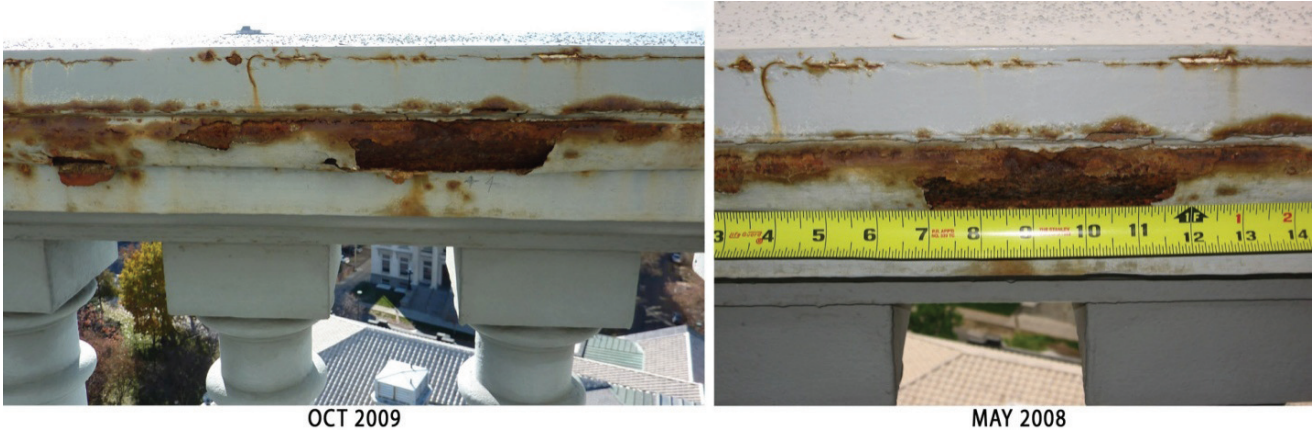
IMAGE US008A

Additional coating failure is noticeable in the Oct. 2009 photo.

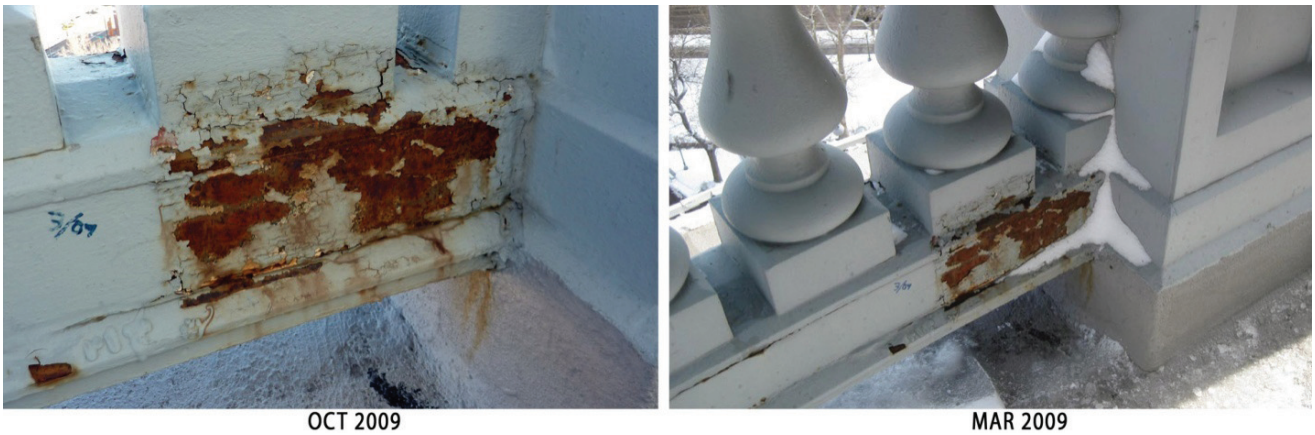
IMAGE UE002

Additional coating failure is noticeable in the Oct.2009 photo.

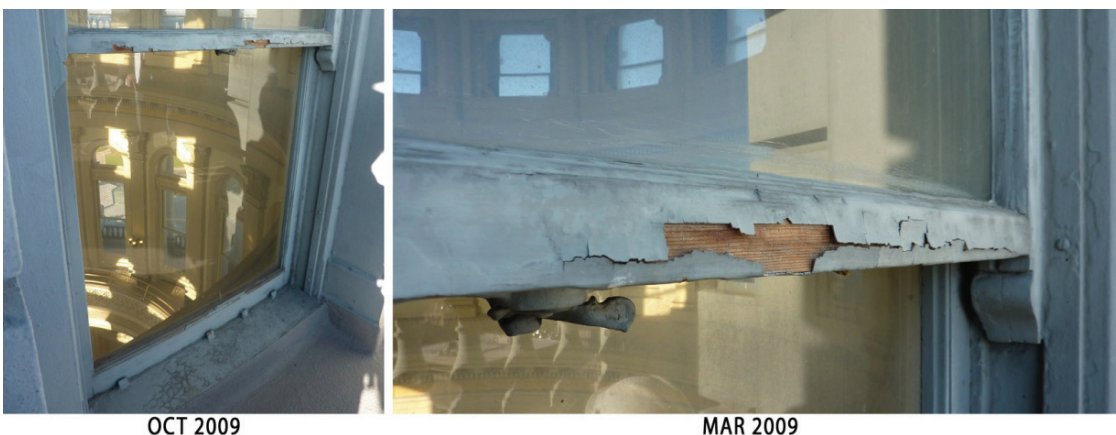
IMAGE UE004A

Paint is continuing to peel from the wood windows. Sealant is starting to deteriorate at the joint between the sill and jamb.

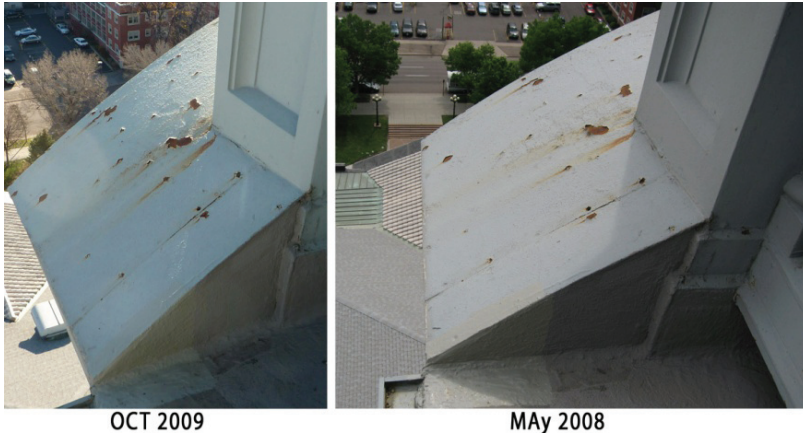
IMAGE UE005

Areas of coating failure have grown larger since May 2008.

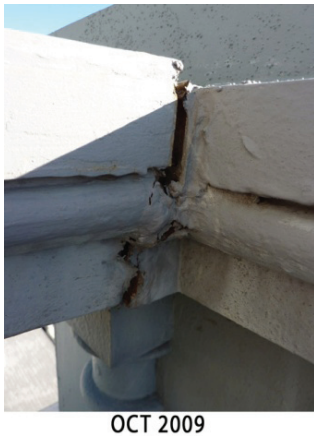
IMAGE UE006A

A detail of displaced balustrade rail cap is shown above.

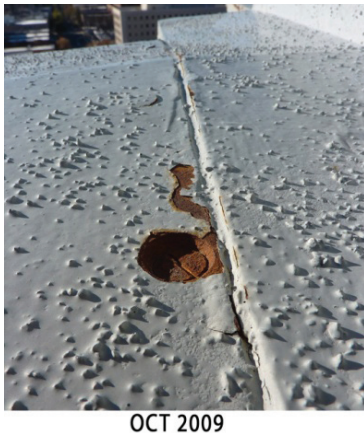
IMAGE UE008

A rusted fastener on the balustrade railing cap has lost its' filler material and coating. Eventually the head of the fastener will break off. This is condition that shows up frequently. See UE007A and UE009 on the contact sheet page 1 of 4.

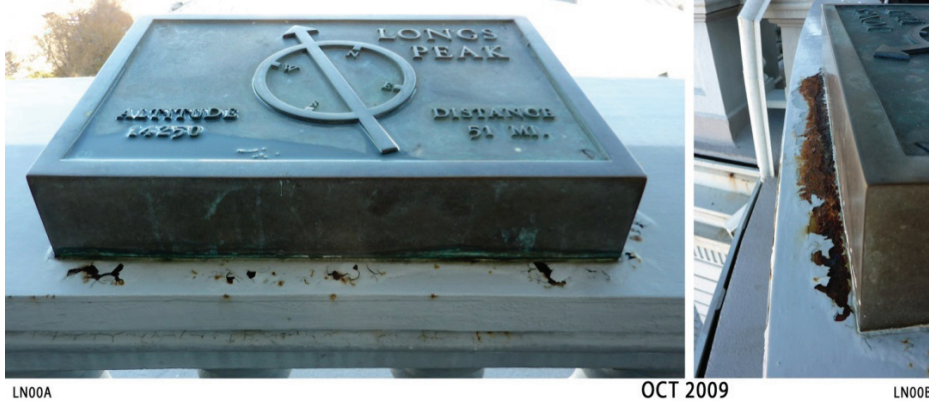
IMAGE LN002A, LN002B

Corrosion is apparent on both sides of the Long's Peak Marker on the Balustrade top rail. Water is seeping under the coating and causing further damage.

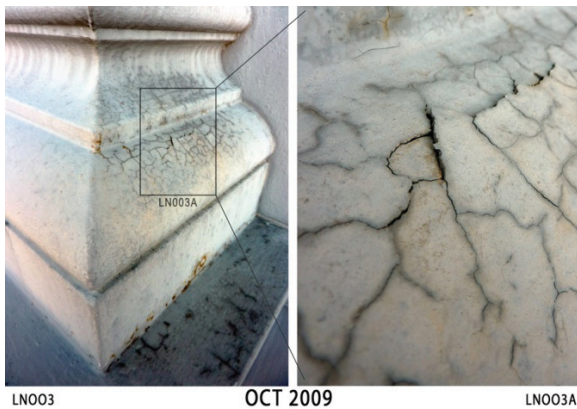
IMAGE LN003, LN003A

The coating on this column base is cracking badly. Water is infiltrating in these cracks and will cause more damage during the freeze thaw cycle.

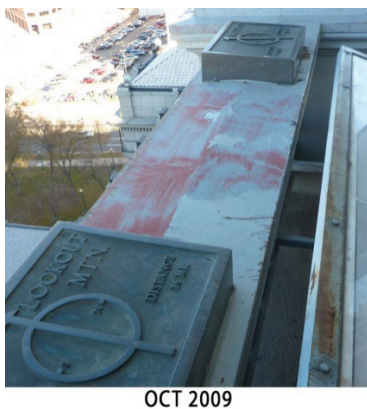
IMAGE LW004

Large areas on top of the balustrade railing have lost the coating exposing the primer coat.

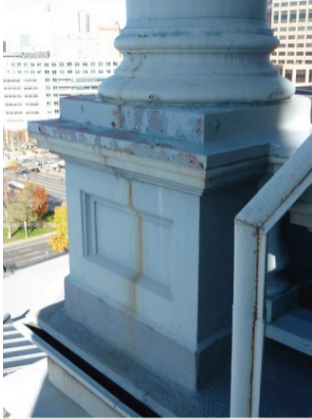
IMAGE L W005

A vertical crack is visible along the side of this column base.

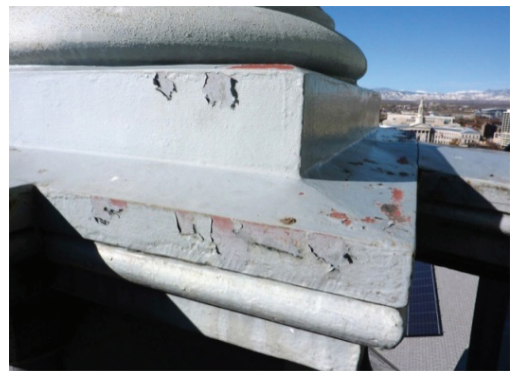
IMAGE LS002

Shown above is additional evidence of the areas where coating is missing and peeling. Leaving the metal unprotected will subject it to further oxidation.

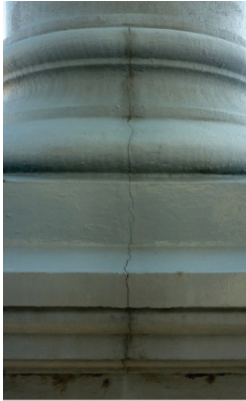
IMAGE LS003

The crack in the column base has gotten bigger since March 2009. The cracks and rusting on the balustrade top rail has expanded as well.

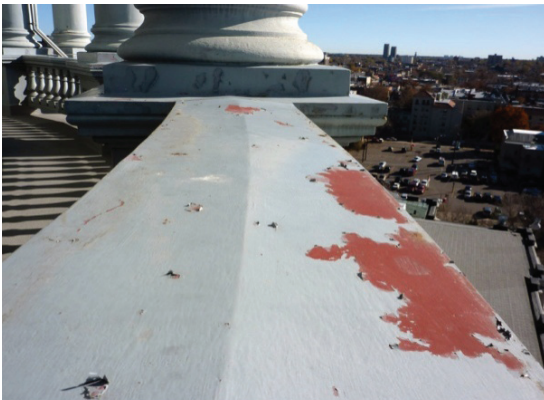
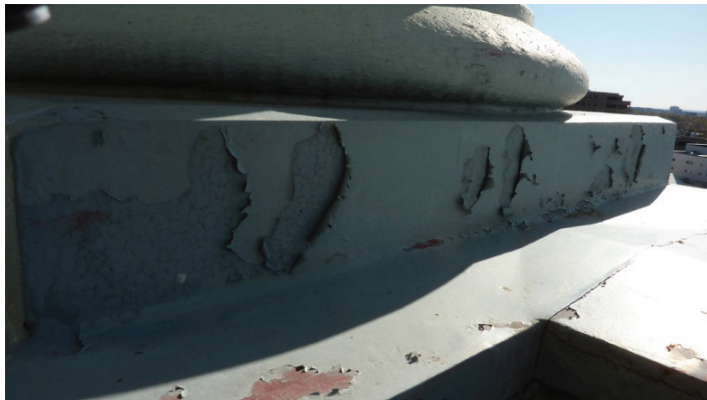
Above is additional evidence of cracking and rusting on the balustrade and column bases.

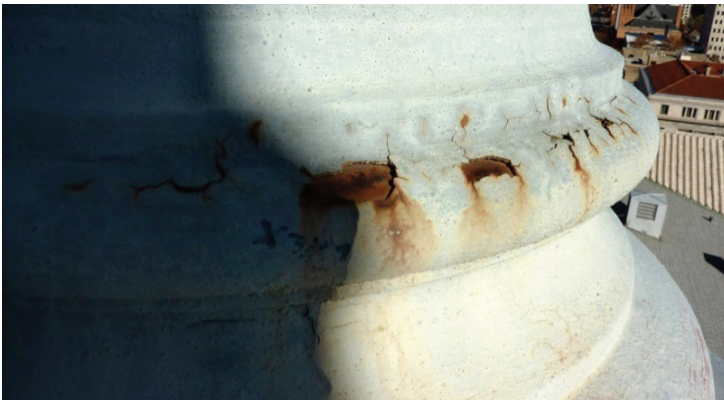
IMAGE LE002

Rust is forming due to the lack of coating on this column.

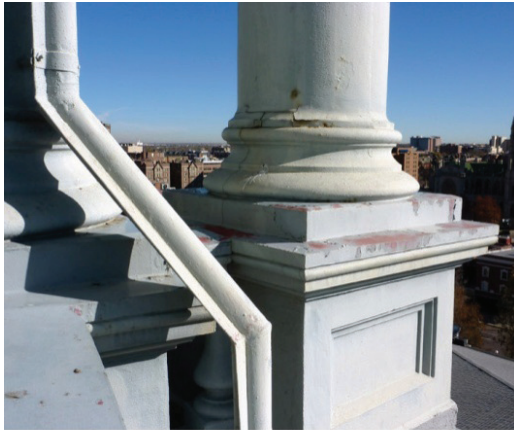
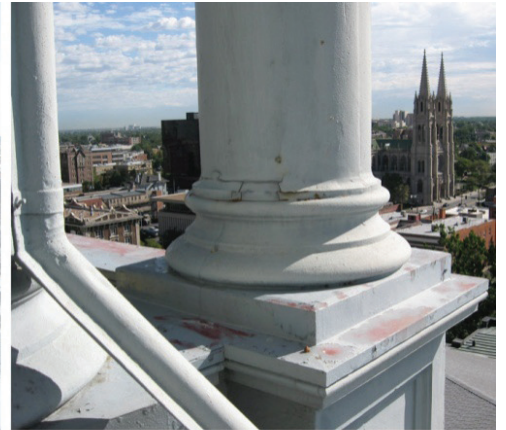
IMAGE LE005

This column has been rusting for a long time and is getting worse and is reaching the point where the metal coating is cracking and releasing water collecting in the column. The moisture is also trapped against the metal in many areas.

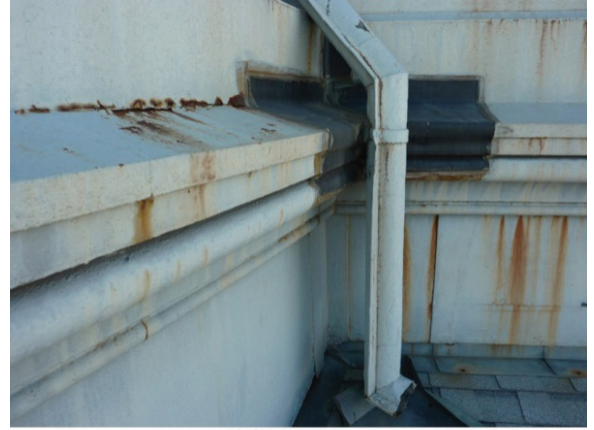
IMAGE DN003

Continuing staining and water infiltration behind the drum battens. Note that the battens are separating from the drum wall. Rusting and staining at the drum base cap. The rusty areas seen to the left of the dark patch will soon be rusted through and require the same kind patch.

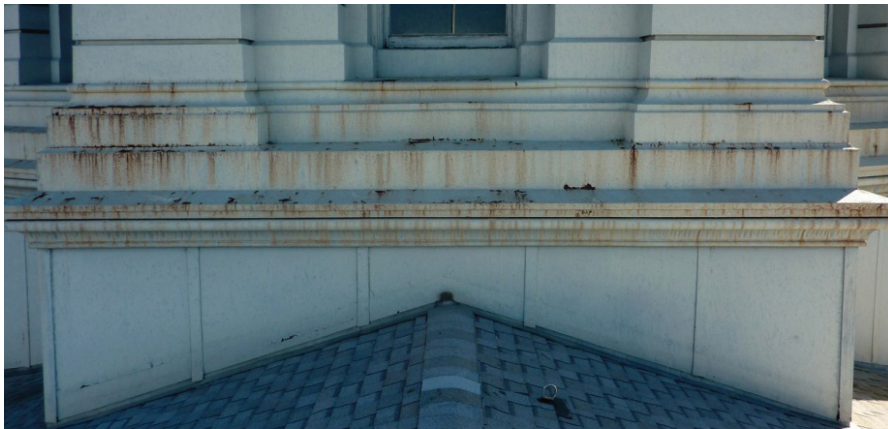
IMAGE DW003

Staining and rusting conditions appear on all four sides of the dome base.

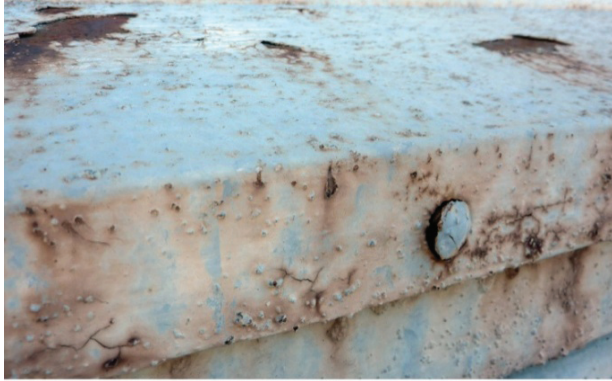
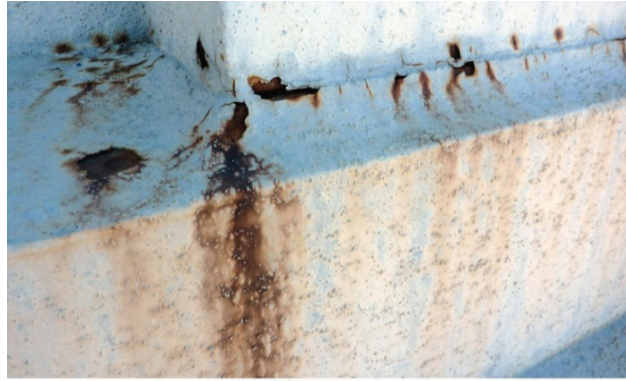
Above you can see that the fastener is working it's way out. Water is getting into the rusty pits in the cast iron and causing the coating to peel.

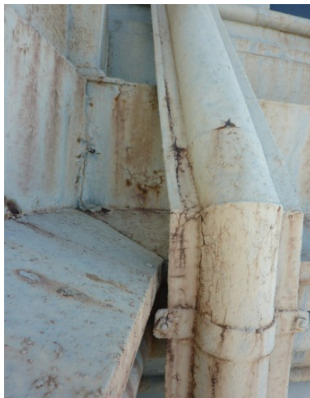
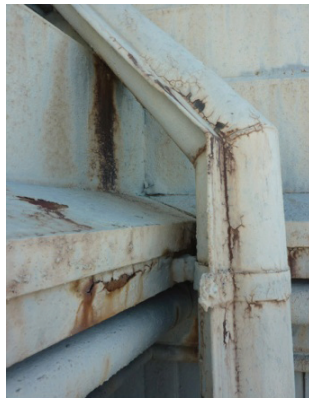
IMAGE DW004

Down spout is rusting and coming loose from the building.

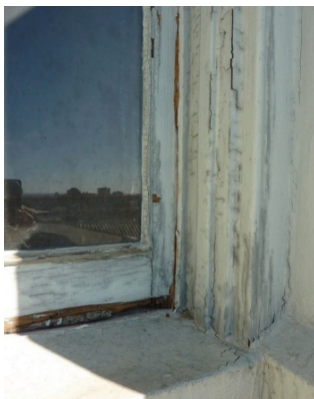
IMAGE DS003A

Window frames are in bad shape as the wood is starting to rot

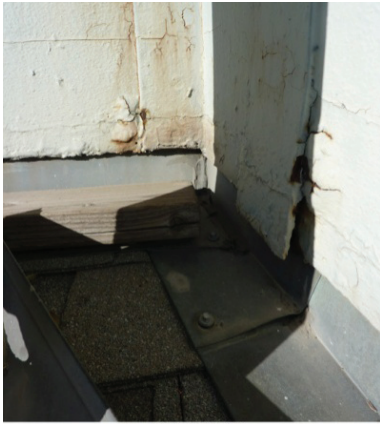
IMAGE DS006

Water is getting behind the batten causing it to pull away from the drum wall.

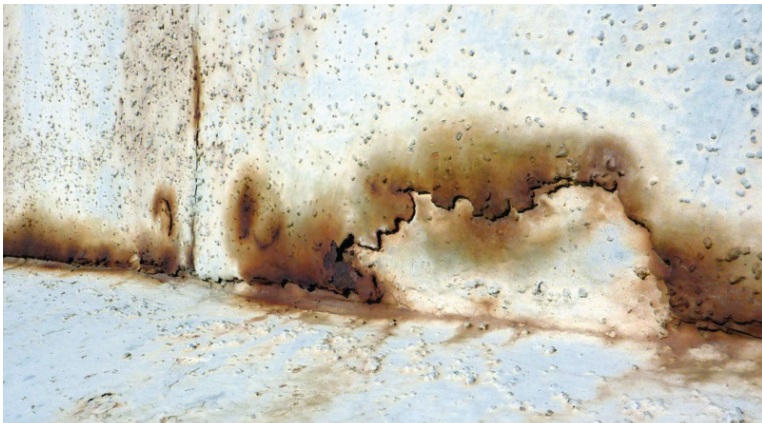
IMAGE DS007

Above is a detail of the deterioration that is seen on all sides of the drum. This condition will only get worse.

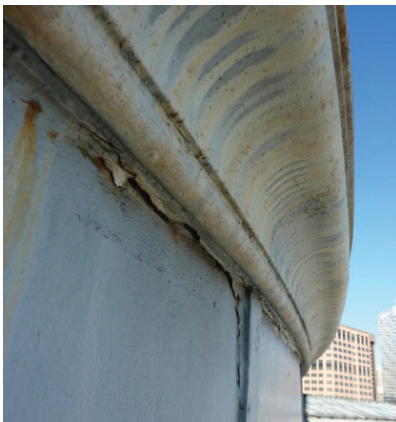
IMAGE DE002

The drum cap is starting to pull away from the drum. Water is getting behind the batten from above.

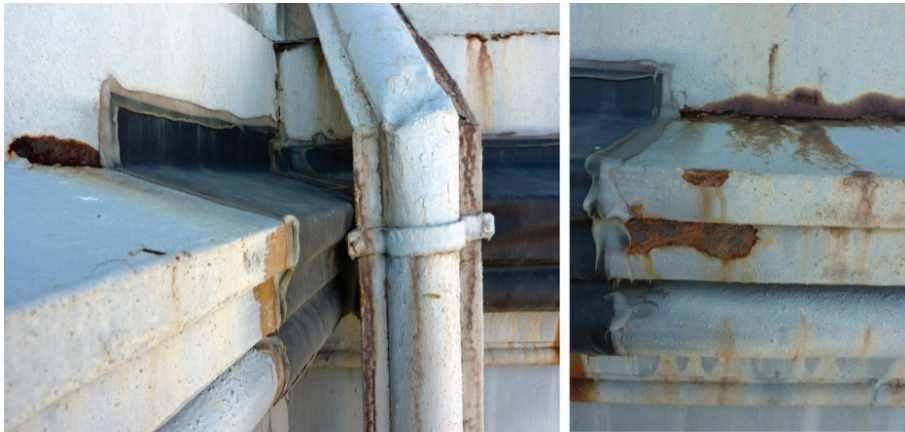
IMAGE DE003A, DE003B

Adjacent to this damaged down spout you can see that the sill is almost rusted through. This is adjacent to a patch that was applied in 2008. It appears that there has been blockage in the downspout and it froze within at some time.

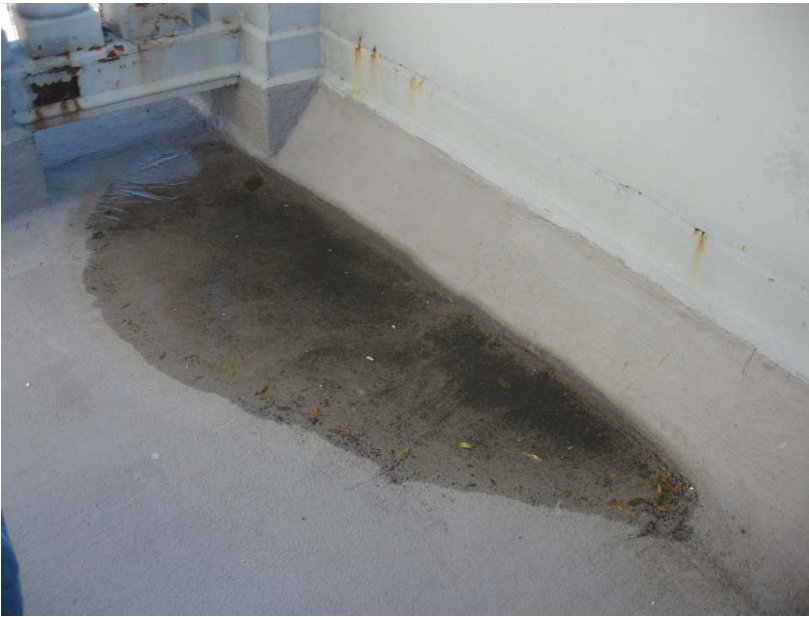
Several areas of ponding water were observed on the deck at each cardinal direction (Figure 1). Ponding water caused by inadequate slope of the decking can lead to accelerated deterioration of the coating, which will allow water into the cast iron structure causing further deterioration.

Figure 1. Ponding water observed on deck of Upper Observation Level.

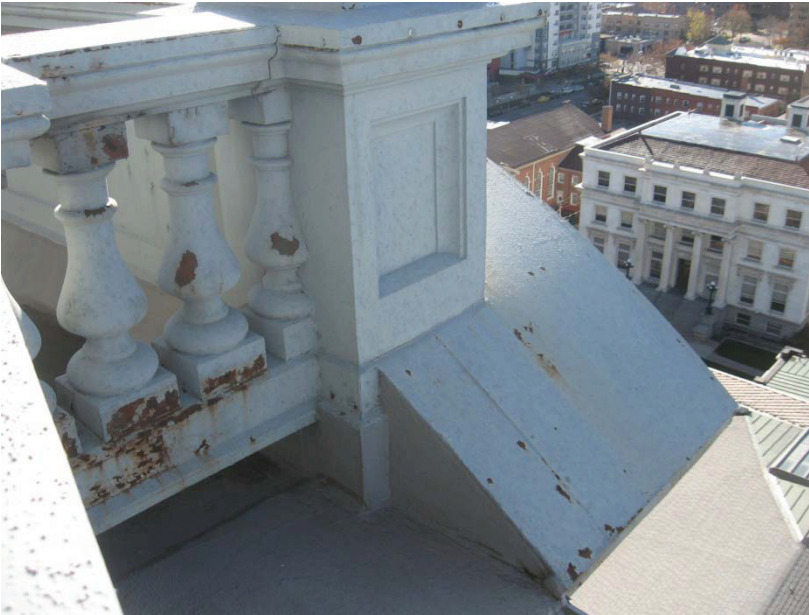
The coating on the balustrade has failed at several areas, leading to surface corrosion of the cast iron (Figure 2). This condition is widespread across the entire Upper Observation Level. The material over many top rail fasteners has deteriorated, leaving exposed fastener heads to corrode (Figure 3).

Figure 2. Deterioration of the balustrade at the Upper Observation Level.

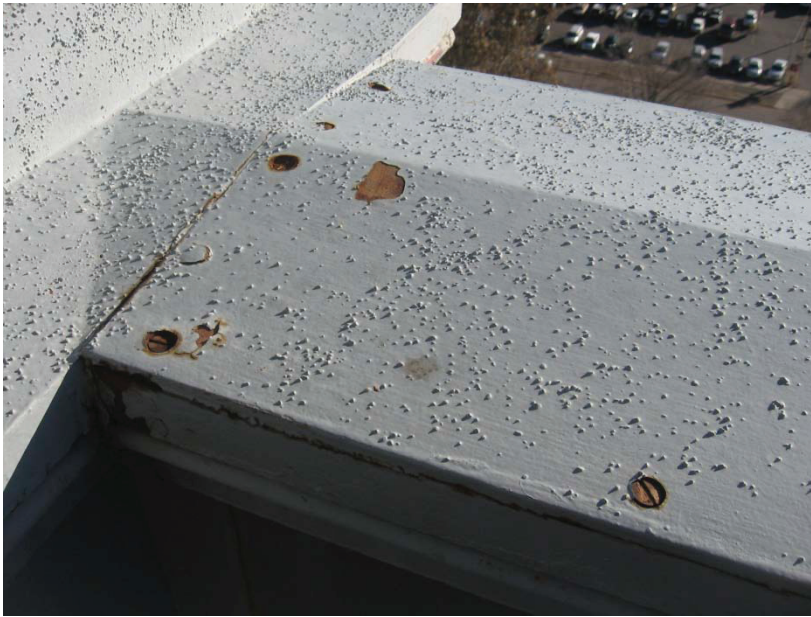
Figure 3. Exposed fastener heads at the balustrade's top rail on the Upper Observation Level.

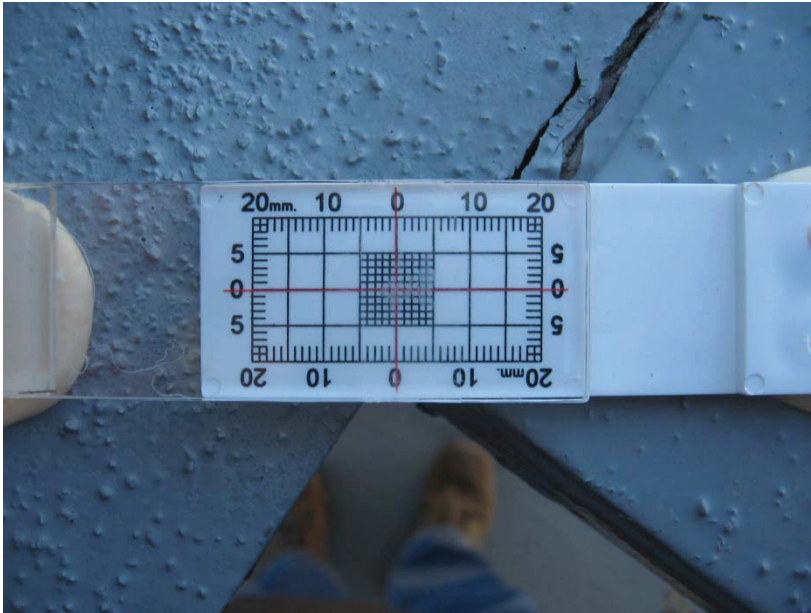
Differential movement of balustrade elements was observed at several locations. It was not readily apparent what was causing this movement. WJE installed a gauge over the displaced rail at the north balustrade to determine if the movement is ongoing (Figure 4).

Figure 4. Movement gauge installed at the north rail on the Upper Observation Level.

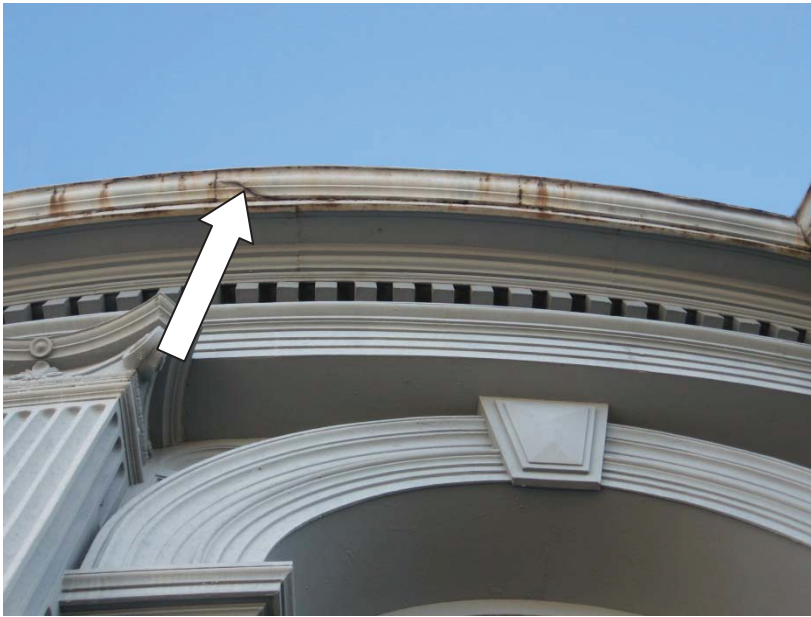
A previously observed crack was noted at the northwest façade above the Upper Observation Level (Figure 5). The crack is visually similar to the condition noted in our November 11, 2008 report (Figure 6). However, it should be understood that we did not observe this piece up close and have no way of knowing if this element is secure. Moisture can migrate into the crack and subsequent freeze/thaw cycles may render this element a fall hazard.

Figure 5. Cracked cast iron element above the Upper Observation Level.

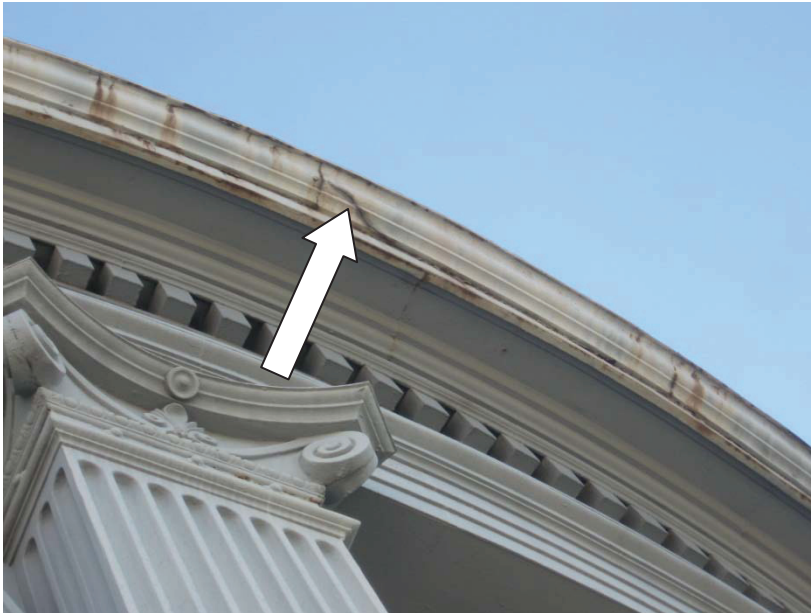
Figure 6. Cracked cast iron element above the Upper Observation Level observed on November 3, 2008.

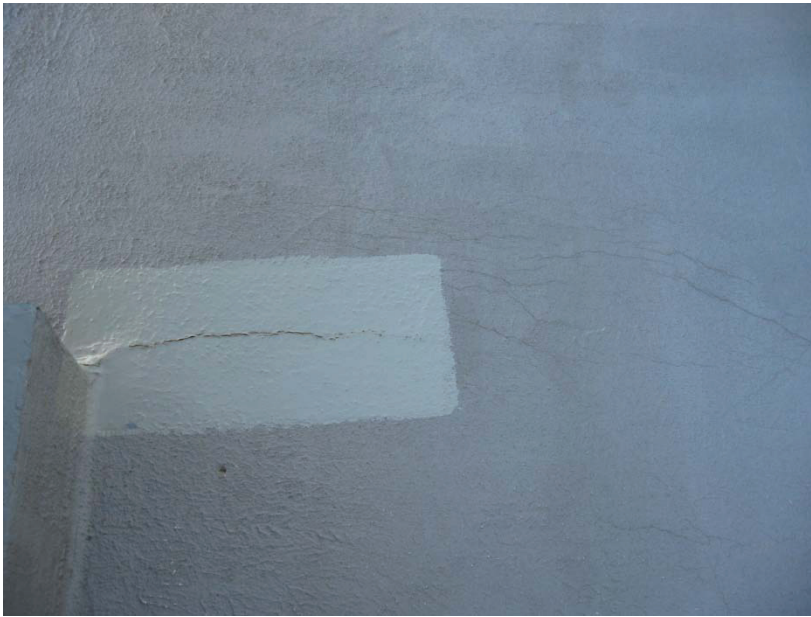
Temporary deck coating repairs are beginning to fail (Figure 7). Elastomeric coating was installed as a temporary repair to minimize the amount of water reaching the cast iron. Water is migrating under the coating from cracks adjacent to the temporary repairs and is causing them to fail.

Figure 7. Temporary deck coating repair has failed at the Upper Observation Level. Note cracking of deck coating adjacent to repair area.

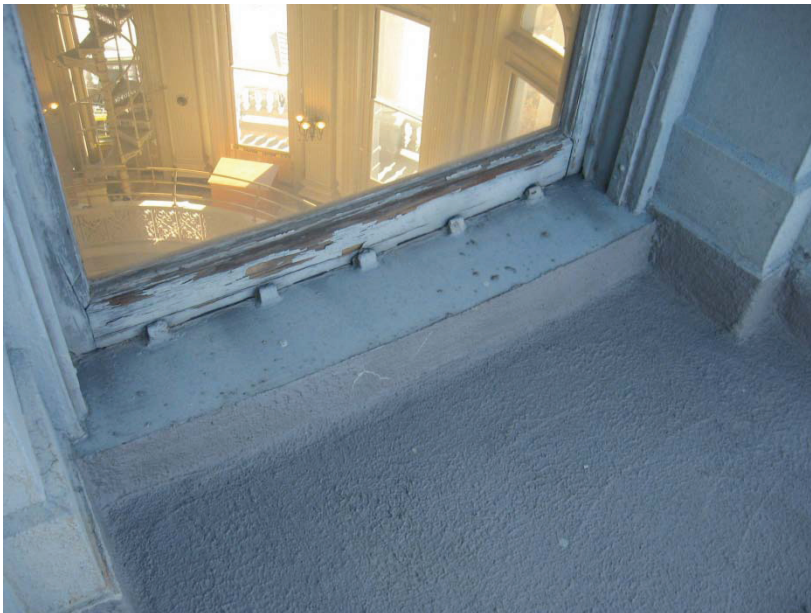
The paint on the wood window sashes is severely deteriorated (Figure 8). The paint protects the wood and glazing materials from the atmospheric elements. When it becomes compromised as it currently is,

the wood is not adequately protected and deterioration occurs. When the glazing materials become compromised, water infiltration can occur. If left unabated, deteriorated wood sashes combined with deteriorated glazing materials may lead to an inadequately contained glass lite.

Figure 8. Typical deterioration of the wood sashes observed on the Upper Observation Level.

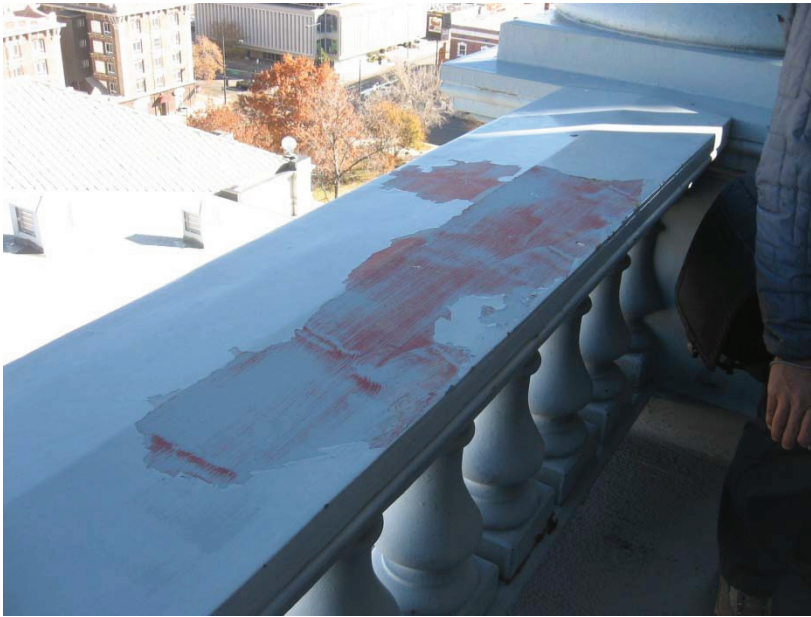
Figure 9. Failed coating at the balustrade of the Lower Observation Level.

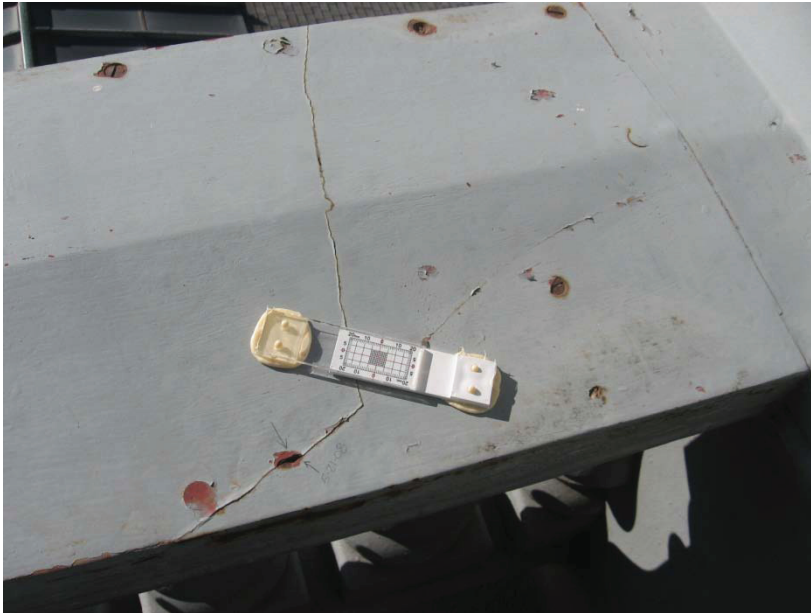
The coating on the balustrade has failed at several areas (Figure 9). A crack was observed through the top rail of the balustrade at the south elevation. WJE installed a gauge over the crack to determine if the crack is moving (Figure 10).

Figure 10. Movement gauge installed over cracked balustrade at Lower Observation Level.

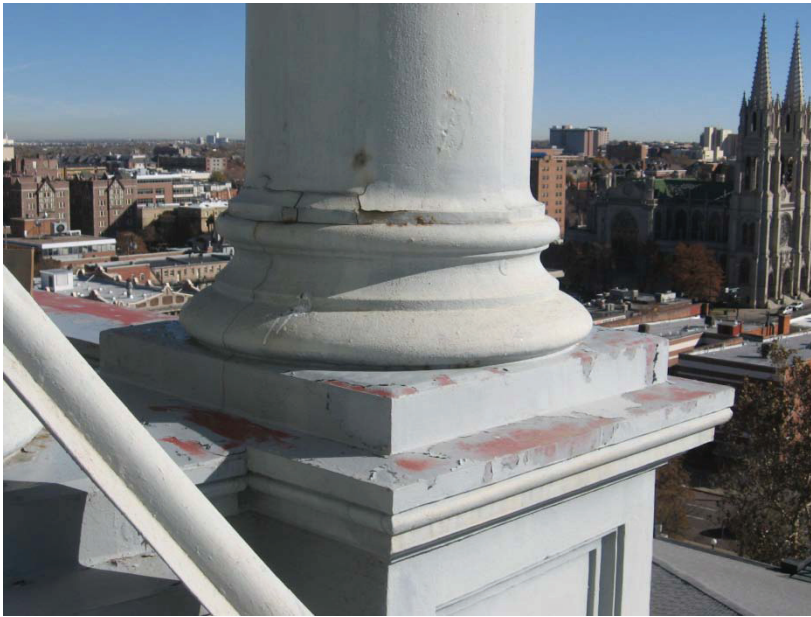
The column bases exhibit cracking and corrosive staining (Figure 11). Snow, ice, and water collect at the bases of the columns and accelerate deterioration at these areas. The drawings reviewed by WJE do not clearly indicate how the cast iron elements at the columns are fabricated. Depending on how the cast iron elements are fastened, this condition may result in a compromised structural attachment of the cast iron column elements. Further investigation into the attachment of the column covers is warranted.

Figure 11. Deterioration and corrosive staining at column bases on Lower Observation Level.

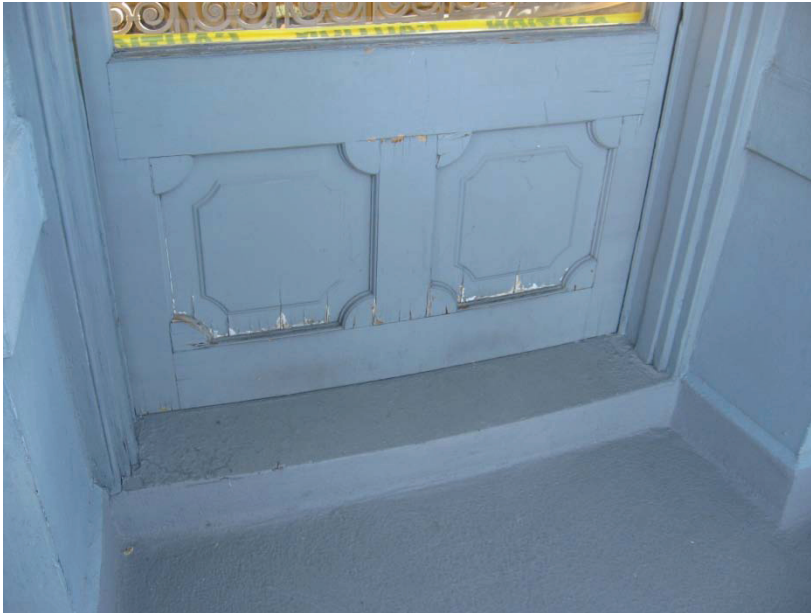
Similar to the Upper Observation Level, the paint on the wood window sashes at the Lower Observation Level is severely deteriorated (Figure 12). The wood is deteriorated and cracked at several locations.

Figure 12. Deteriorated sash of operable window at Lower Observation Level.

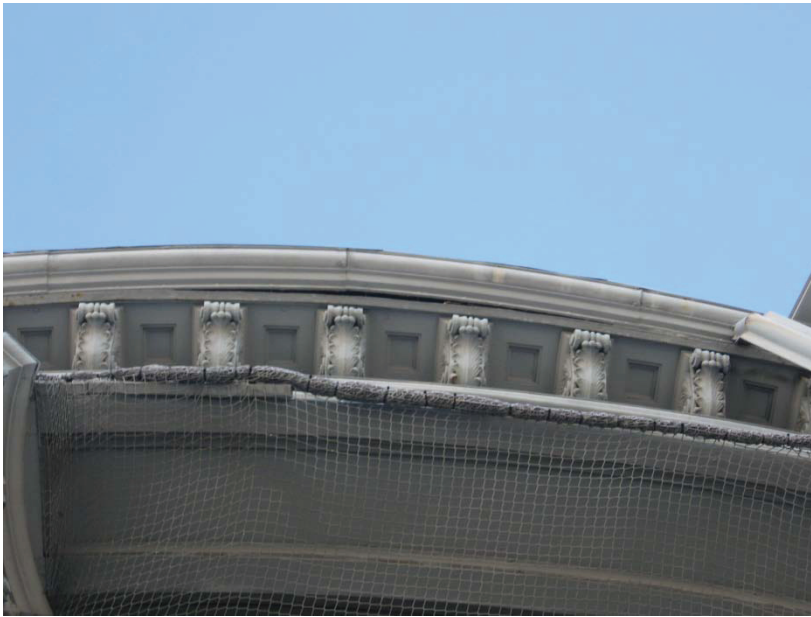
A separation exists at the fascia piece on the west façade above the Lower Observation Level (Figure 13). This condition was also observed on November 3, 2008 (Figure 14). Due to accessibility constraints, we could not verify if this element is secure. This fascia piece is not contained by the installed netting, thus it is a potential fall hazard.

Figure 13. Separation of fascia element above Lower Observation Level.

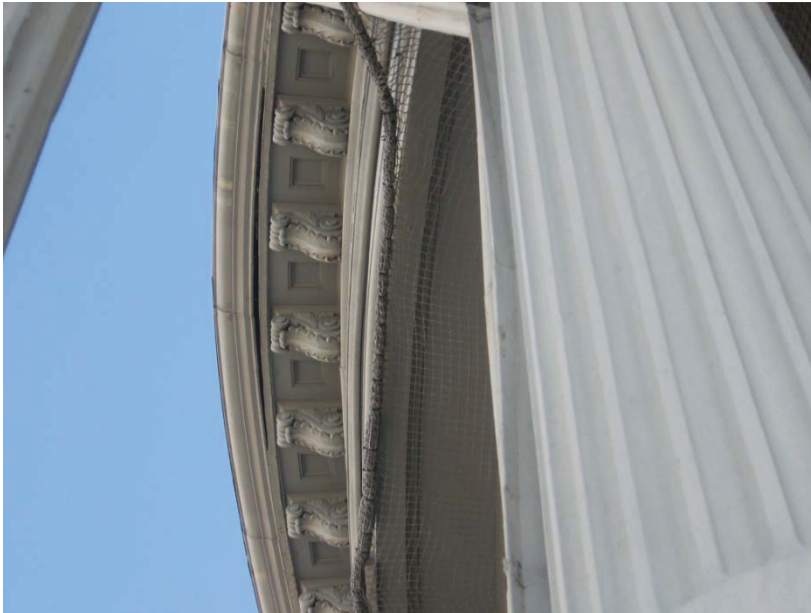
Figure 14. Fascia separation observed on November 3, 2008.

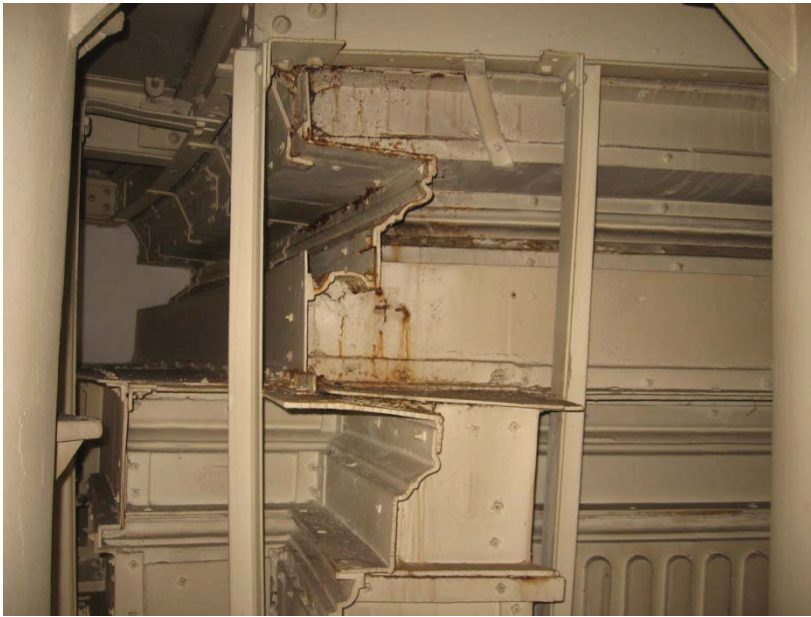
The cast iron façade was observed from the interior stairwell. Water staining and deterioration was observed at the interfaces between cast iron pieces (Figure 15).

Figure 15. Water infiltration staining and corrosion at interior stairwell below Lower Observation Level.

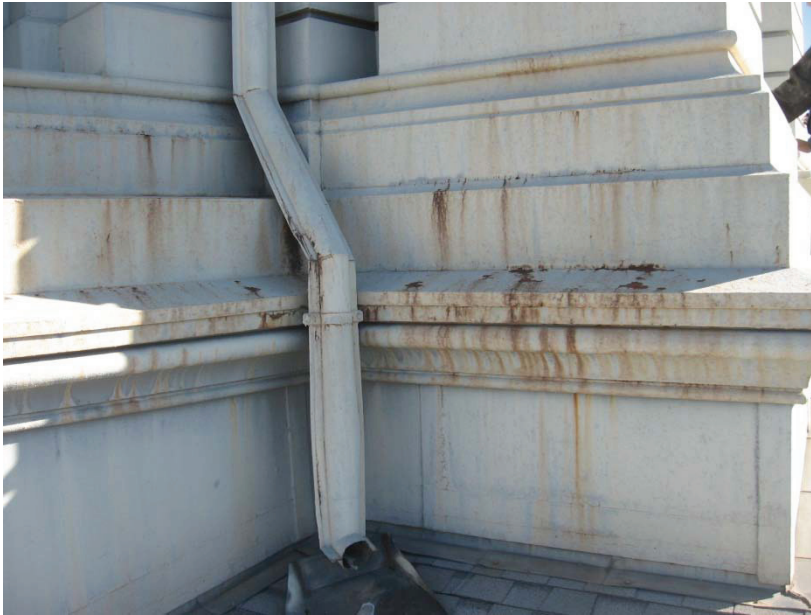
Severe corrosive staining exists along the entire base of the drum (Figure 16). Water from the upper levels cascades down the drum base. Severe deterioration of the cast iron has occurred at reentrant corners adjacent to downspouts. At five areas, the cast iron material deteriorated through its entire thickness. An EPDM membrane was installed over the openings caused by this deterioration as a temporary repair to minimize the amount of water entering these locations (Figure 17).

Figure 16. Staining at the base of the drum.

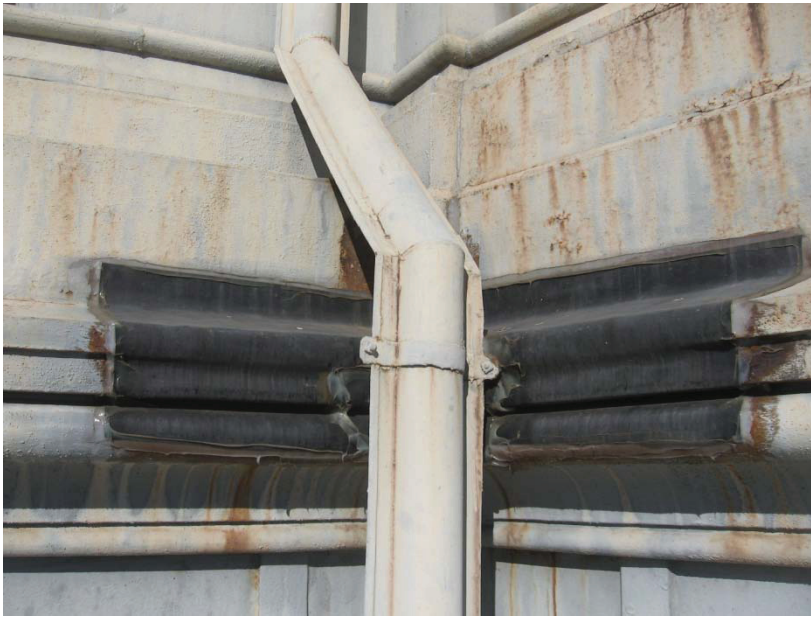
Figure 17. EPDM membrane installed over severely deteriorated cast iron reentrant corner.
