**Report No. CDOT-2011-10**  
**Final Report**

# **INVESTIGATING CRACK SEALANT PERFORMANCE AND CAUSES OF BUMPS IN NEW HOT MIX ASPHALT OVERLAYS OVER CRACK SEALANTS**

**Scott Shuler**

**COLORADO DEPARTMENT OF TRANSPORTATION  
DTD APPLIED RESEARCH AND INNOVATION BRANCH**

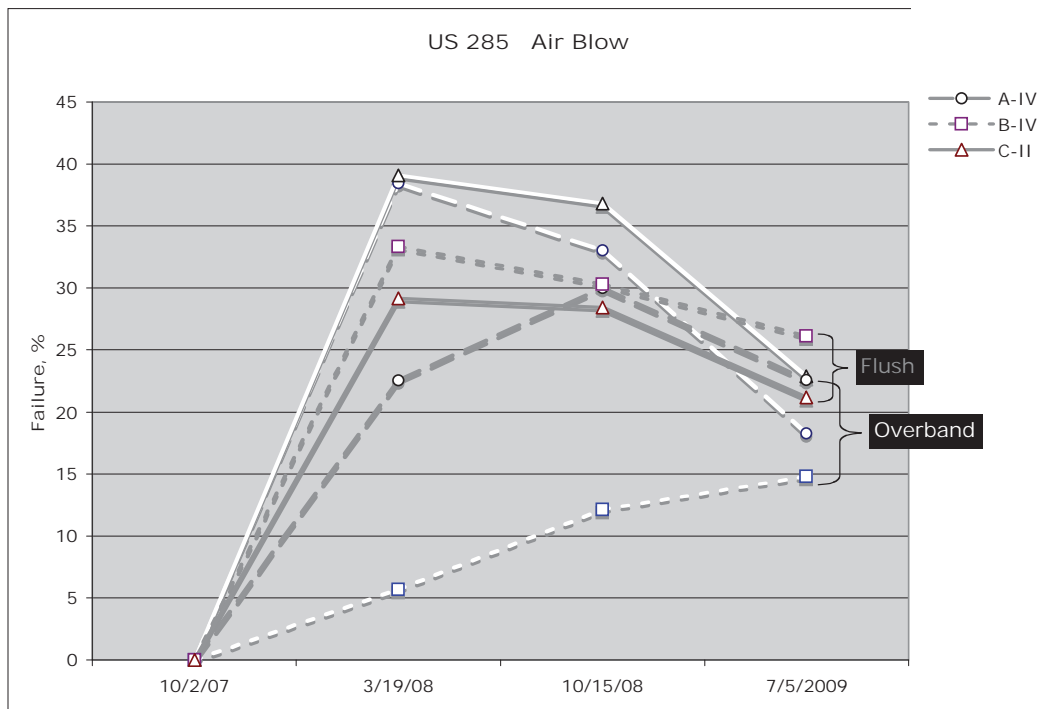
**Figure 8. Sealant Performance on US 285-Cracks Prepared by Air Blowing**

Analysis of the results from this study is challenging. There is variation in the data and few trends stand out consistently with the exception of one. It appears that for most of the conditions studied, performance of the crack sealants has not followed a linear path of an increase in failure over time, as might be expected. Instead, the failures increased from installation in October 2007 to the first survey in March 2008, continued to increase until the second survey in October 2008, then declined at the third survey in July 2009 to levels of failure approximately equal to that observed in March 2008. There are eight exceptions to this. These are on Figure 3, where Supplier A for the flush, routed application shows a consistent increase in failure rate over time to a total of 10 percent failure and Supplier B for the flush and overband, routed application shows a consistent increase in failure rate over time to a total of 3 and 4 percent failure. Also, from Figure 4 Supplier C increases to approximately 7 percent failure for the hot air lance and recessed application. Products B and C in Figure 6 for routed and overbanded application on US 285 reach approximately 2 and 4 percent failure. And Figure 8 indicates that Supplier B

reaches 15 percent failure for the air blow and overband process on US 285. Supplier C reaches 4 percent failure on US 350 in Figure 10 for a hot air lance and flush application and Supplier A-I has an 11 percent failure rate on US 350 for the air blow and overband application shown on Figure 11.

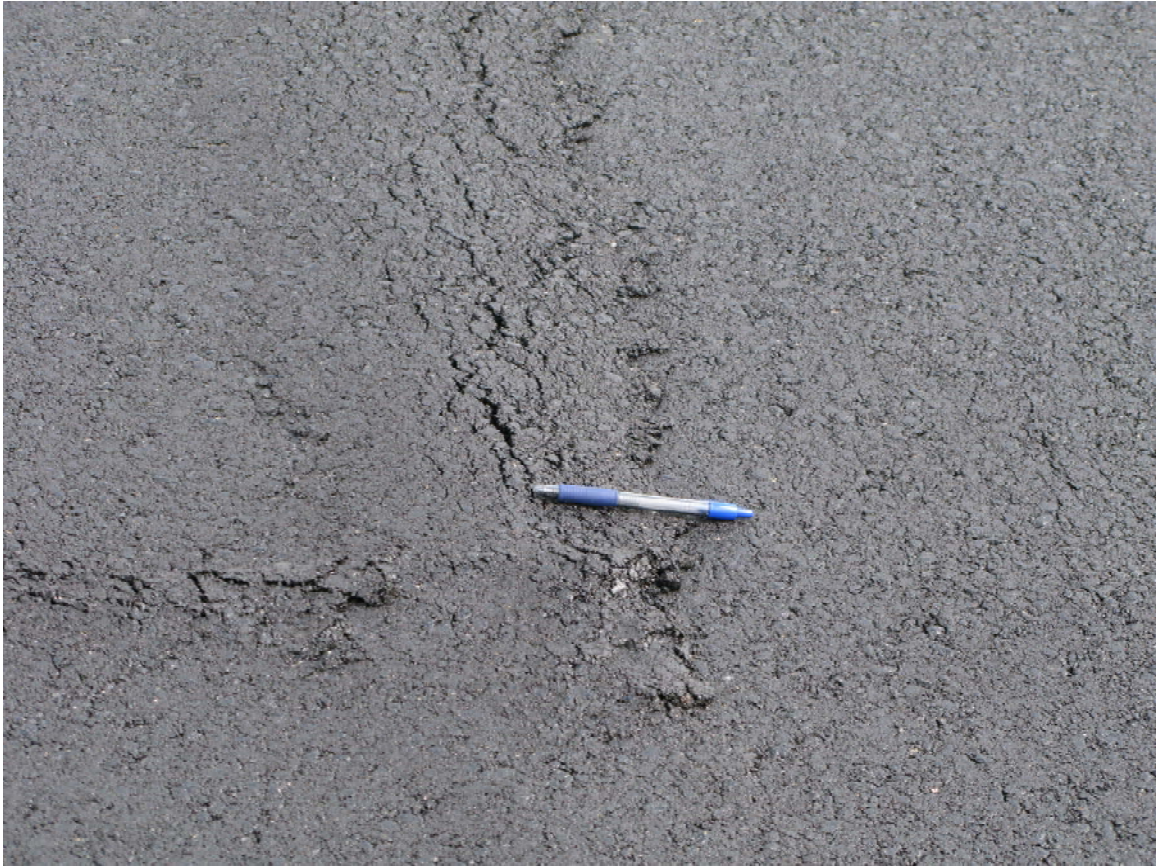
330 to crack 1. The experiment was repeated with some exceptions as shown in Table 7 in an attempt to ‘create’ the bumps and transverse cracks witnessed at cracks 271 and 272 in the southbound lane on September 2. The first evidence of bumps and cracks occurred at cracks 271 to 275 as shown in Figure 13. These bumps were much more severe than those witnessed on September 2 in the southbound lane.

**Figure 13. Bump and Transverse Cracks over Crack 271 on US 285**

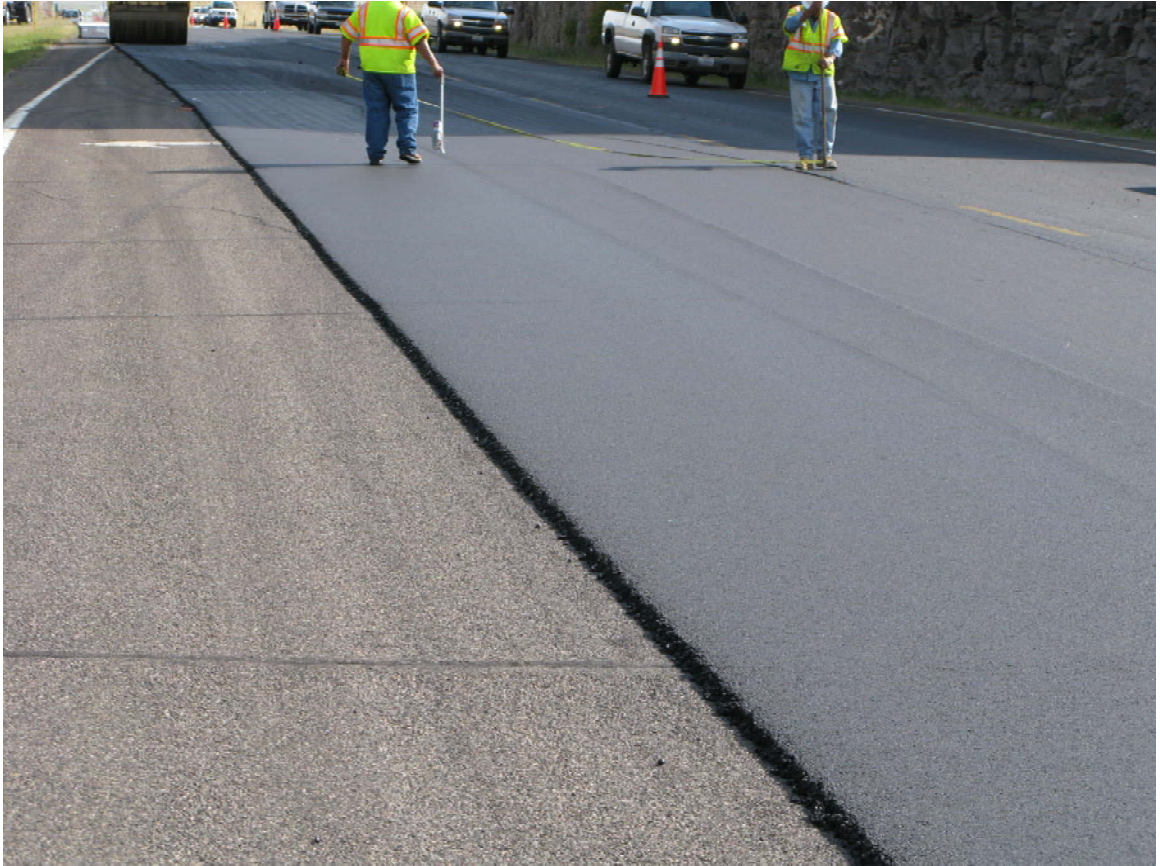
Second and third attempts to create the bumps and transverse cracks were done over cracks 199 to 204 and again at cracks 127 to 132. The results of this experiment are shown in Figures 14 and 15. The severity of the cracks and bumps appeared directly related to the number of passes of the vibrating roller. As cracks began to appear after the first pass of the roller, the contractor was reluctant to continue the experiment with additional roller passes. The severity of the cracks and bump shown over crack 271 was not observed over cracks 199 to 204 or 127 to 131 due to fewer passes of the vibrating rollers.

**Figure 14. Bumps and Transverse Cracks over Cracks 129, 130, and 131  
Northbound US 285**

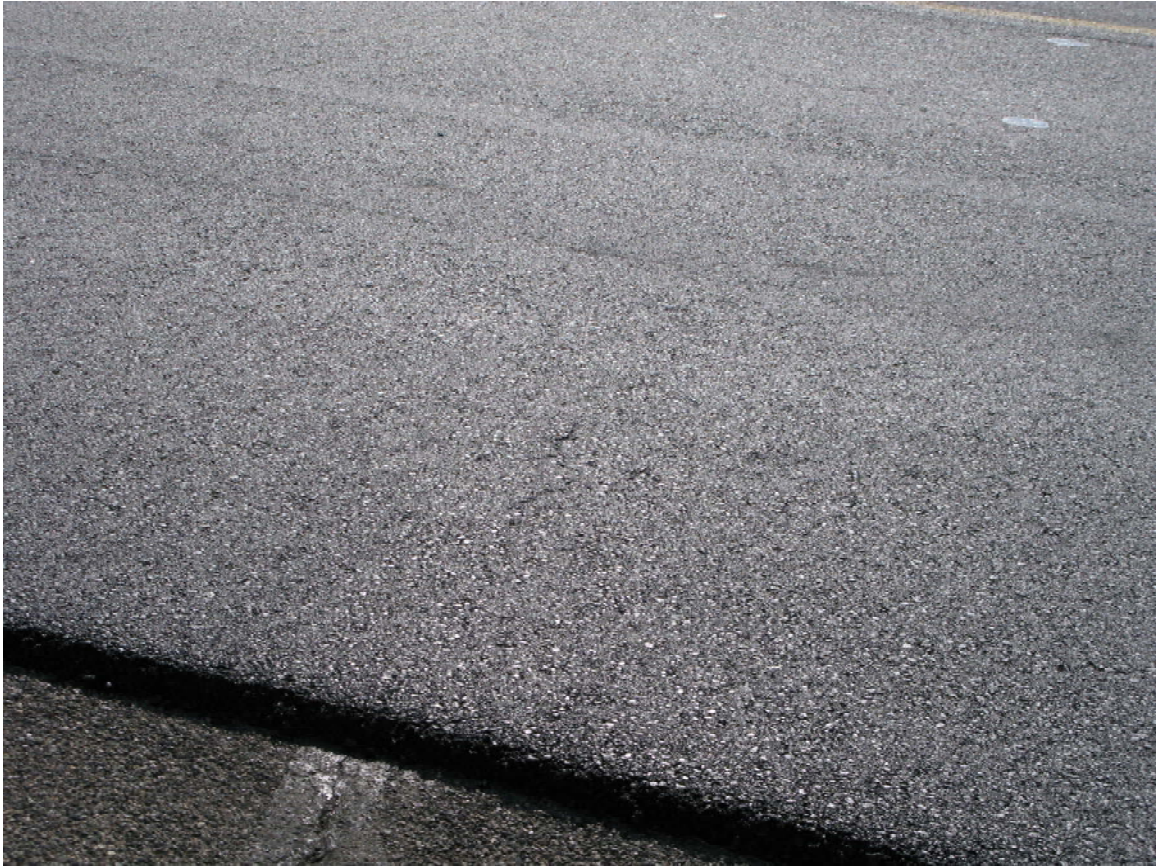
**Figure 15. Transverse Crack Forming over Crack 201 Northbound US 285**
