QUICK RESPONSE REPORT

VULNERABILITY OF REINFORCED CONCRETE FRAME BUILDINGS AND THEIR OCCUPANTS IN THE 2009 L'AQUILA, ITALY EARTHQUAKE

Abbie B. Liel¹

Kathryn P. Lynch²

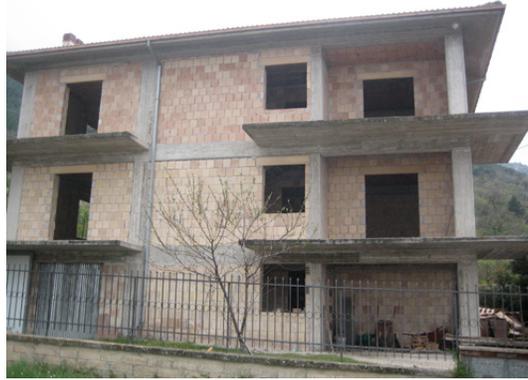
Figure 2a. Structural system and construction practices common in L'Aquila. Photos by Abbie Liel or Kathryn Lynch unless otherwise noted.

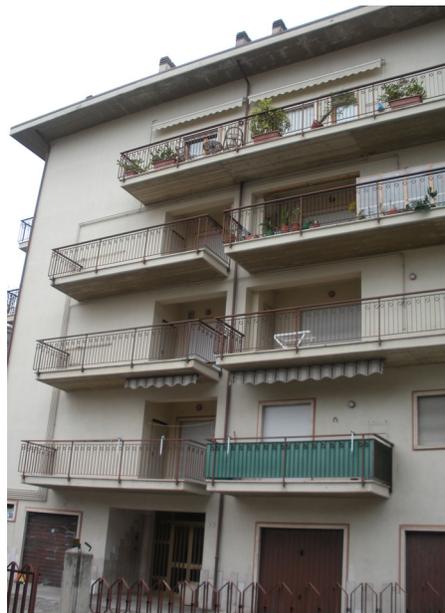
Figure 2b. Typical MFR building included in database (Building 222 shown here).

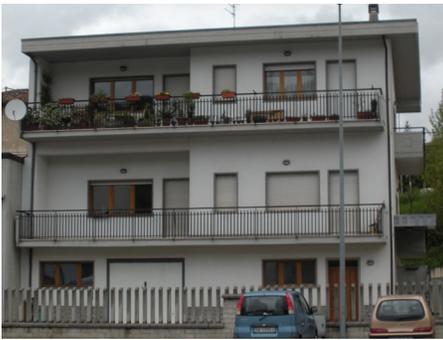
Figure 3a. Negligible Damage (Building 431)

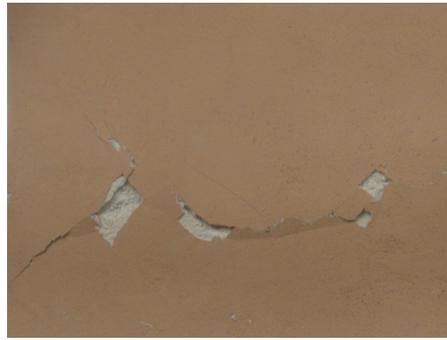
Figure 3b. Insignificant Damage (Building 206)

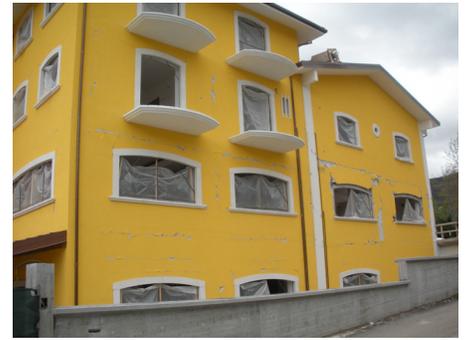
Figure 3c. Moderate Damage (Building 485)

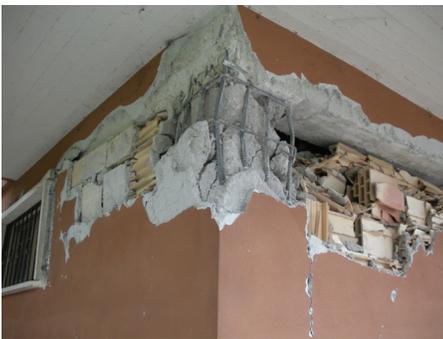
Figure 3d. Heavy Structural Damage (Building 214)

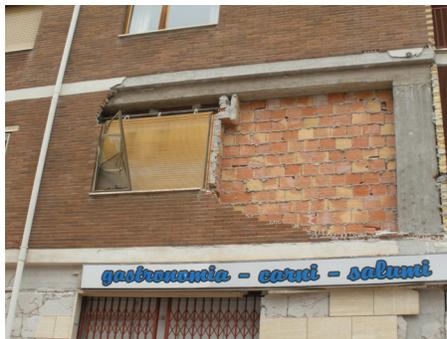
Figure 3e. Heavy Nonstructural Damage (Building 325)

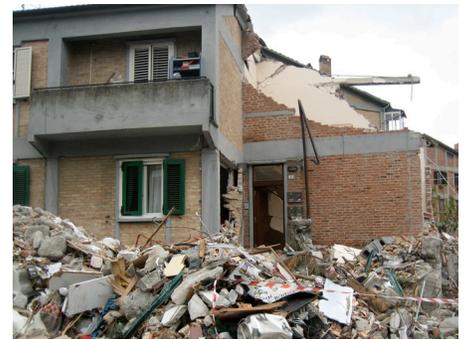
Figure 3f. Collapse (Building 372)

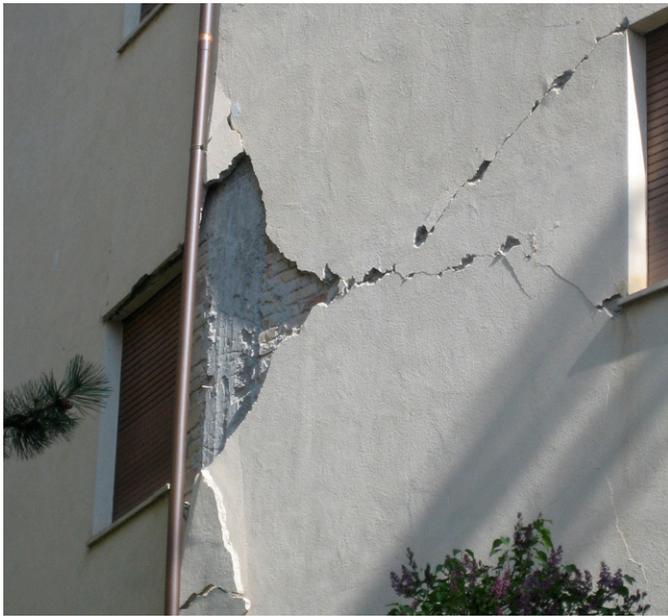
The most common source of nonstructural damage was cracking or complete brittle failure of masonry infill walls. In some cases (as in Figure 5a), walls experienced X-cracking characteristic of infill shear failure. These cracks often propagated from window openings in narrow wall piers. In other cases, infill failure resulted from out-of-plane failure at the connection between the infill and structural elements, as in Figure 5b. Moderate or more severe damage to masonry infill occurred in 29 percent of database buildings. Minor nonstructural damage included cosmetic cracking in plaster or brick facade or detachment of marble facade from structure.

Figure 5a. Common mechanisms of infill wall failure observed in database RC buildings. Shear cracks are illustrated here.

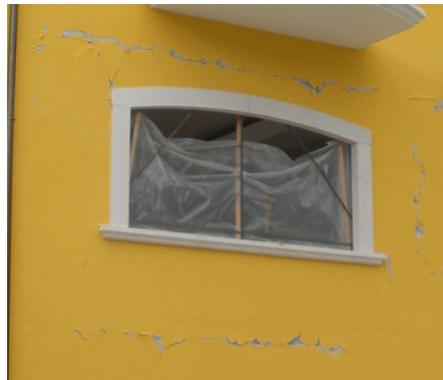
Figure 5b. Common mechanisms of infill wall failure observed in database RC buildings. Incipient out-of-plane failure (Building 485) illustrated here.

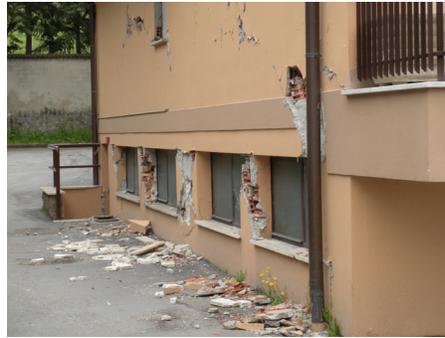
Failure mechanisms in structural elements included shear failure of short columns (Figure 6a), anchorage failures (Figure 6b), and compressive failure in columns (Figure 6c). These failure modes were initiated by well-known deficiencies in non-ductile RC design, including insufficient anchorage of longitudinal reinforcing bars and use of smooth (rather than deformed) reinforcing bars, column reinforcement

columns and beams and in the joint region (see also Camata et al. 2009; Bazzurro et al. 2009; Verderame et al. 2009). Short column shear failures most commonly occurred around window openings at the basement or garage level or were caused by infill configurations. Figure 6c illustrates detailing found in many of the structures, including widely spaced transverse reinforcement (approximately 10 inches on center), 90-degree hooks on shear reinforcement, and insufficient development length in beams.

Figure 6a (1). Shear failure of short columns (Building 344)

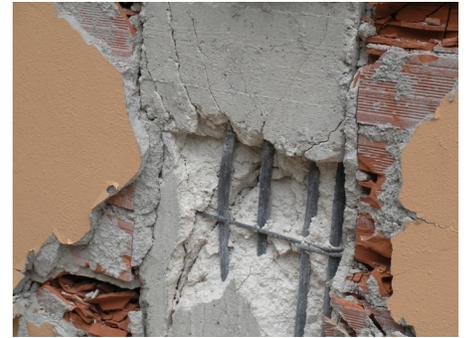
Figure 6a (2). Close up of shear failure of short columns (Building 344)

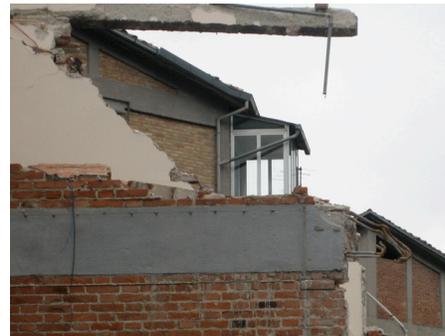
Figure 6b. Anchorage failure (in this case, in collapsed Building 372)

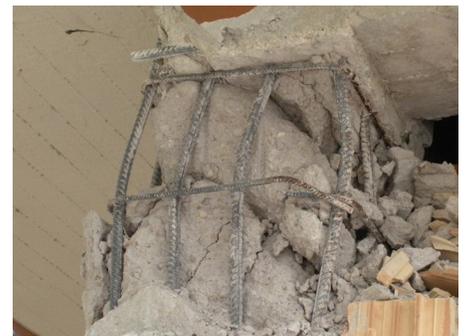
Figure 6c. Compressive failure at corner columns (Building 325)

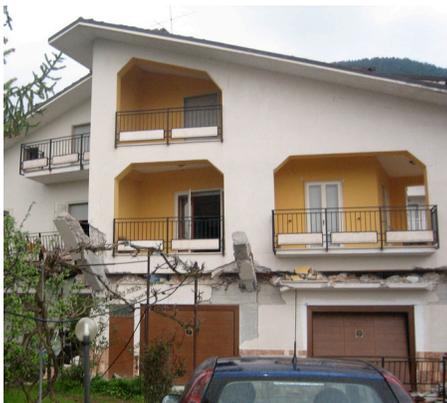
In buildings with garages or retail at the ground level, most damage occurred at the level immediately above the garage, as shown in Figure 7a-b. In many past earthquakes, for example the 1999 Duzce, Turkey, earthquake (Gur et al. 2009), damage in RC frame buildings is concentrated in soft-stories created by large openings for garages and retail space in the first story. We hypothesize that in many of the database structures, damage concentrates above the garage because the building is located on an incline and the garage/retail level is strengthened by soil on one or more sides. In other cases, like Figure 7c, structural damage is greater at building connections, due to pounding from adjacent buildings and lack of seismic joints.

Figure 7a. Damage concentration in the story above the garage in a partially collapsed single-family home in Pianola

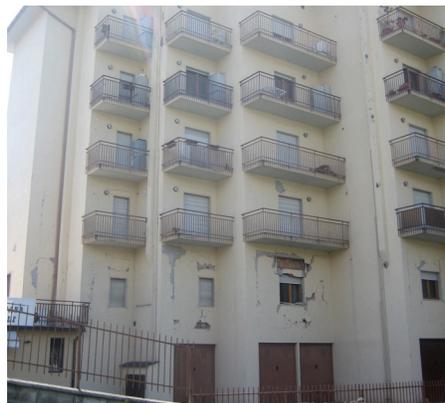
Figure 7b. Damage concentration in the story above the garage in an MFR structure in L'Aquila

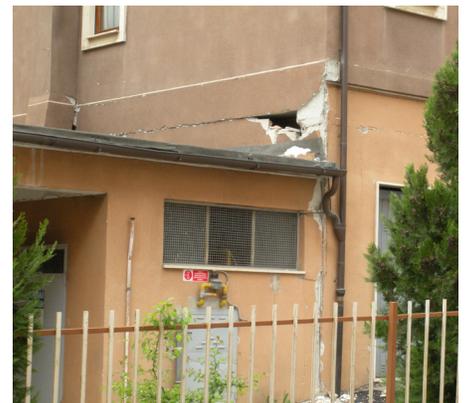
Figure 7c. Increased damage from pounding between Building 351 and garage structure

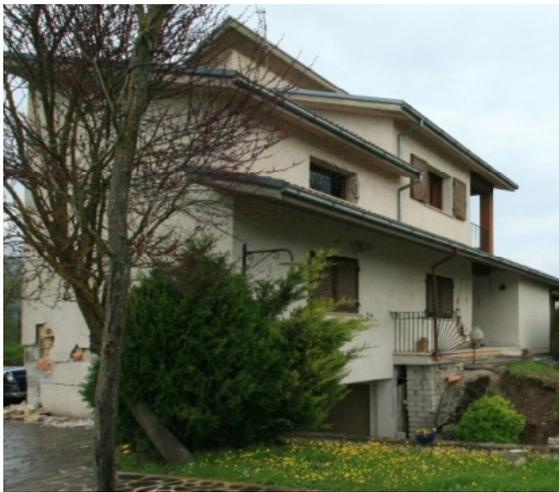
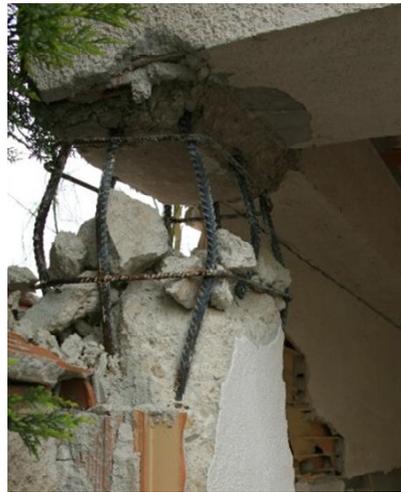
Figure 10. A building in Onna had an irregularly configured retaining wall in plan, which contributed to the structural damage (right).
