THE APRIL 30, 1987 TELLURIDE AIRPORT
LANDSLIDES AND RESULTANT DEBRIS FLOWS

Bruce K. Stover, Susan H. Cannon, and W. Rahe Junge

Colorado Geological Survey
Department of Natural Resources
Denver, Colorado

1987

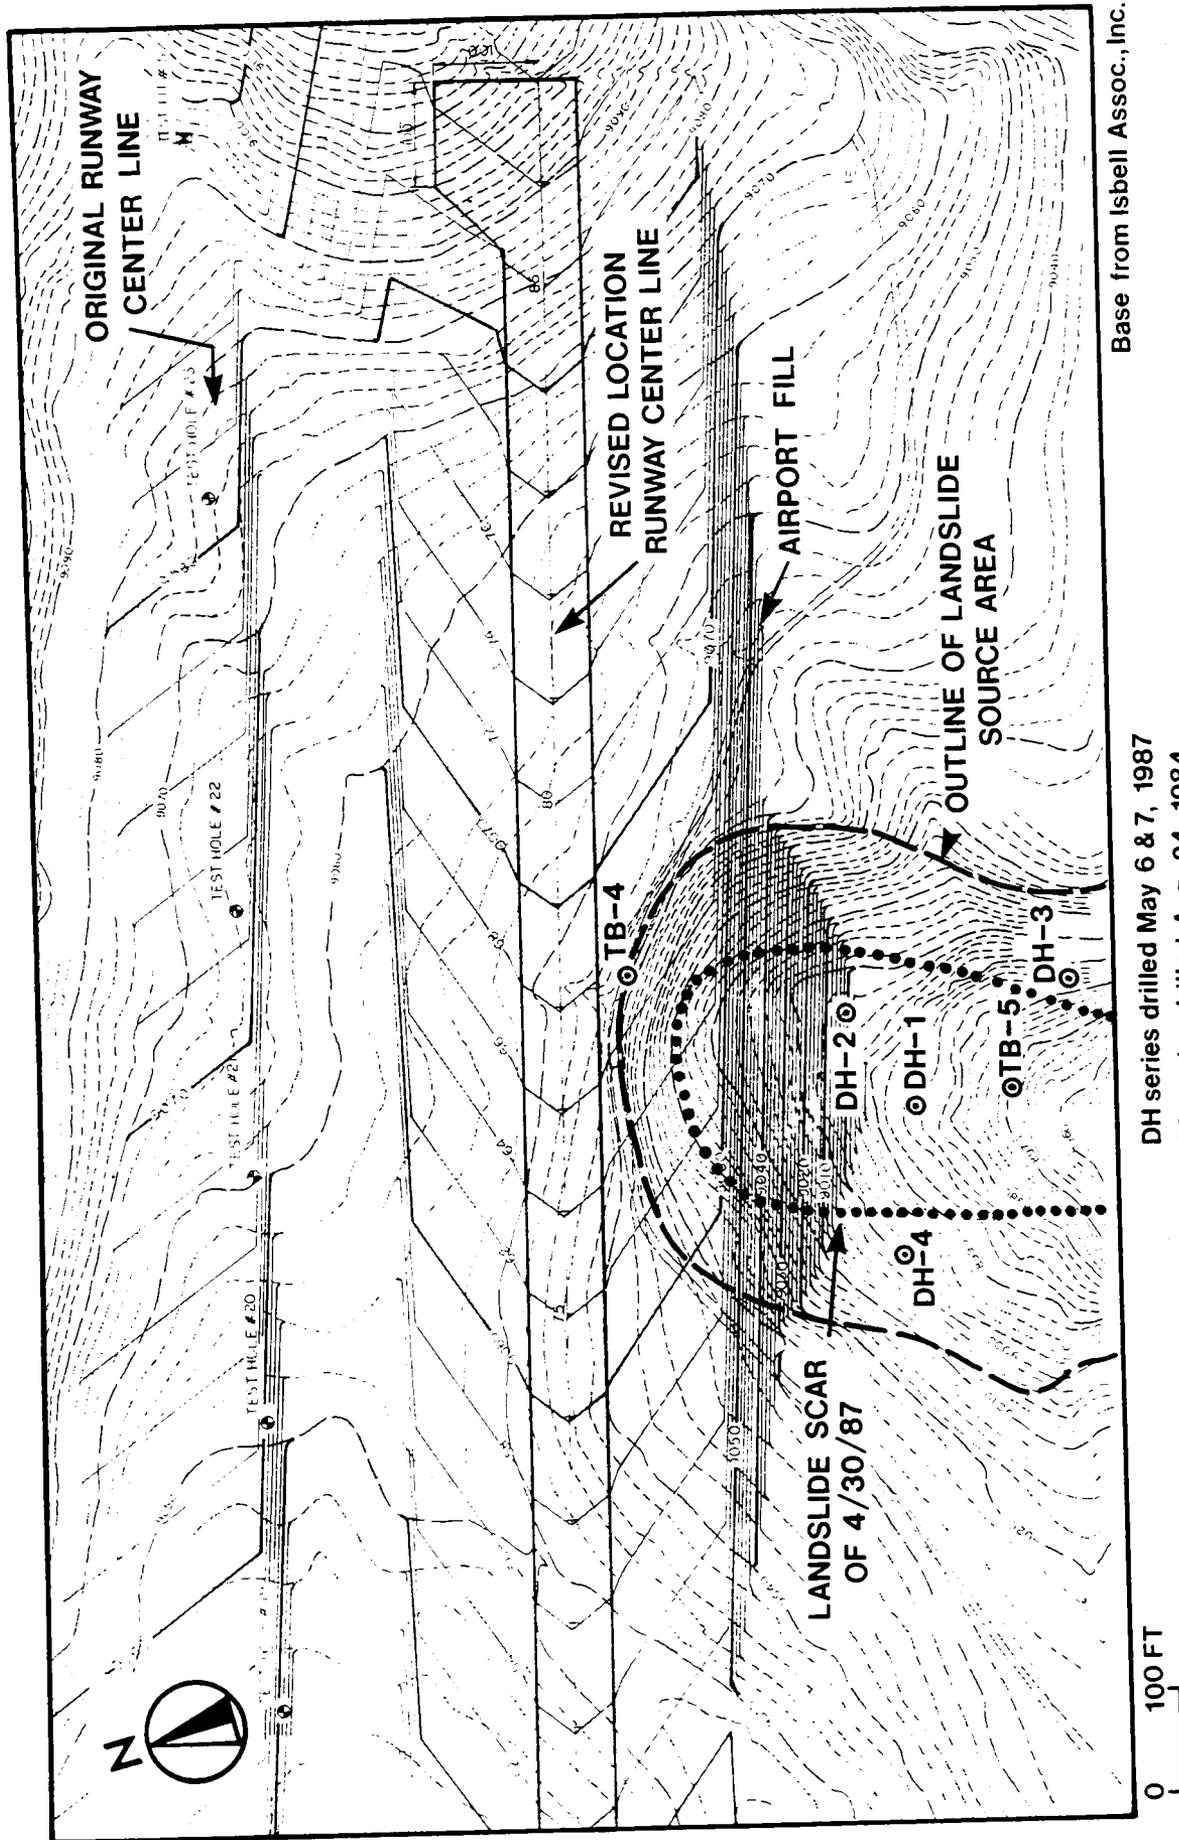
Figure 2. Map of landslide source area showing locations of test borings, fill configuration, and runway location.

Test borings by Lincoln DeVore, a geotechnical engineering firm, along the original proposed runway centerline (Figure 2) indicate that what had been previously mapped as Mancos shale outcrop was actually 5 to 15 ft of weathered colluvial clay overlying glacial clayey sands and gravels that extend to a depth of at least 20 ft. Water was present at the contact between the glacial deposits and the underlying Mancos shale.

Inspection of large-scale aerial photographs taken prior to airport construction (provided by Lincoln DeVore) indicates that the present landslide scar occupies a pre-existing landslide source area (Figure 2). The area consists of a bowl-shaped depression that outlets downslope over the edge of Deep Creek mesa. The slope of the head of the bowl is approximately 60%, and the base is approximately 17% and steepens to 30% in a narrow throat near the edge of the mesa. Test holes drilled by Lincoln DeVore during airport-siting studies, and on May 6 and 7 of this year, indicate that at least 20 ft, and at most, 32 ft, of colluvial silty clay, sand, and gravel derived from nearby Mancos Shale and glacial deposits have been deposited in the source area (Figure 4). The drill log for TB-5 describes saturated, silty clay to a depth of 13 ft, then gravel to refusal at 20 ft. Drill-hole 1 encountered water-bearing gravels and cobbles to 32 ft. A map of the airport site by Lincoln DeVore also shows five springs and a wet, marshy area on the floor of

In order to build the Telluride Airport runway a fill prism of Mancos Shale derived from nearby "Windy Knoll" was placed across the upper part of the landslide source area (Figure 2). The fill was up to 70 ft thick with a 2:1 slope and extended 270 ft southward into the source area.

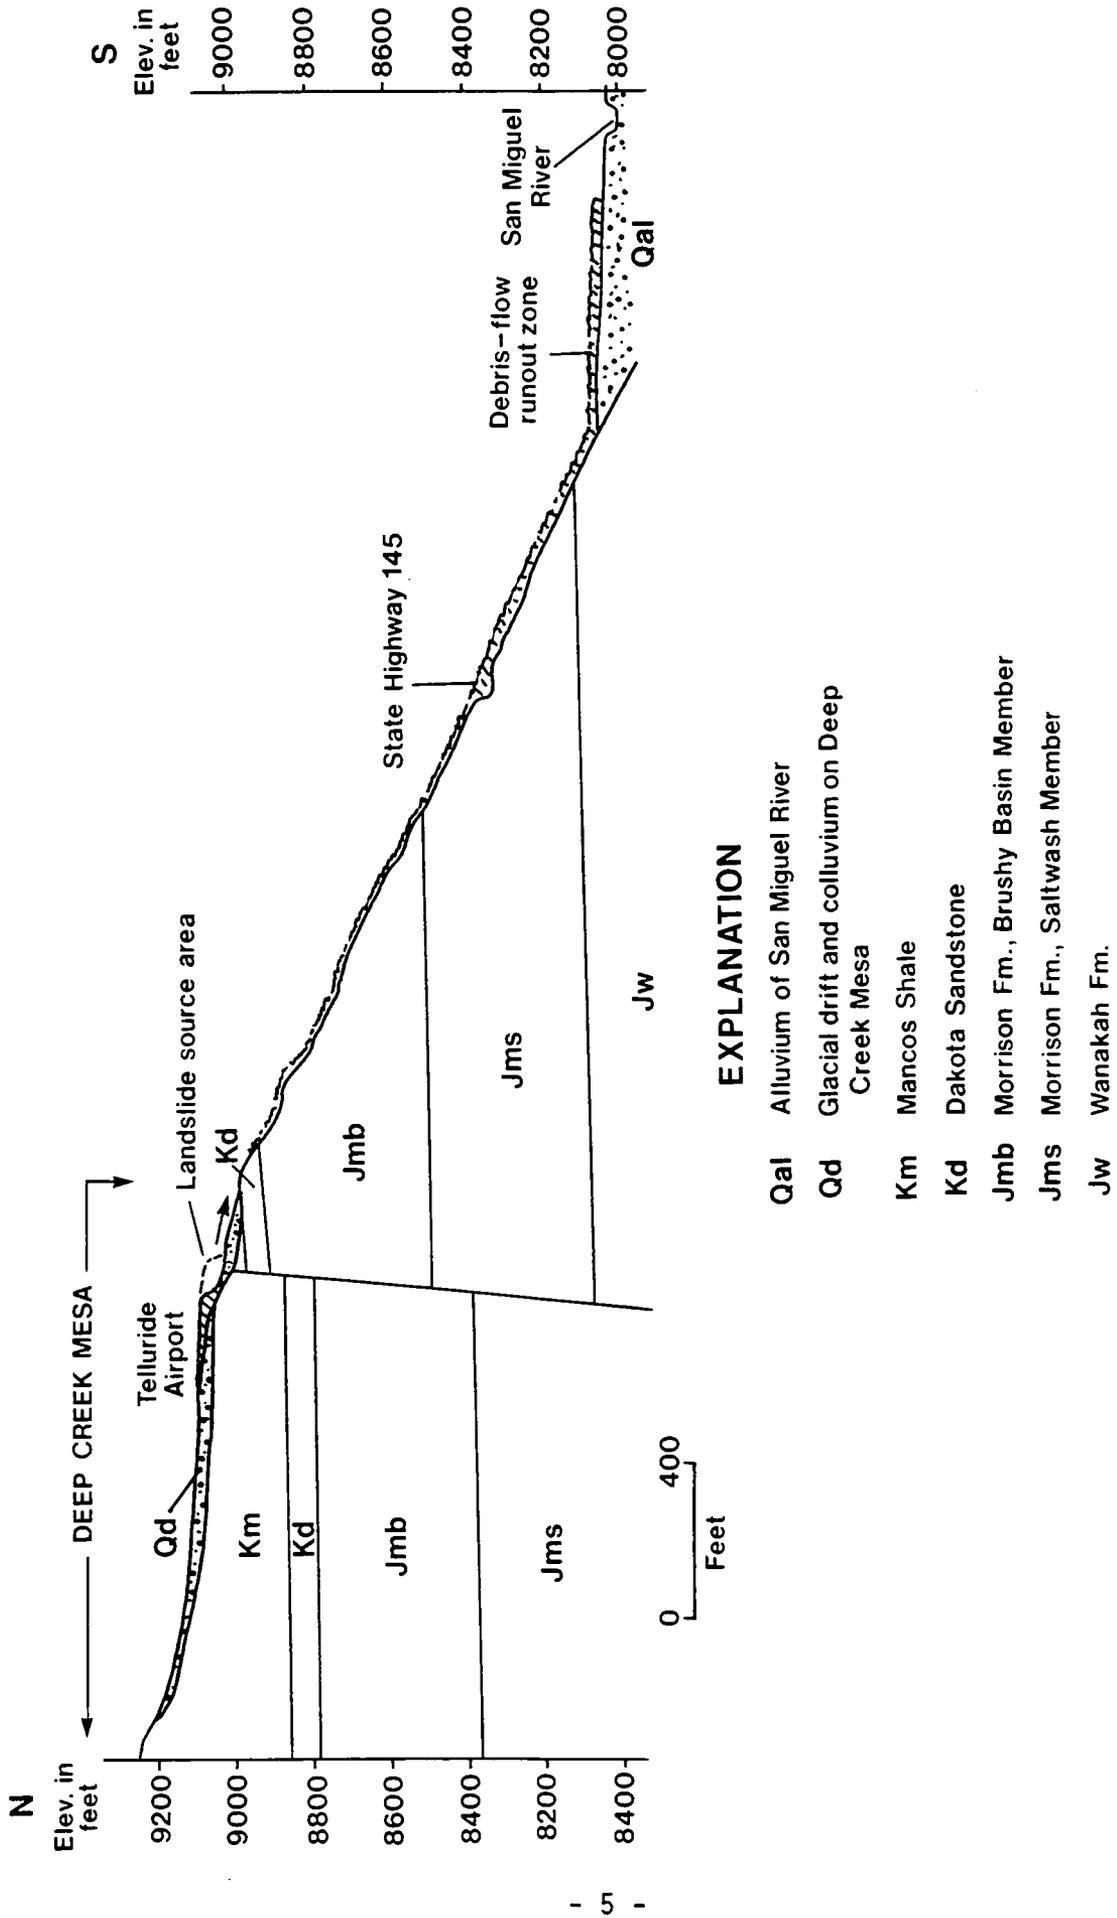
Figure 3. Schematic-geologic cross section of Telluride Airport landslide and debris flow.

Deep Creek Mesa is underlain by interbedded sandstones and shales of the Cretaceous-age Dakota Group and the Mancos Shale (Figure 3). The Dakota Sandstone forms the resistant rim of the mesa, the remainder of which is underlain by Mancos Shale. These units dip approximately 3° towards the northeast. Scattered patches of glacial drift overlie the Mancos and Dakota in swales and form small isolated hills on top of the mesa. The glacial deposits consist of brownish to brownish-orange silty clays, clayey sands, granitic and volcanic gravels, cobbles, and boulders.

In the area of concern, the east-west trending Vanadium fault (Bush, et al., 1961) displaces the Dakota Sandstone up against the Mancos Shale approximately 350 ft from the edge of the mesa (Figures 1 and 3).

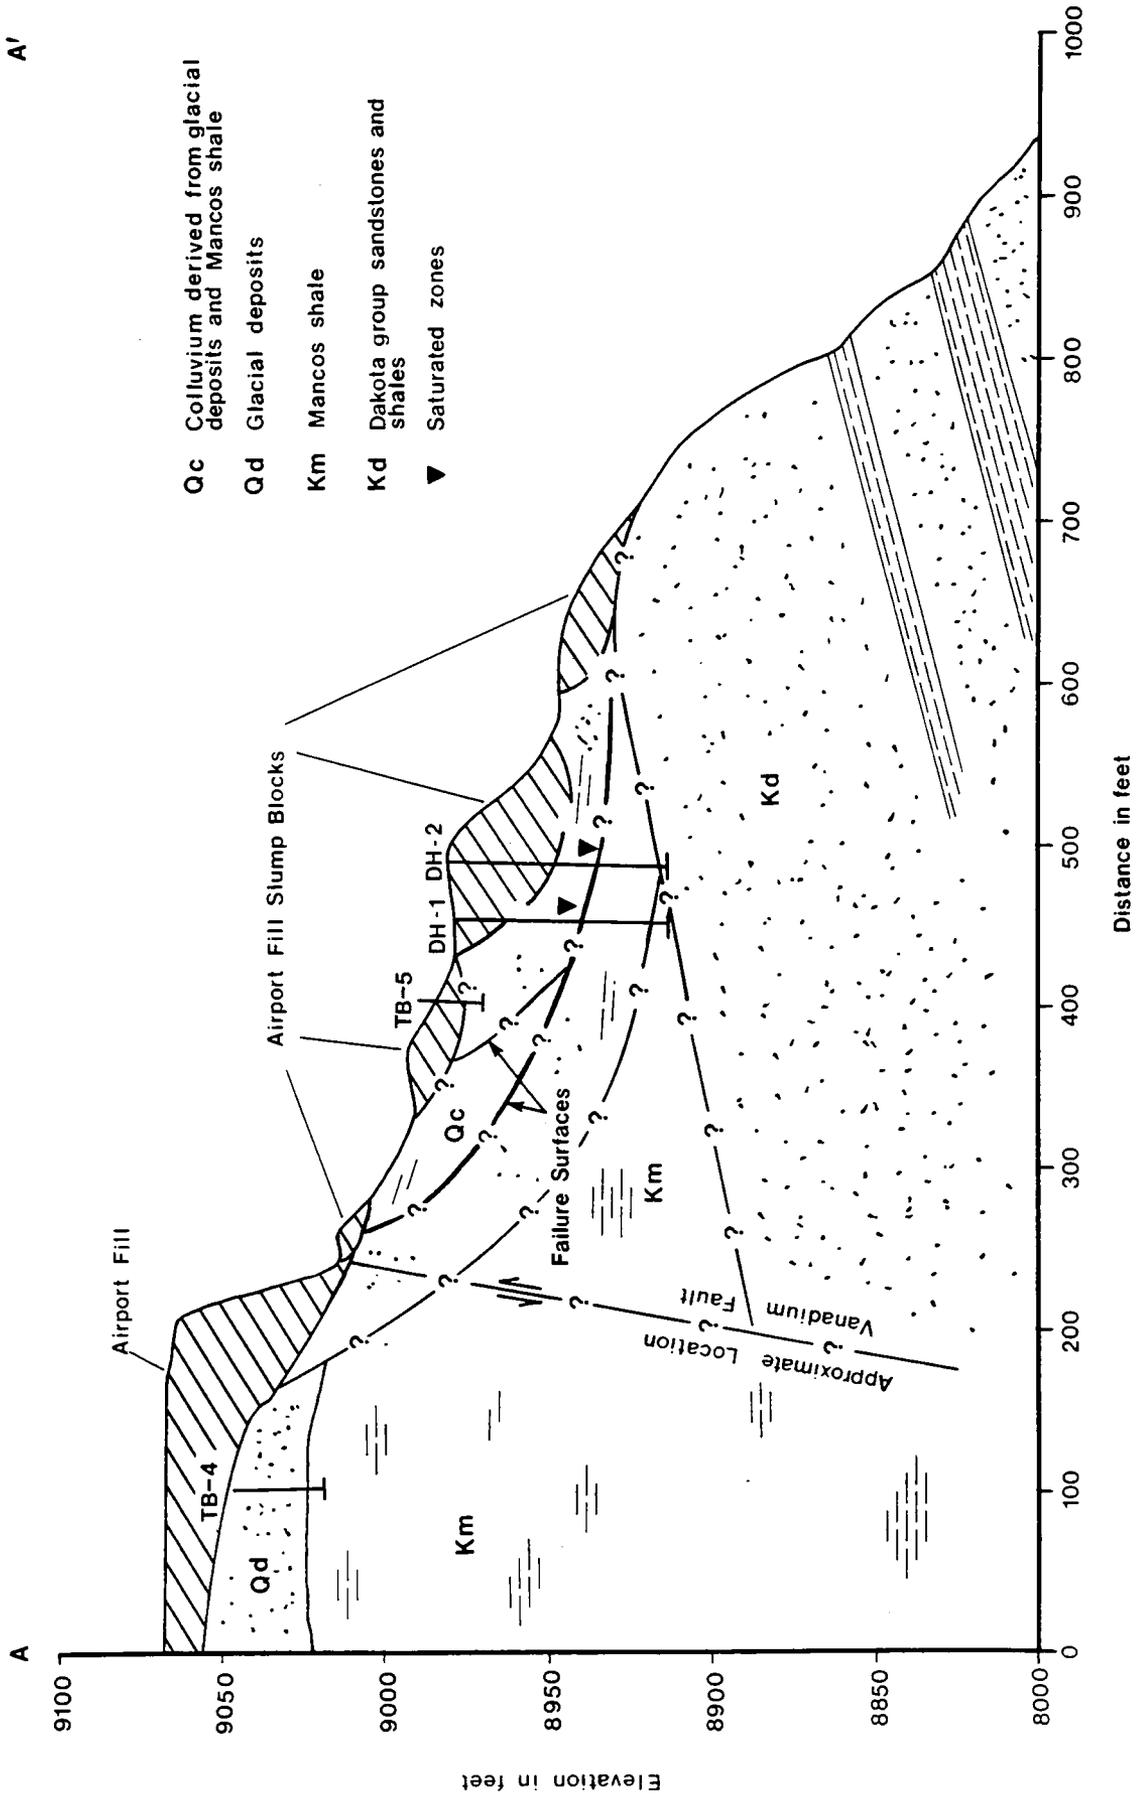
Figure 4B. Geologic cross section through landslide source area following movement.

The landslide scar is located in a pre-existing landslide source area that had been partially filled by engineered materials (Figures 2 and 4, Plate 1). Portions of the runway and safety zone of the Telluride Airport are constructed on the fill, and the headscarp of the failure is in the fill (Figure 4B). The day following the event, the fill exposed in the headscarp was essentially dry.

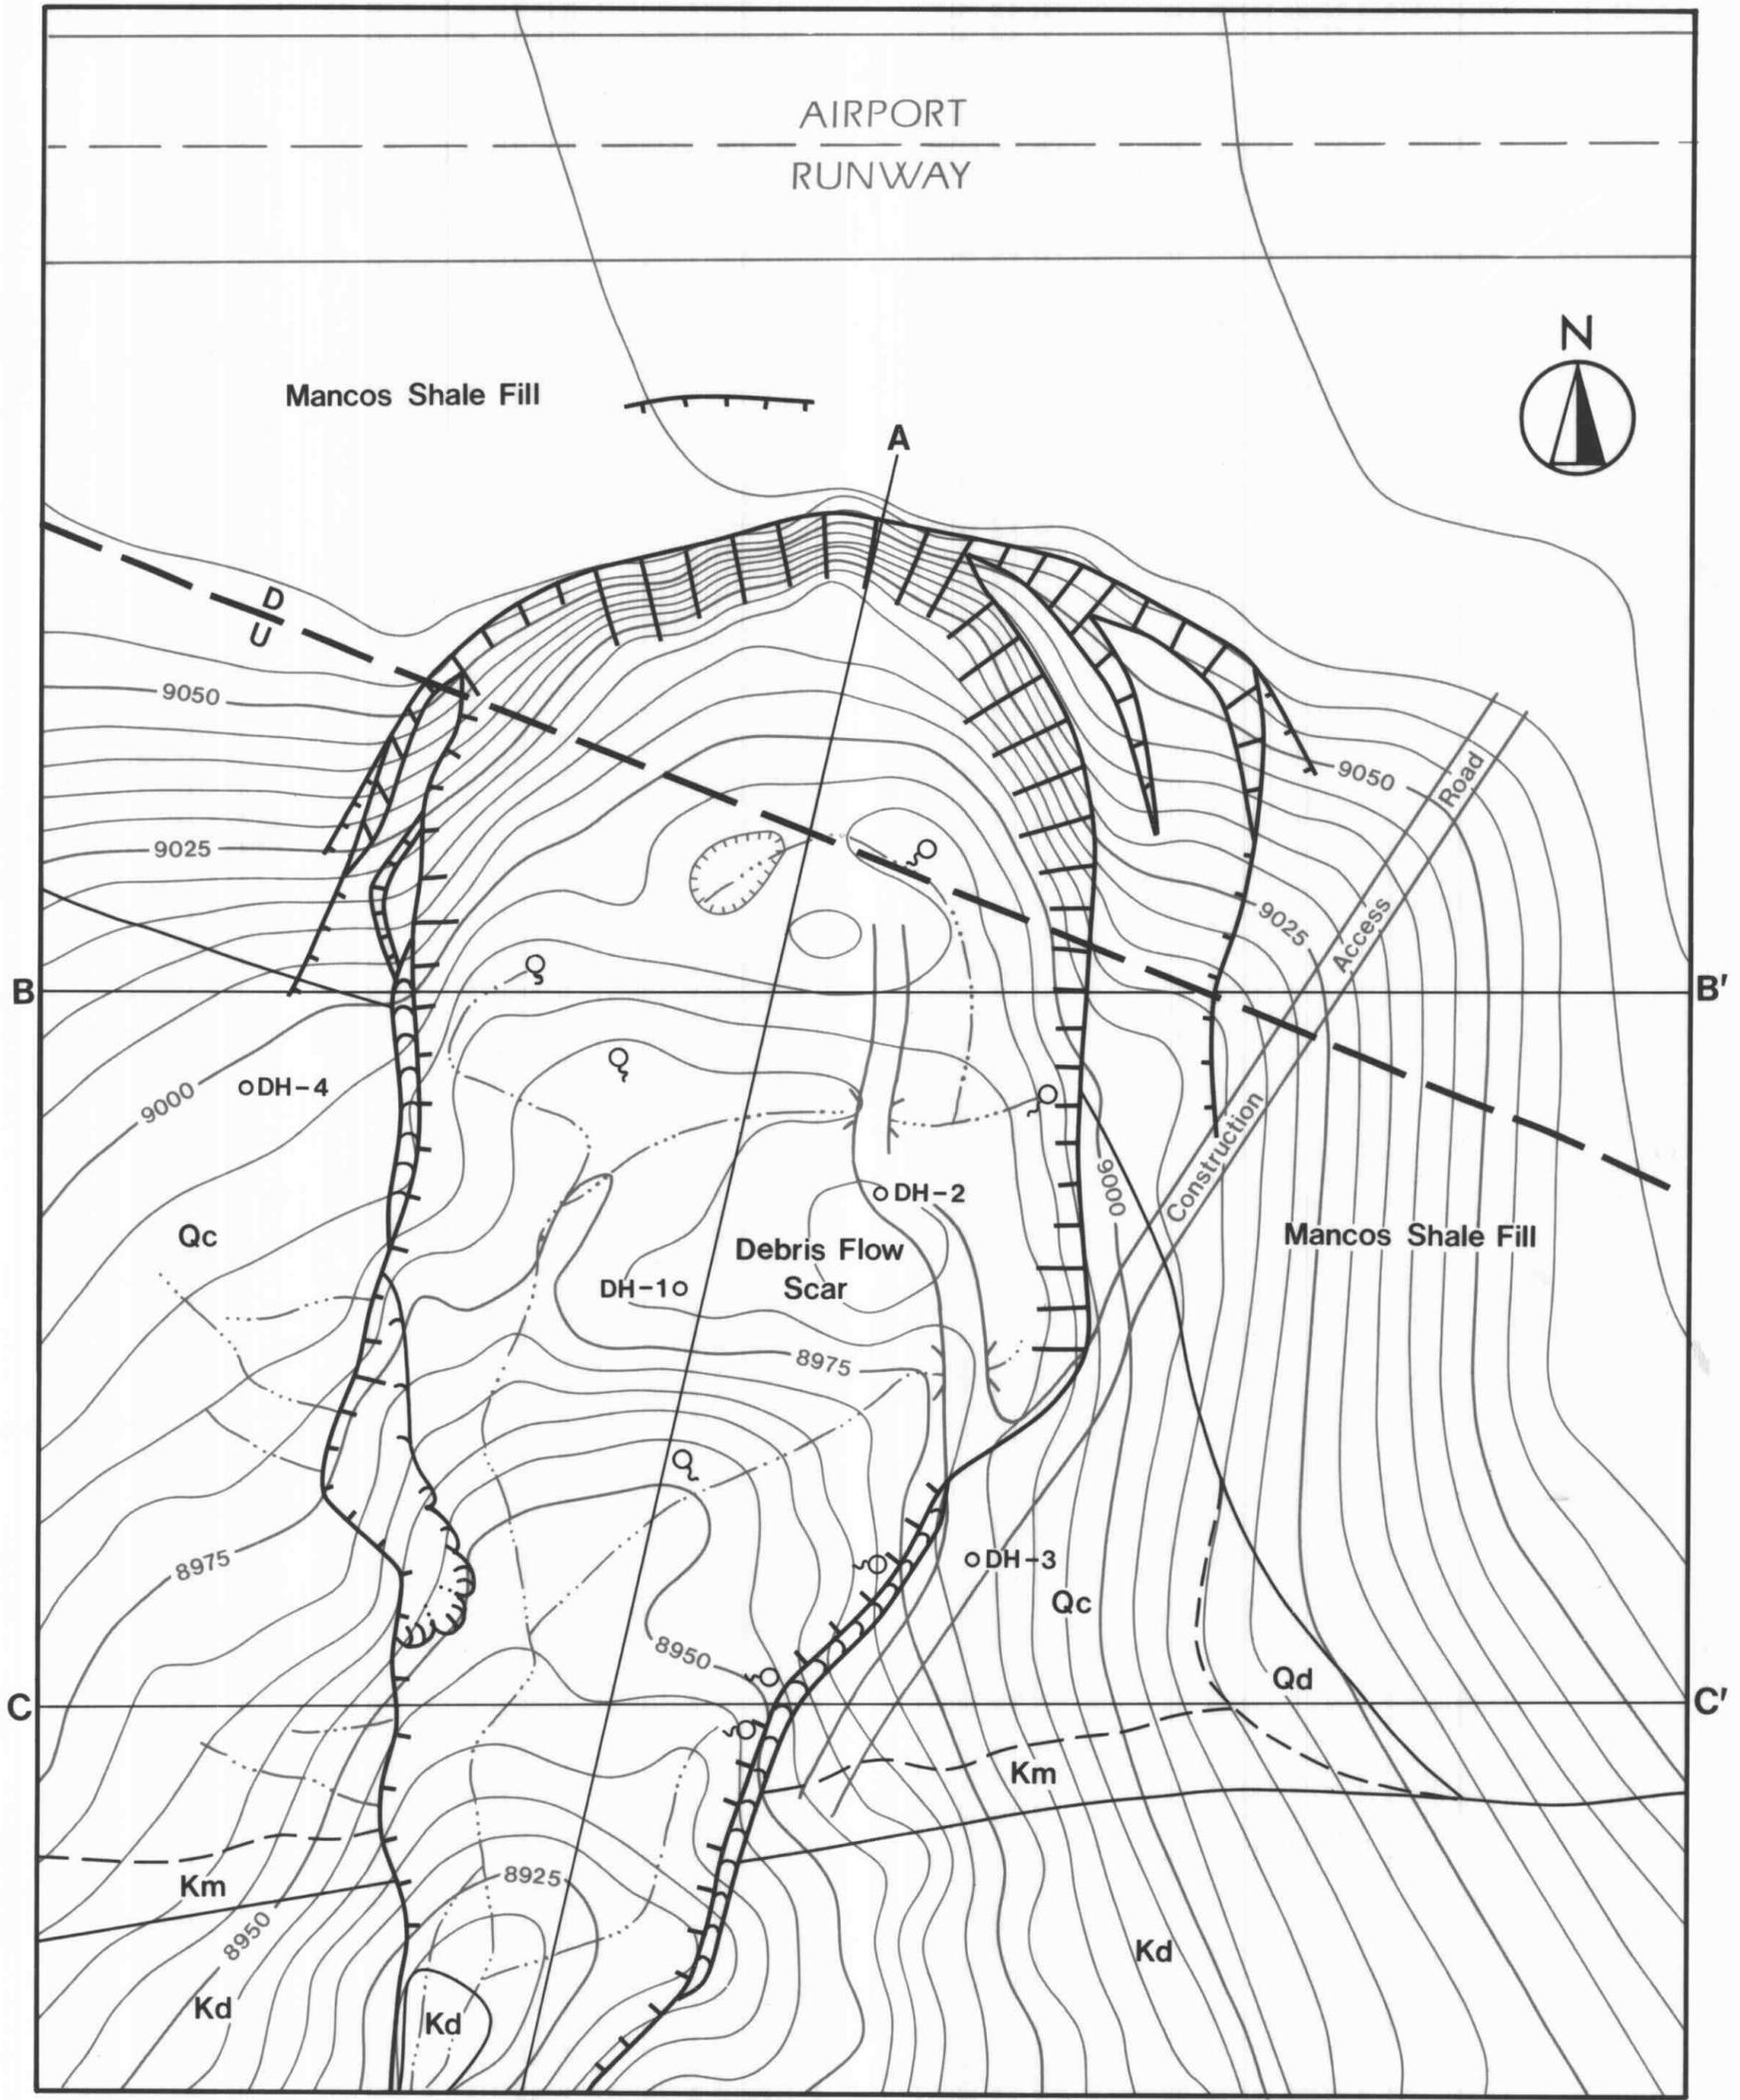
Topographic and Geologic Map of the Telluride Airport Landslide

An additional fill prism (not shown on the available grading plan [Figure 2]) was constructed parallel to, and on the eastern edge of, the source area (Plate 1). This fill covered a small surface drainage channel.

The sides of the landslide scar extend from the toe of the fill 380 ft to the edge of the mesa. The u-shaped scar is 300 ft wide and 52 ft deep at its head, and narrows and thins to 130 ft wide and 2 to 3 ft deep at its lip (Plate 1).
