Report No. CDH-DTP-R-84-4

BRIDGE DECK
REPAIR AND PROTECTIVE SYSTEMS
LATEX MODIFIED CONCRETE TOPPING

HERBERT N. SWANSON
Colorado Department of Highways
4201 East Arkansas Avenue
Denver, Colorado 80222

Interim Report
July, 1984

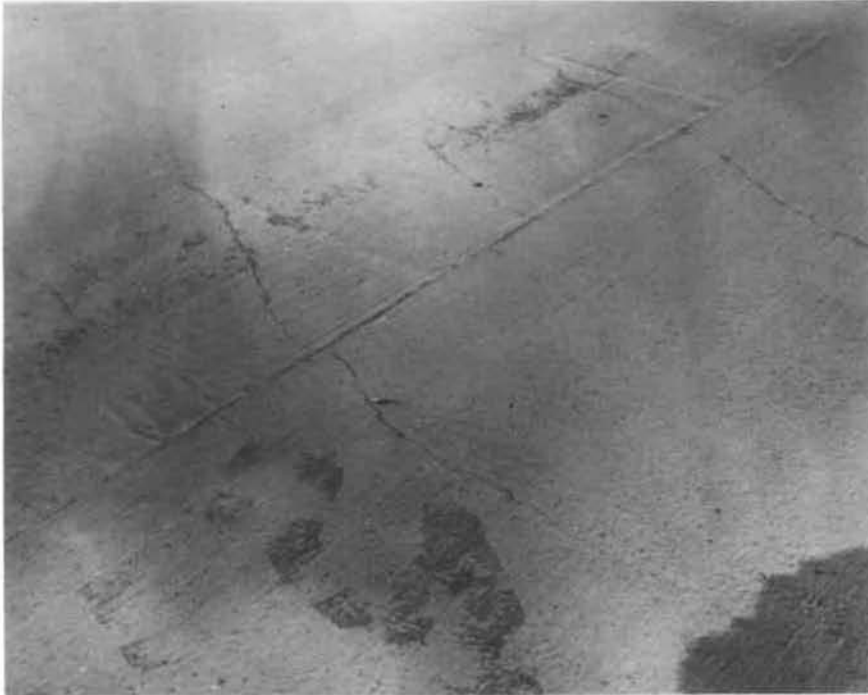
Photo #1

This structure was built new and topped with latex modified concrete. Hairline cracks showed up on both the surface and the underside within the first year. Surface cracks present in the spring of 1977 increased in number, length and width by December 1977.

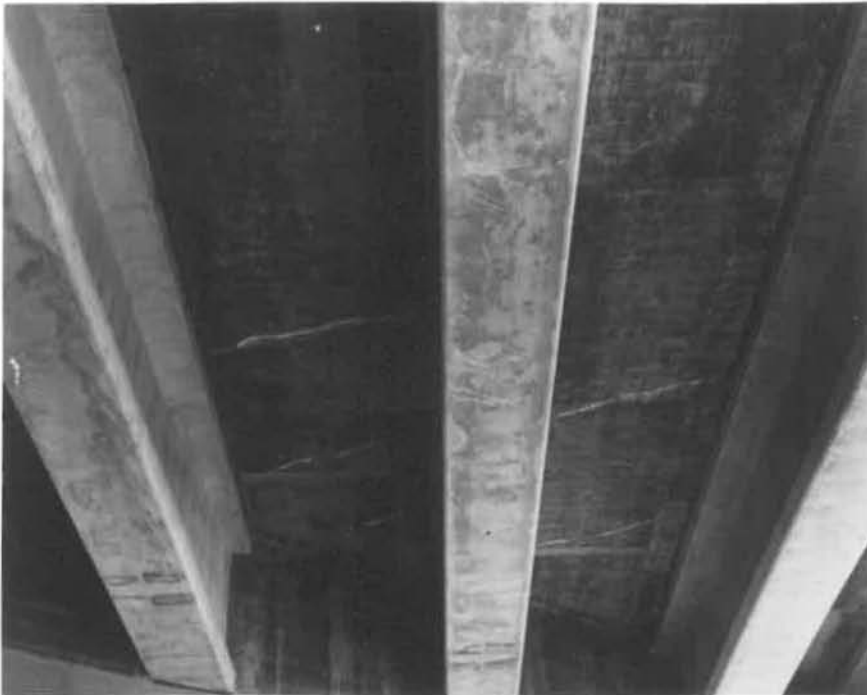
Photo #2

Cracks through the deck show salt evaporates to the underside. December 1977. Although this cracking was disappointing it was hoped that salt contamination and subsequent deterioration would be limited to the narrow vertical cracks.

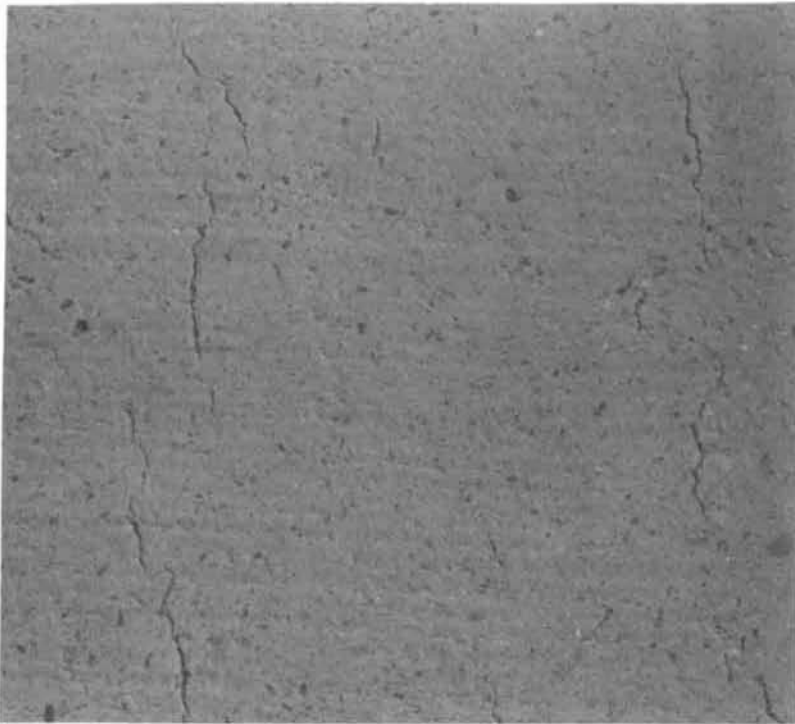
Photo #3

Cracking had increased on the surface of the deck in 1980.

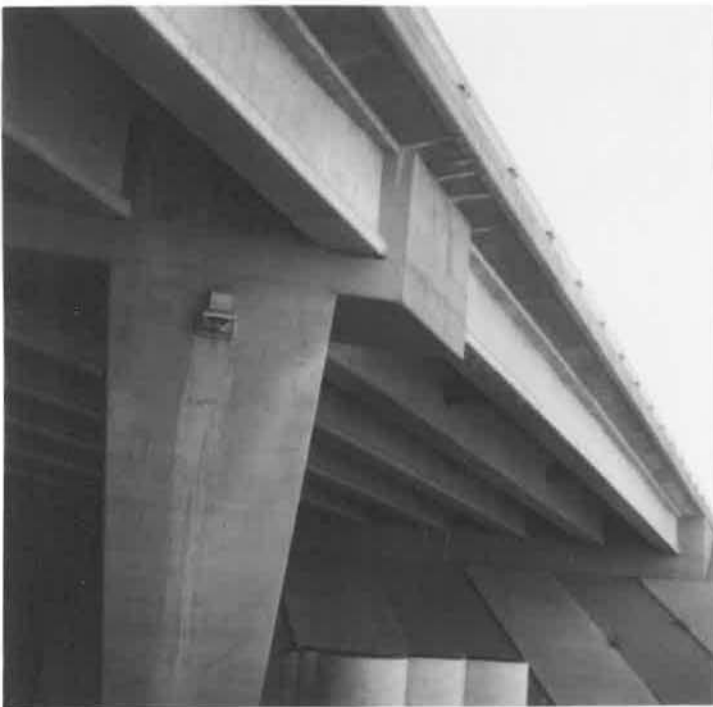
Photo #4

More salt stains were present on the underside of the deck in 1980.

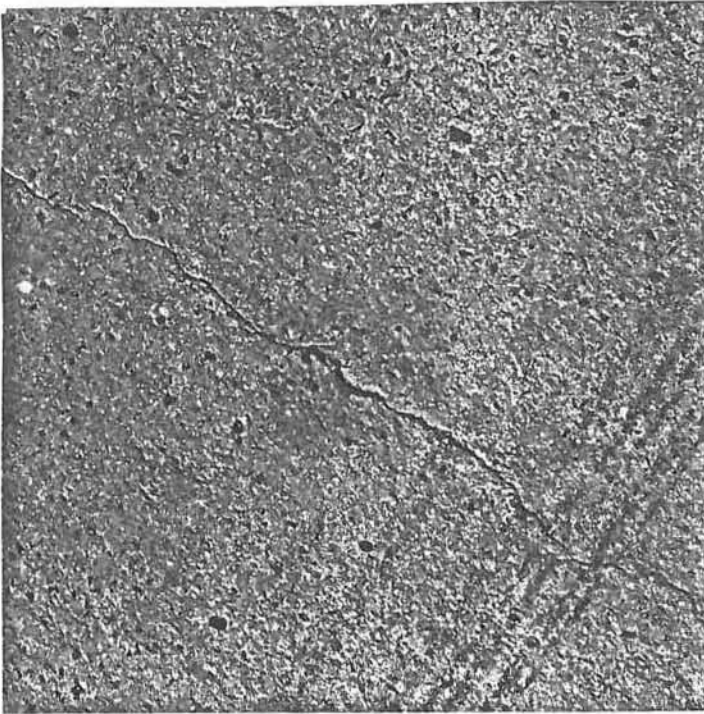
Photo #5

Surface cracks are visably
larger Feb. 84

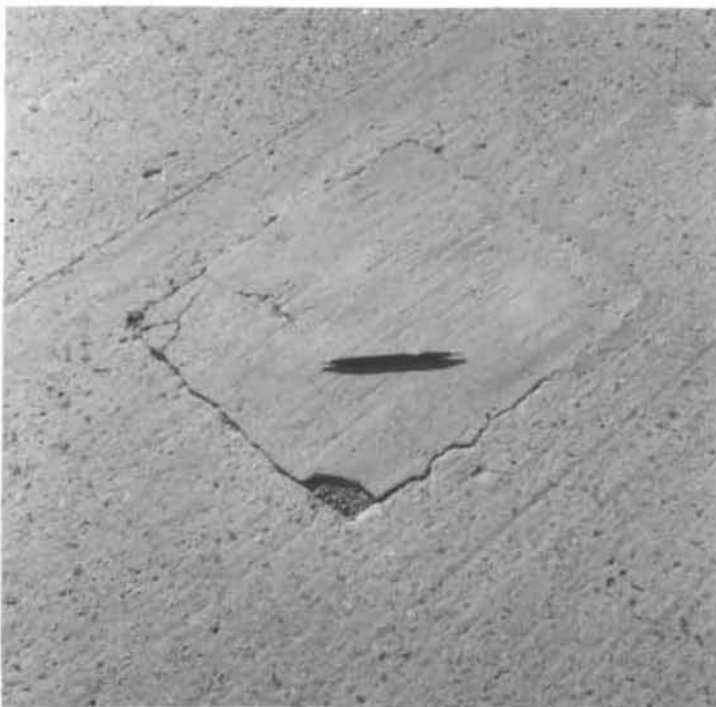
Photo #6

Seven one foot square
duracal patches have been
placed by maintenance
forces. These are
surface patches generally
less than 2" deep. Feb. 84

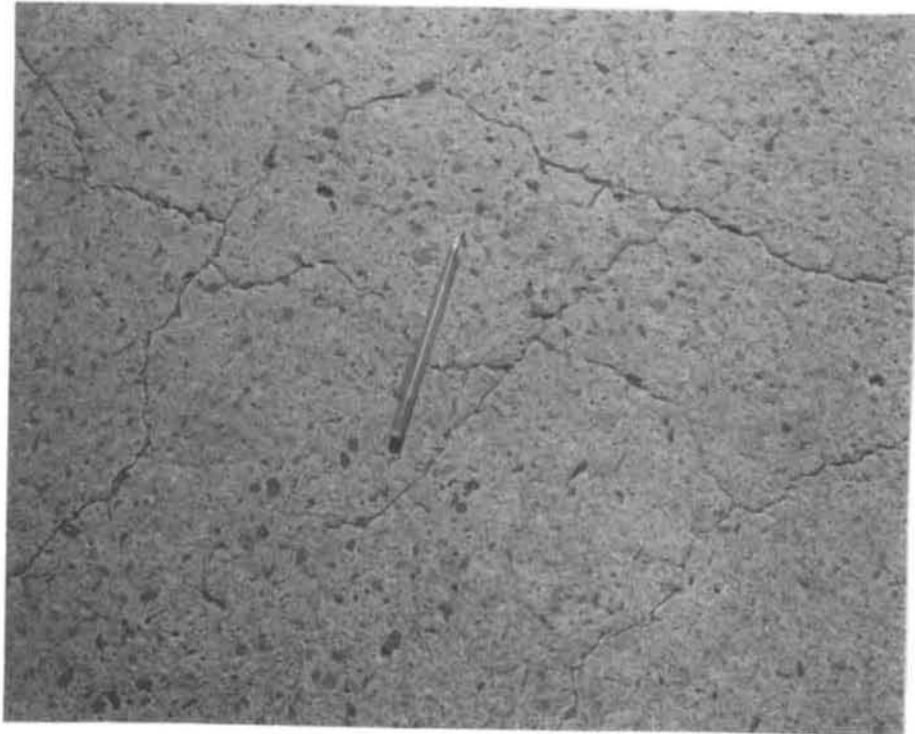
Photo 7

Sept. 1980
Close-up of
typical cracks.

Structure E-17-DQ is I 76 west bound over state highway 85. The surface showed many hairline cracks within two years after it was repaired. These cracks covered approximately 30% of the surface by 1982 (6 years after repair). By 1984 the surface was cracked to about 80% of the area and a pothole has developed near the west end which has been patched with asphalt.

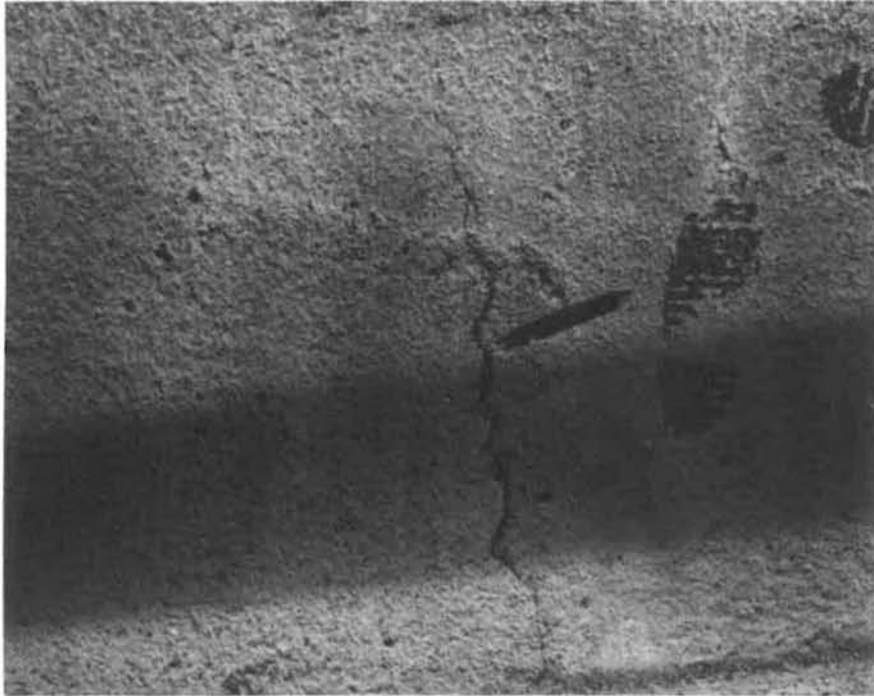
Photo # 8

Surface cracks started to appear in the latex modified surface as early as December of 1977.

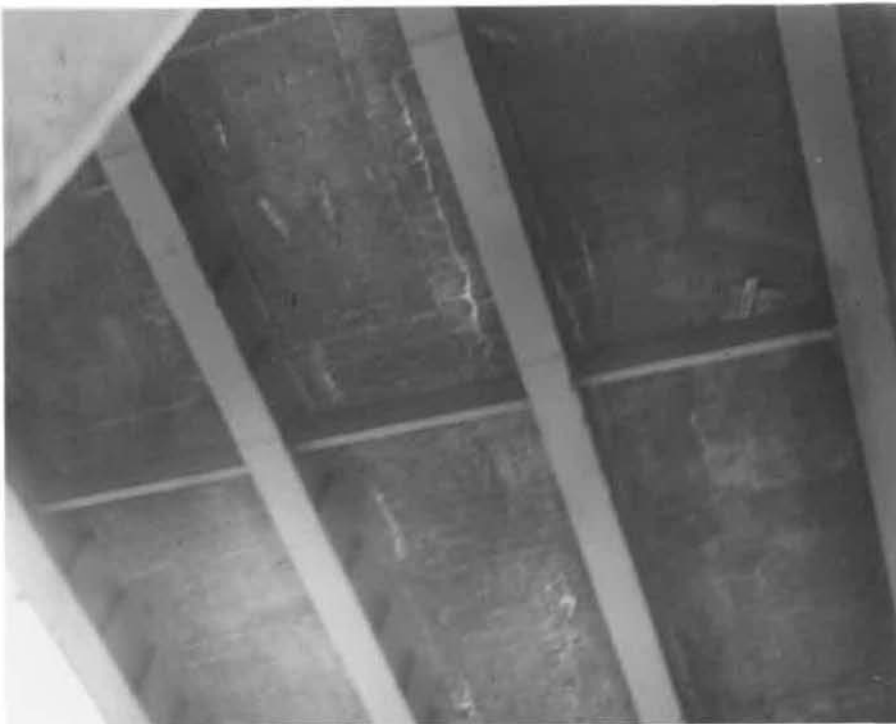
Photo # 9

Cracking and salt precipitates were visible on the bottom of the deck, however most of this salt was here before the repair took place. Dec. 1977.

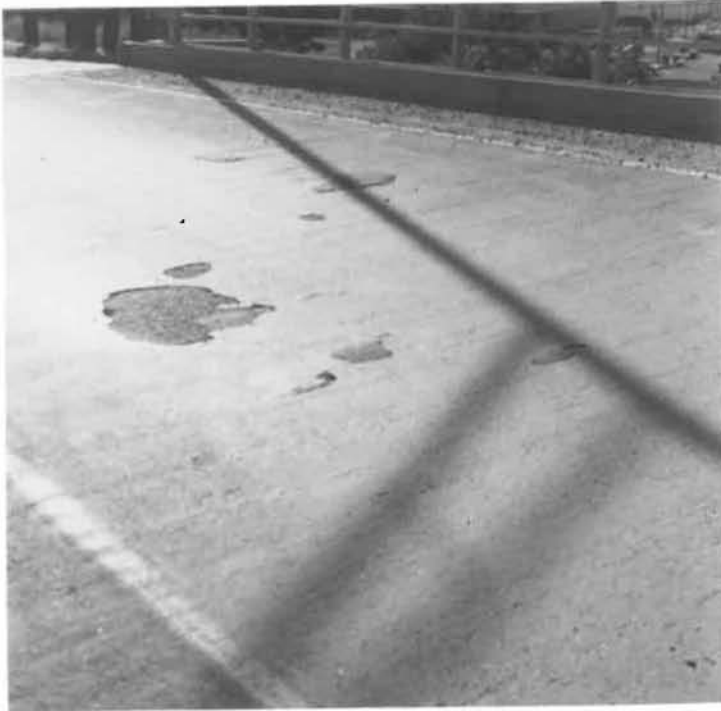
Photo # 10

Several pop outs had occurred in the south span by 1982.

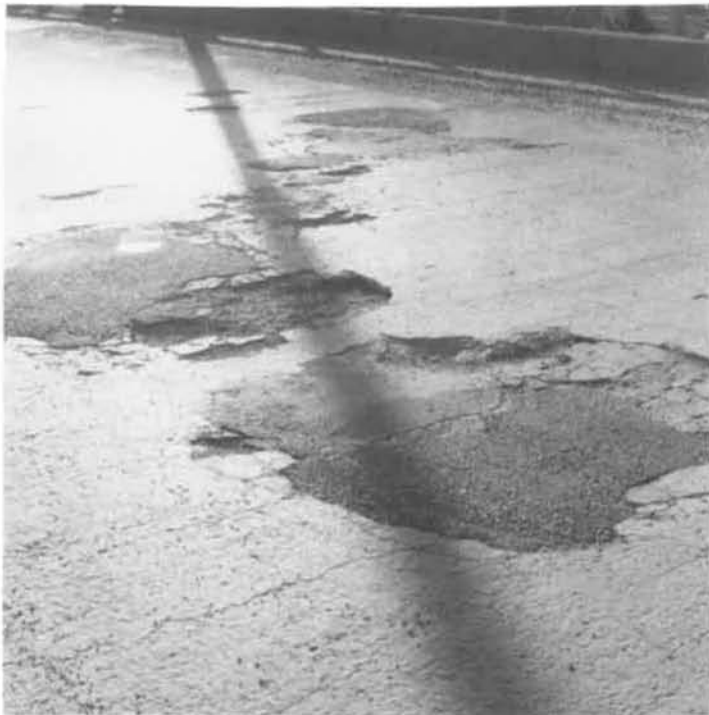
Photo # 11

Delamination and popouts became quite extensive by 1984.

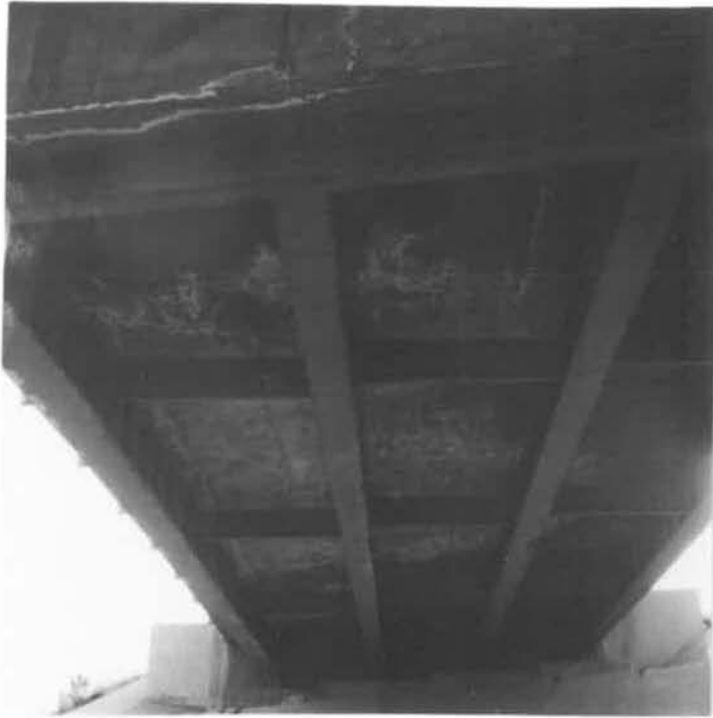
Photo #12

There was much more salt precipitates on the underside of this deck in 1984 than there was just after the repair in 1977.

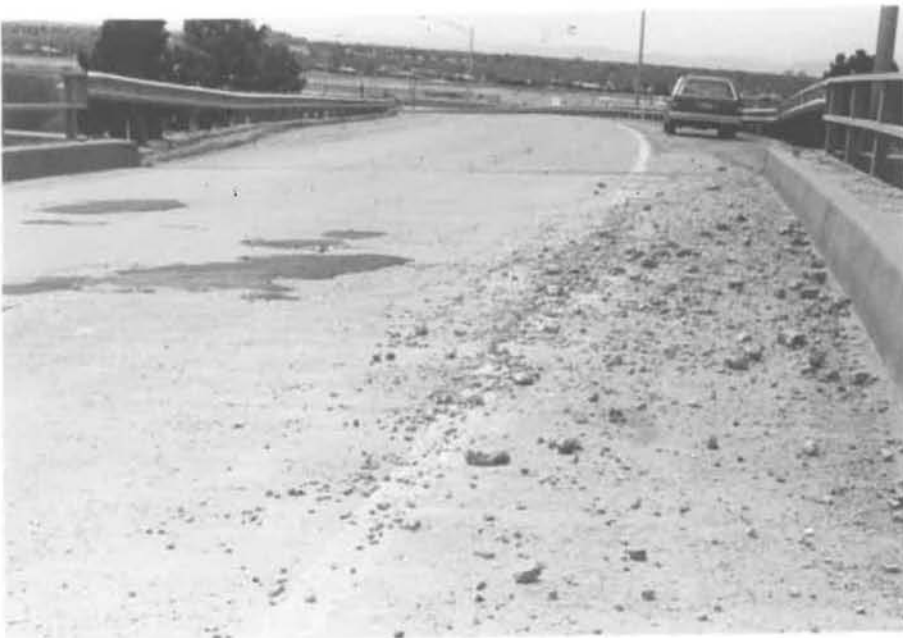
Photo #12a

Delaminated concrete is broken out and scattered by traffic causing hazards of the potholes and debris on the highway.

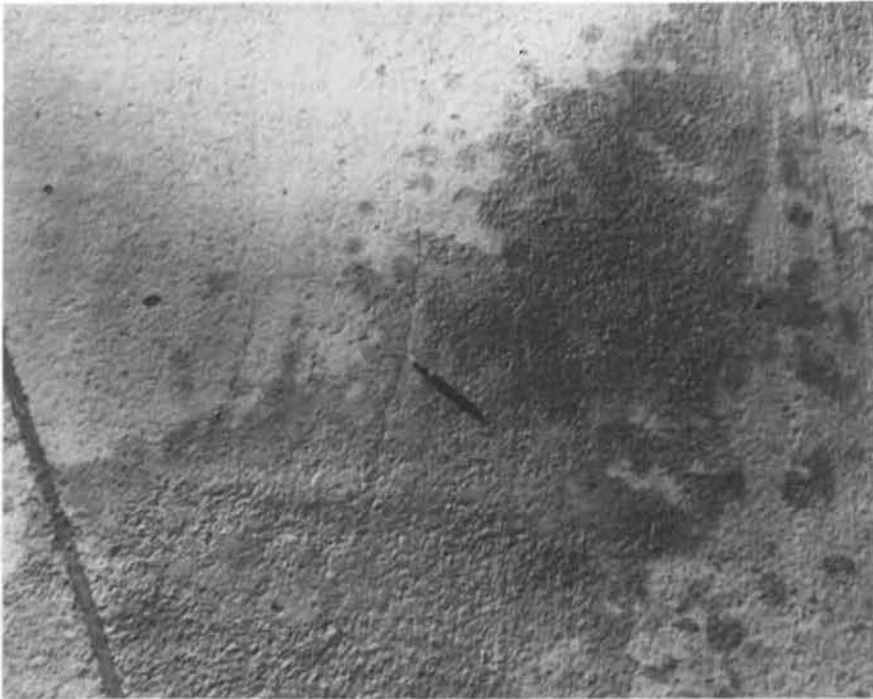
Photo #13

A few cracks
appeared in the
Latex Modified
Surface by December
of 1977.

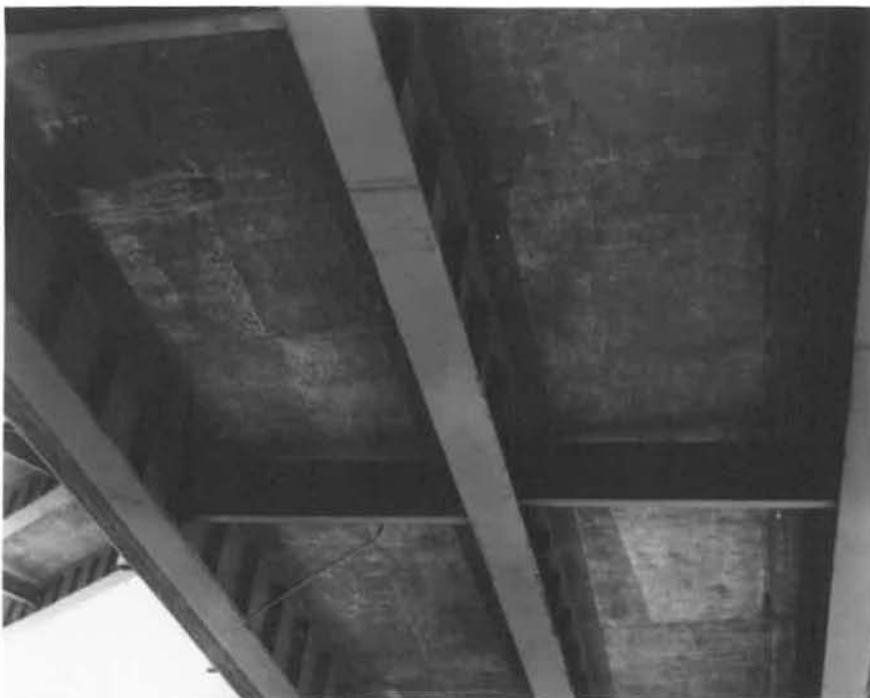
Photo # 14

The underside was in
relatively good
condition in 1977.

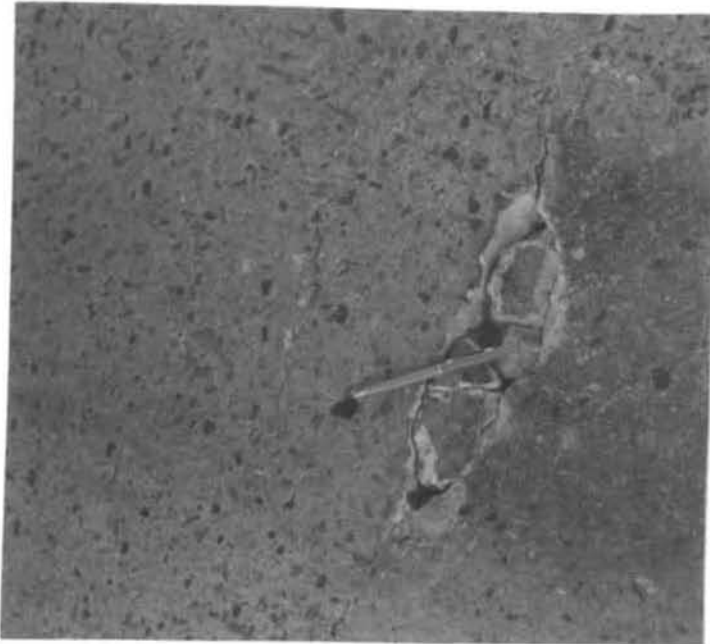
Photo # 15

A new spall appeared in 1982 on a former crack over a rebar. The deck surface for several inches after the trailing edge of this spall is iron stained as if rusty water had been excreted from the crack under traffic in a similar manner to that of roadway pumping on saturated subgrade.

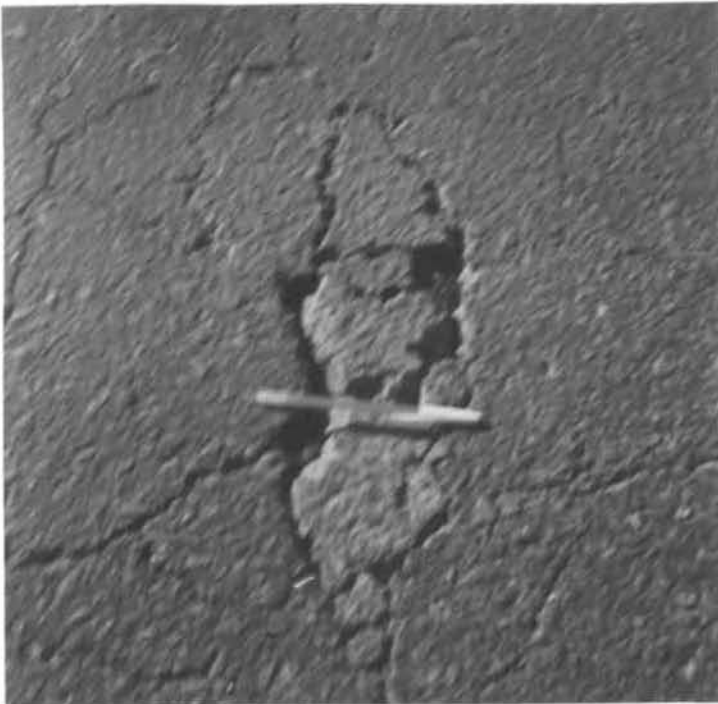
Photo # 16

In the fall of 1983 the entire deck was delaminated. "D" cracking had progressed to the point where 4" square blocks were thrown out causing hazards to vehicles. Maintenance patched and overlaid the structure.

In February of 1984 the asphalt overlay is showing reflective cracking and potholing.

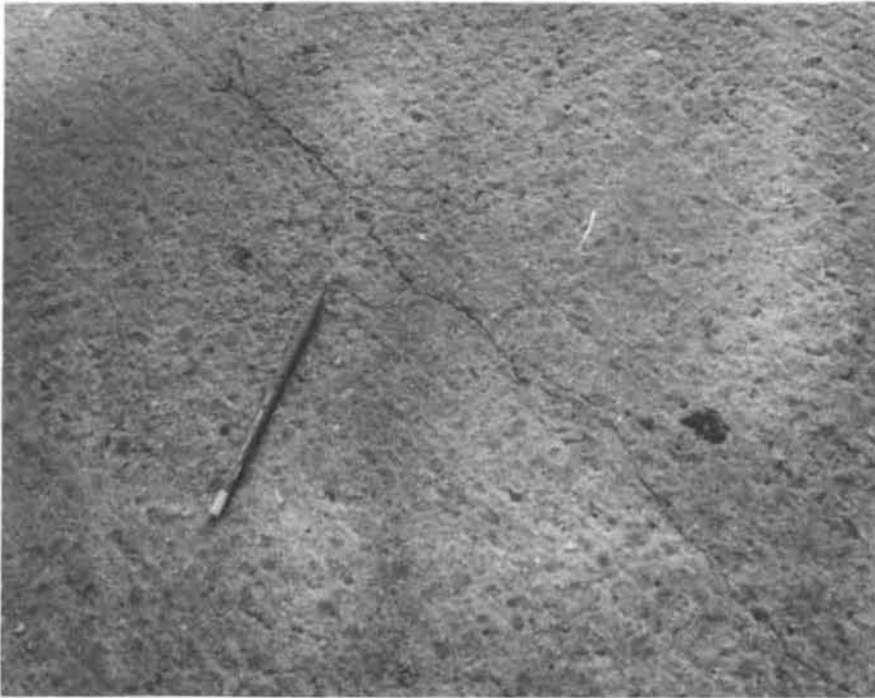
Photo # 17

Cracks developed in the
new Latex Modified deck
after only three
months. December 1977

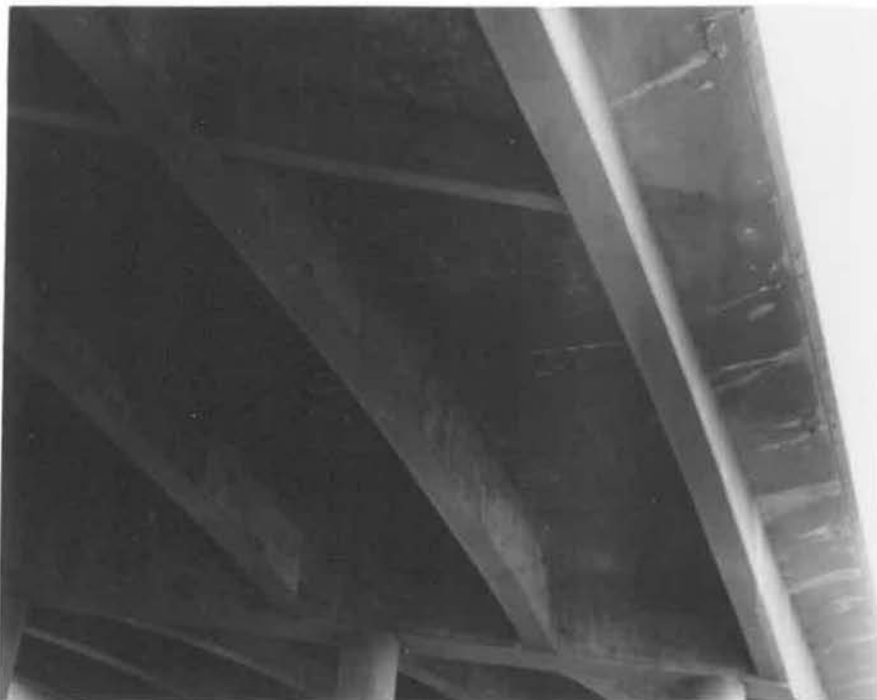
Photo # 18

Salt stains on the
underside are probably
from the old salt
contaminated concrete.
1977

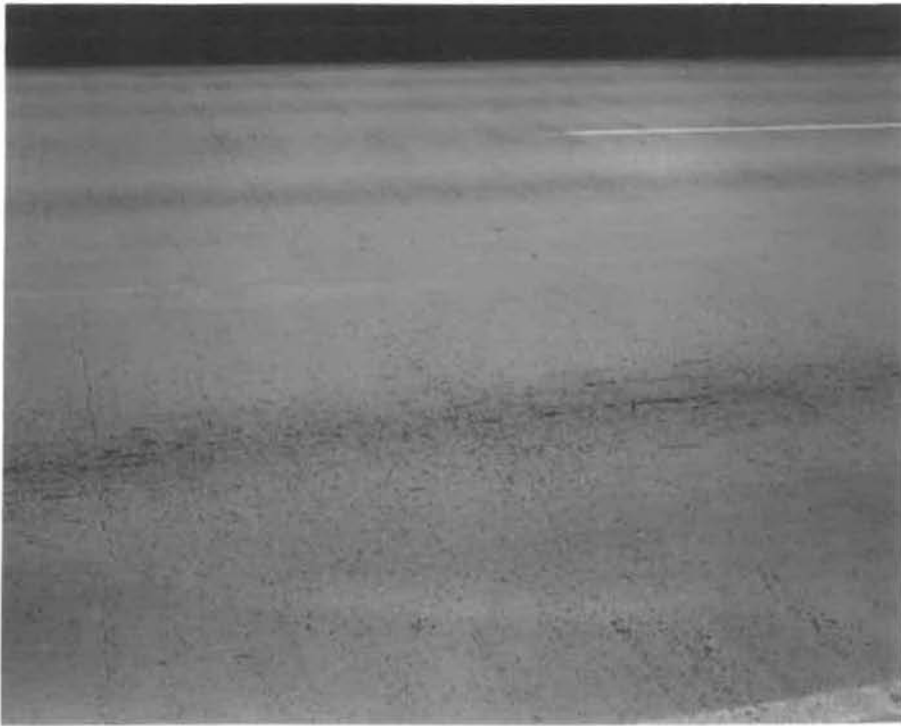
Photo # 19

By May of 1980 there was considerable cracking over the reinforcing steel. It was estimated that over 50% of the surface was cracked.

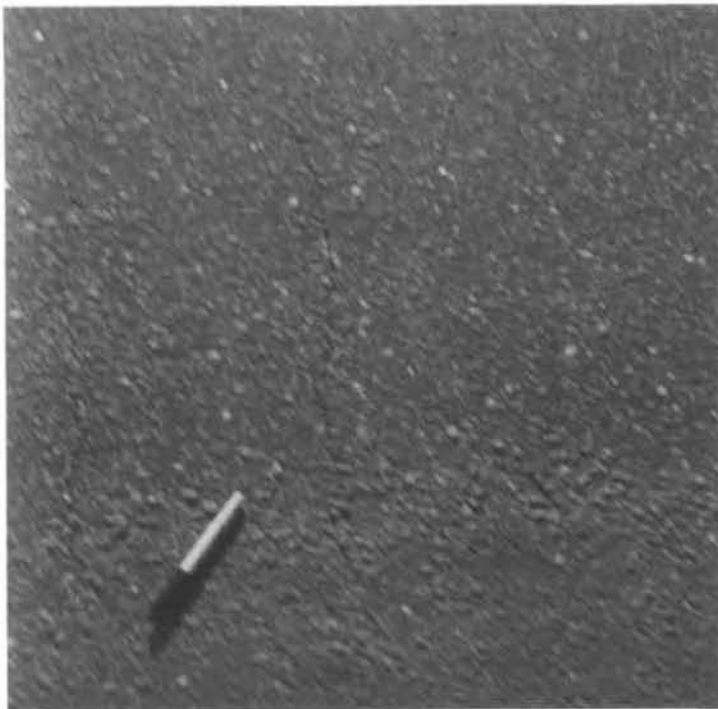
Photo # 20

During the late summer and early fall of 1983 most of these decks were delaminated as tested by the hammer method. Many 4" blocks had come out causing a traffic hazard. Maintenance forces patched the holes and overlaid the structures.

This February 1984 photo shows reflective cracking in the asphalt overlay from a popout in the concrete.

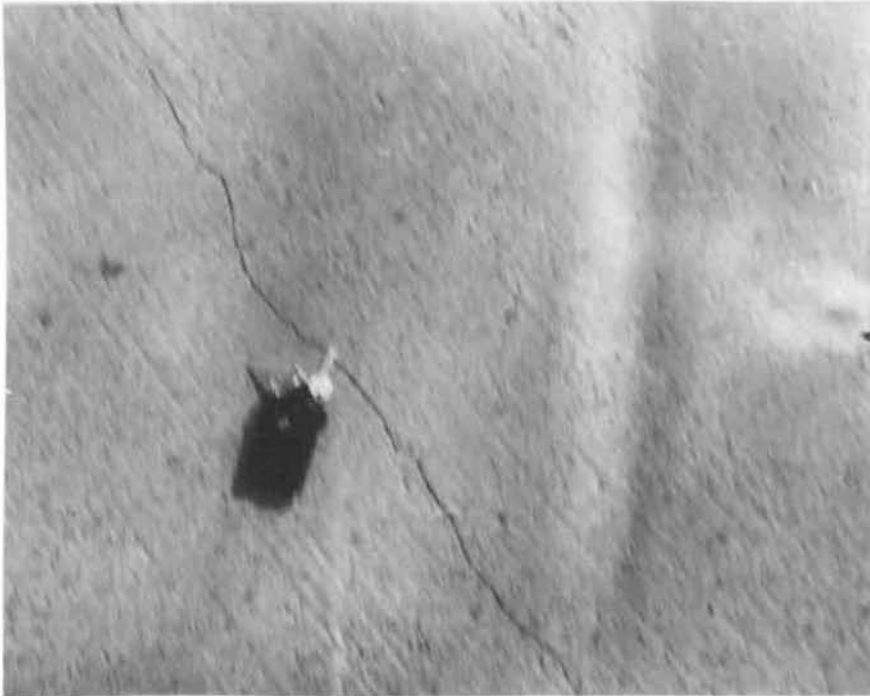
Photo # 21

Cracks developed
in the new Latex
Modified deck
after only three
months. December
1977

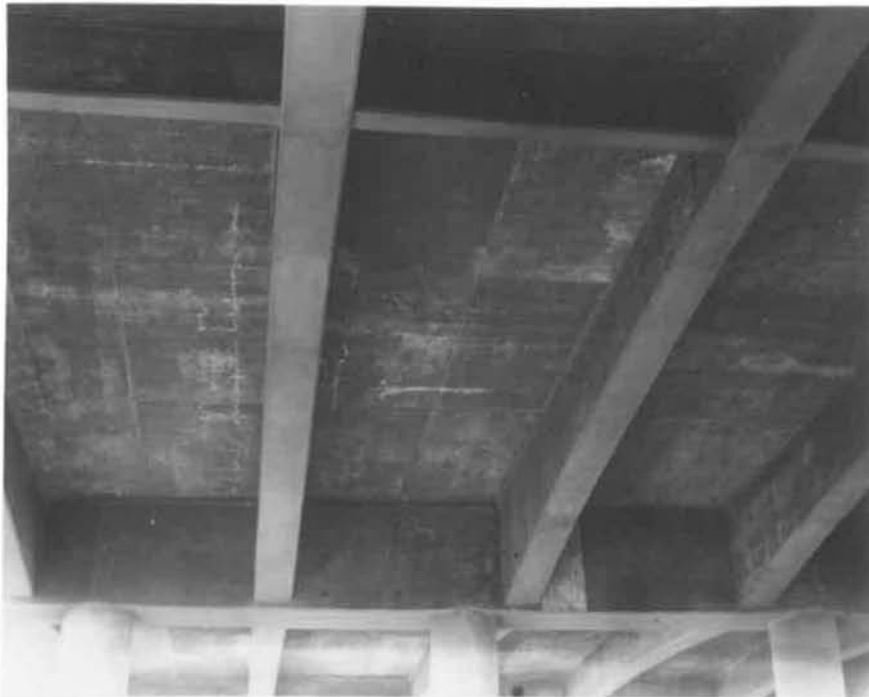
Photo # 22

Eight to ten
cracks per span
showed salt
precipitation
under the bridge

Most of this was
residual salt from
the before 1977
repairs.

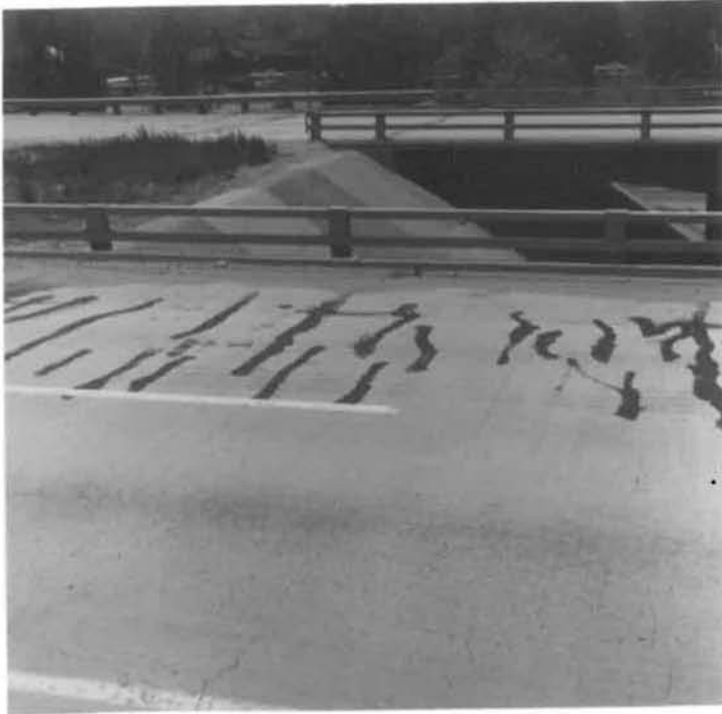
Photo # 23

In June of 1983 the surface cracks were wider and quite extensive.

During the late summer and fall of 1983 most of these decks were delaminated as tested by the hammer method. Many 4" blocks had come out causing a traffic hazard.

Maintenance had to apply crack sealer to the passing lane.

Maintenance forces patched the holes and overlaid the structures.

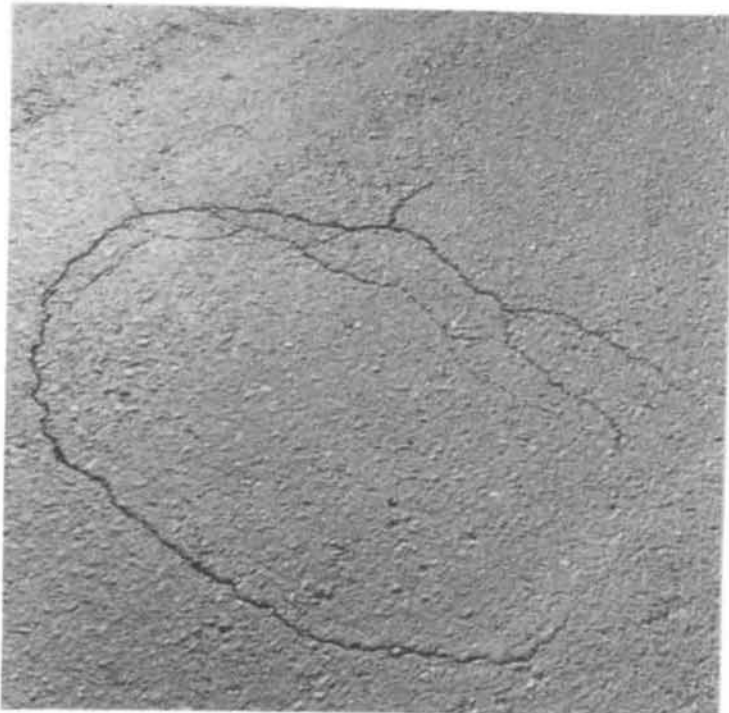
Photo # 24

This photo shows reflection cracking over a concrete pop out. Several others are just starting to reflect through. February 1984.

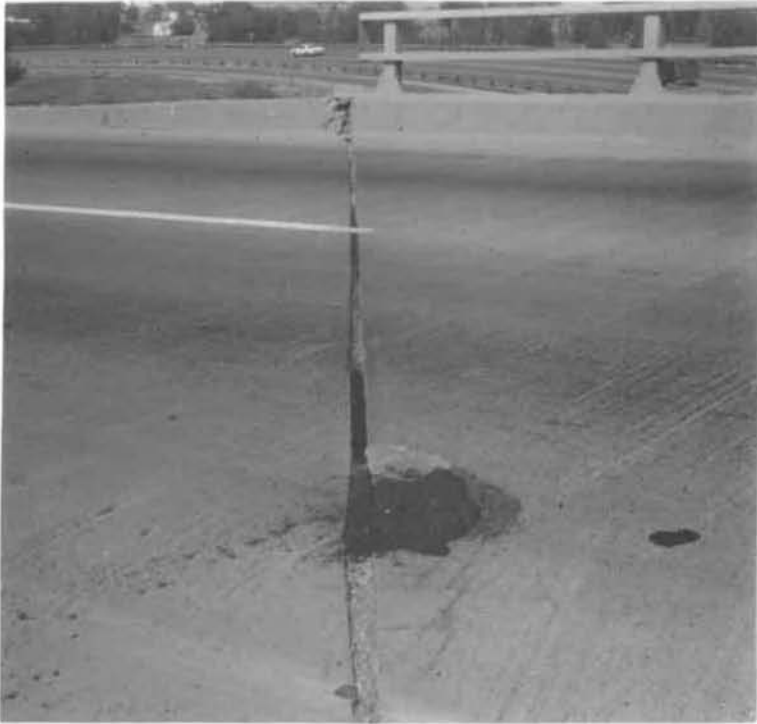
Photo # 25

A concrete pop out appeared near the end of the deck in September of 1980.

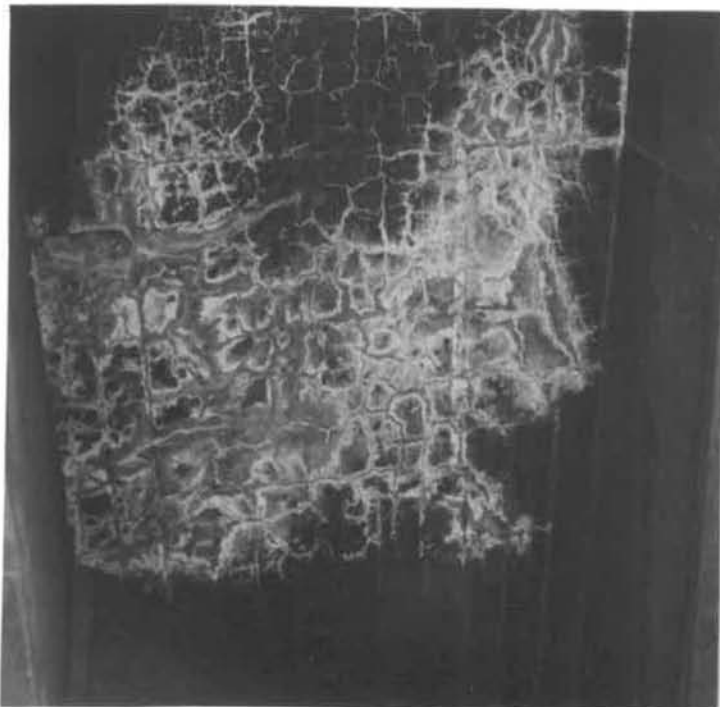
Photo # 26

Chicken wire cracking and salt are prominent over a 10 Ft. square area on the underside of the deck near the west end center. 1984.

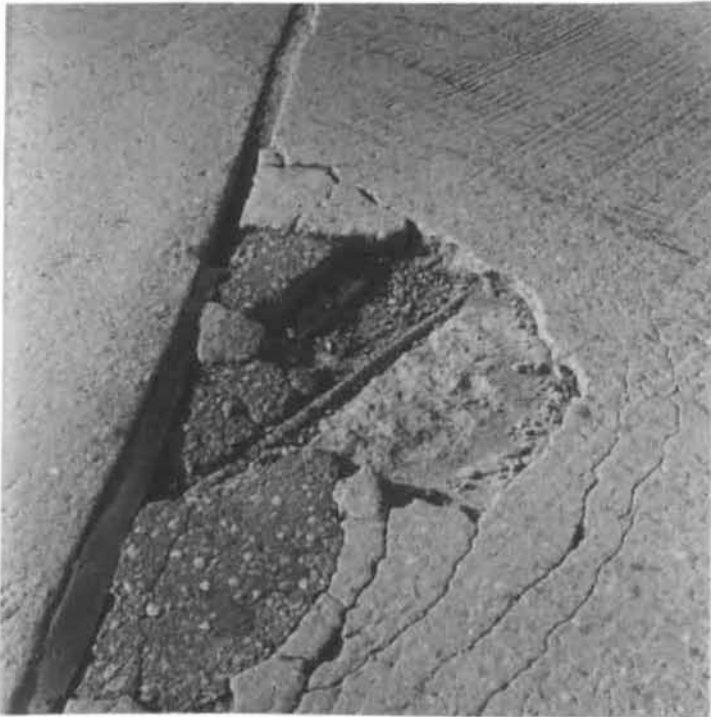
Photo # 27

Feb. 1984 The popout at the end of the deck is growing.

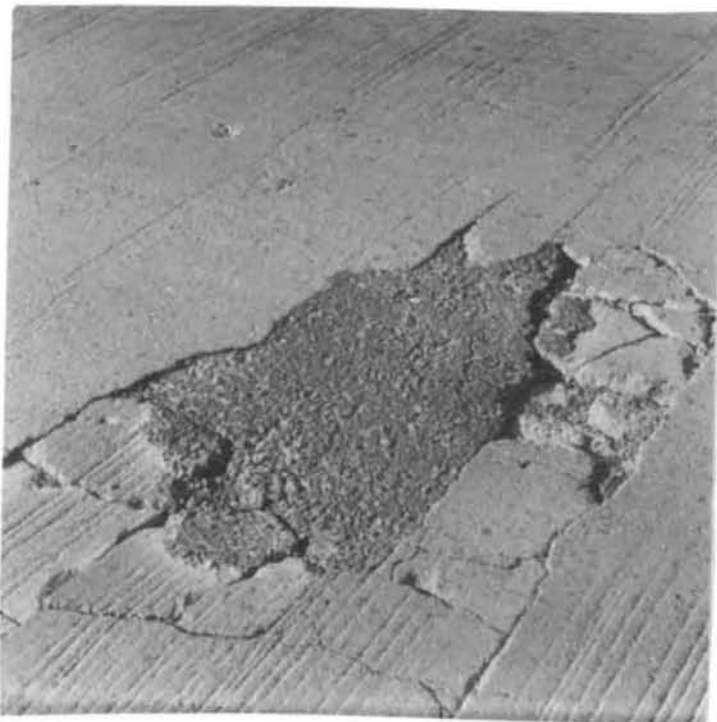
Photo #28

A second popout has appeared near the center of the deck.

Several other areas are now showing "D" cracking and will be popouts within a few months. 1984.
