Report No. CDOT-DTD-R-2000-5

PERFORMANCE OF GEOSYNTHETIC- REINFORCED WALLS SUPPORTING THE FOUNDERS/MEADOWS BRIDGE AND APPROACHING ROADWAY STRUCTURES

**REPORT 1: DESIGN, MATERIALS, CONSTRUCTION,
INSTRUMENTATION, AND PRELIMINARY RESULTS**

**COLORADO DEPARTMENT OF TRANSPORTATION
RESEARCH BRANCH**

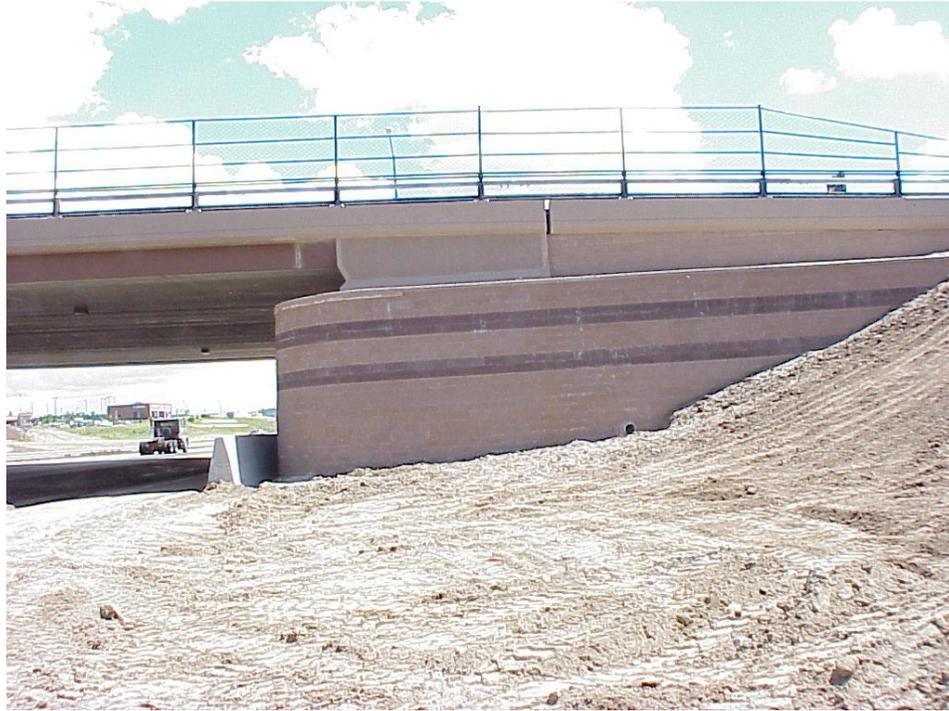
Figure B-1. A view of the northwest side of the completed Founders/Meadows bridge-approaching roadway structure showing lower and upper MSE walls, wing walls, and girders.

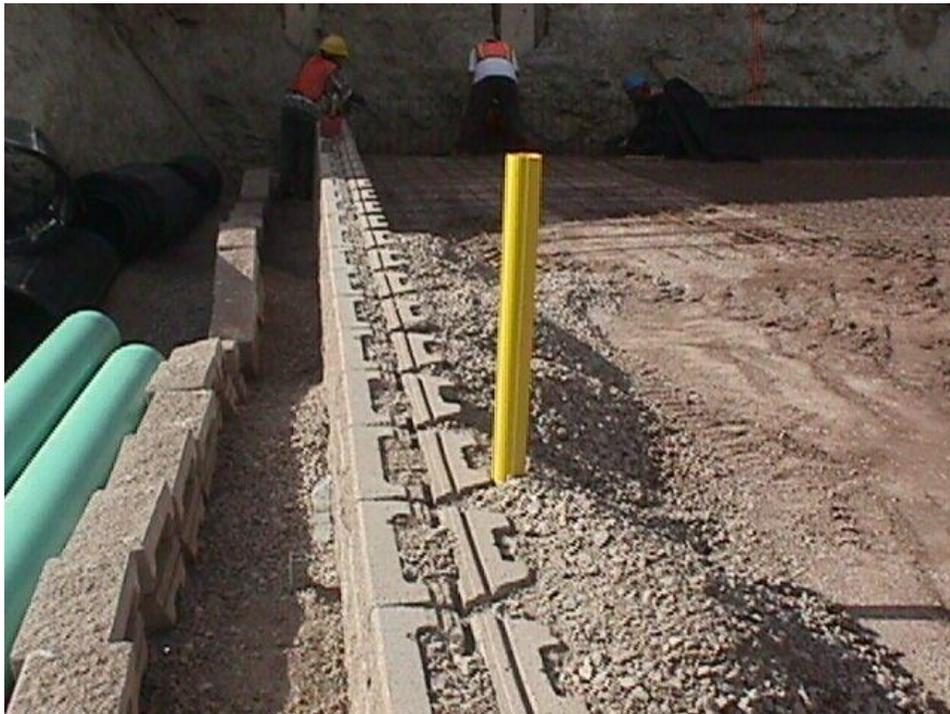
Figure B-4. Picture showing facing blocks, crushed stone used to fill in and 0.3 m behind the blocks, and the compacted CDOT Class 1 backfill. The yellow inclinometer tube was used to measure lateral movement in the structure along Section 400.

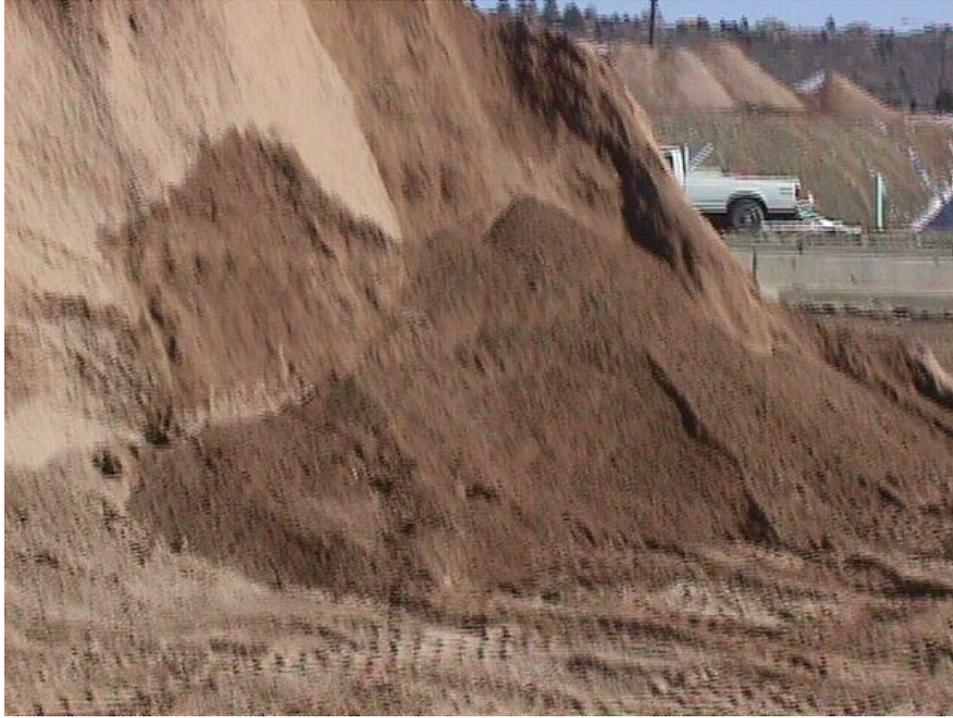
Figure B-5. Backfill material meeting requirements for CDOT Class 1 backfill.

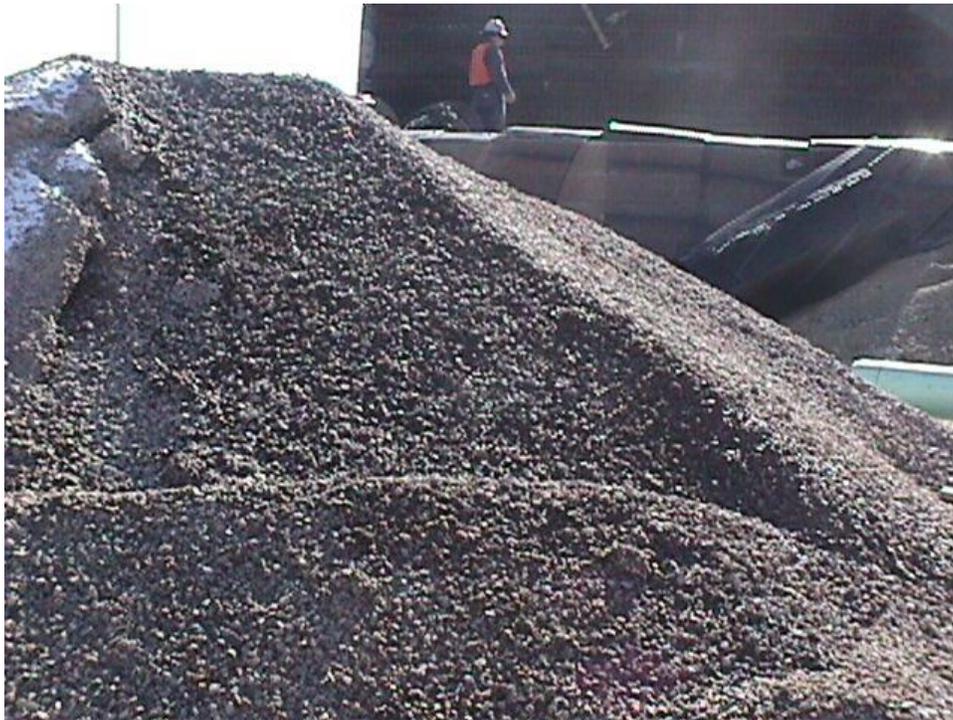
Figure B-6. The 19 mm maximum size crushed stone aggregate used to fill in and for .3 m behind the blocks to facilitate compaction and drainage behind the blocks, prevent washout of the fines in the fill material, and facilitate compaction behind the facing.

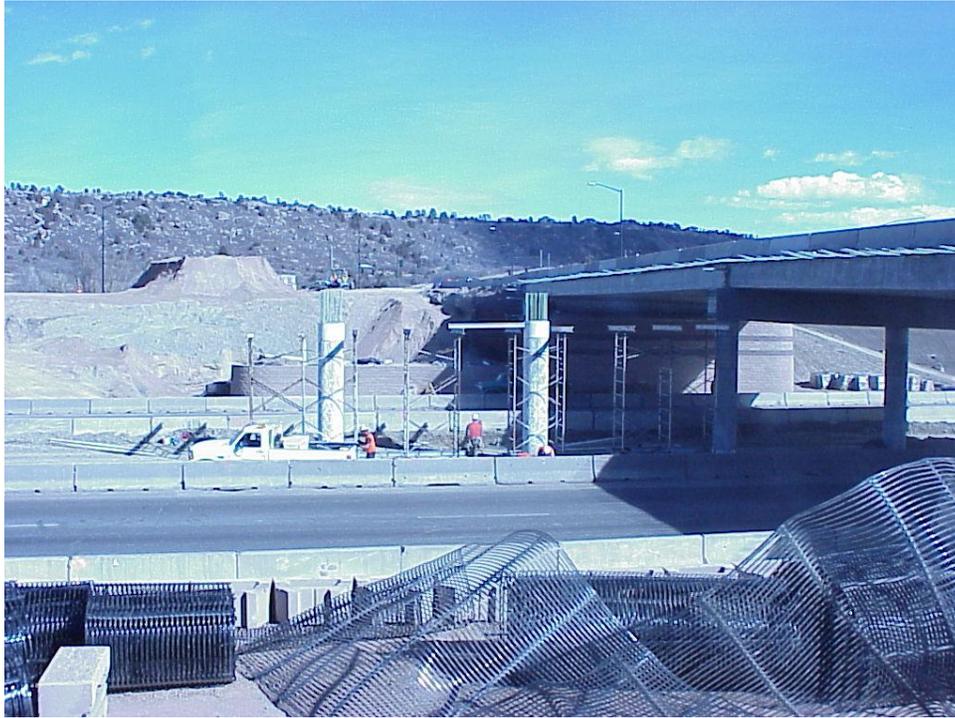
Figure B-7. Rolls of Tensar UX 6 geogrid placed below the bridge foundation.

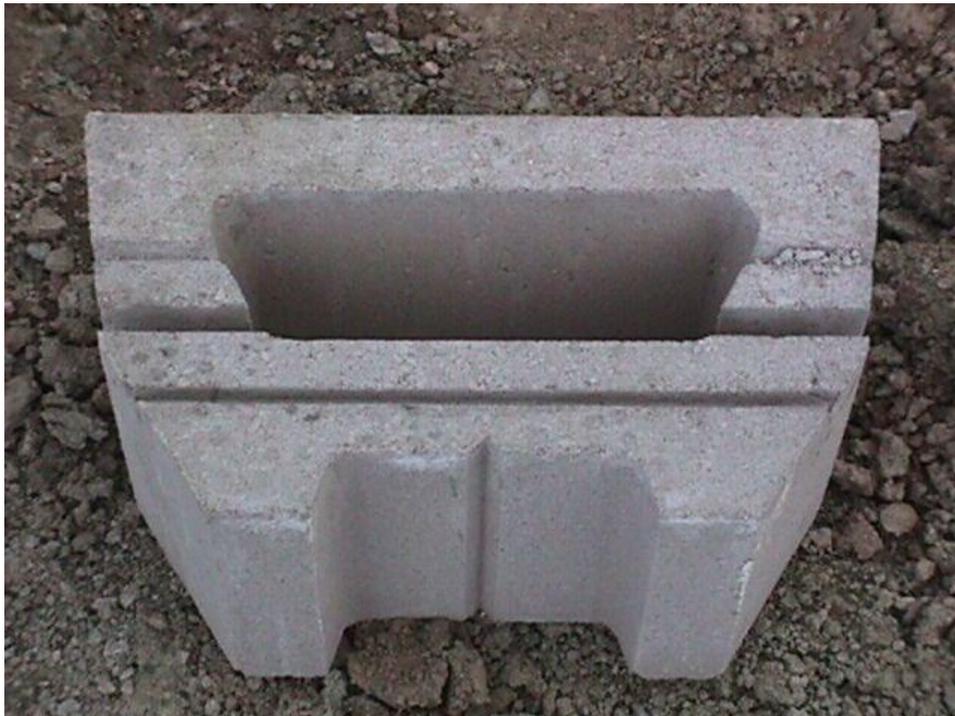
Figure B-8. Top view of the Mesa Block - the outside face of the block is toward the top of the picture.

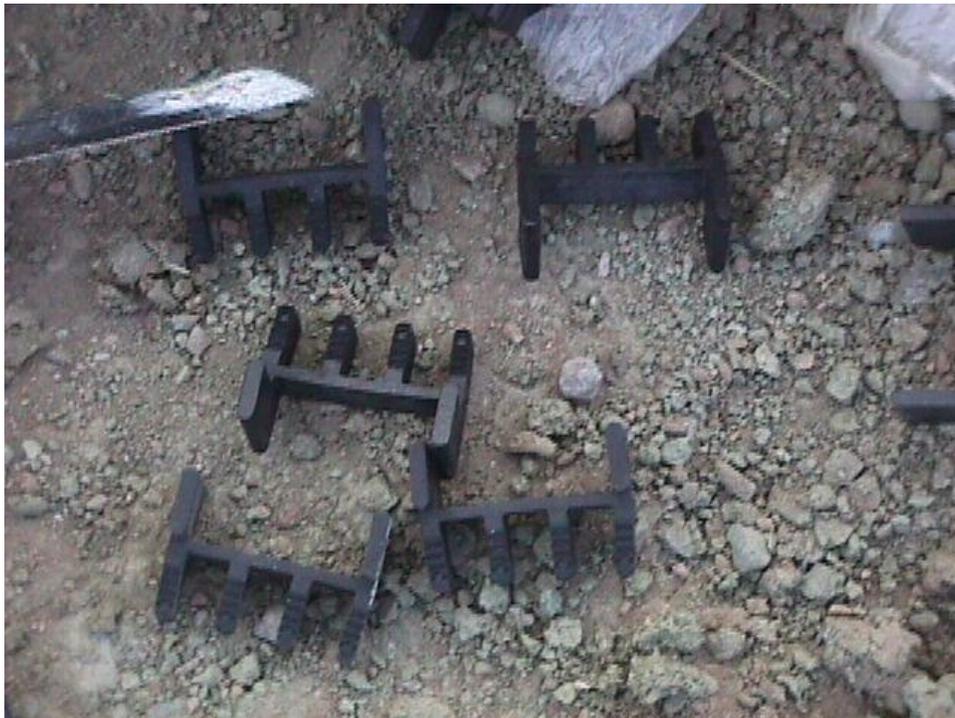
Figure B-10. The Standard Mesa Connectors which provide the positive mechanical connection strength between blocks and between blocks and geogrid. This connector has four “teeth” that fit down into the groove of the block (Fig 8) and two “flags” where the geogrid is hooked. The rear of the cavity of the next row of blocks rests against the two large flags. This provides connection strength between blocks.

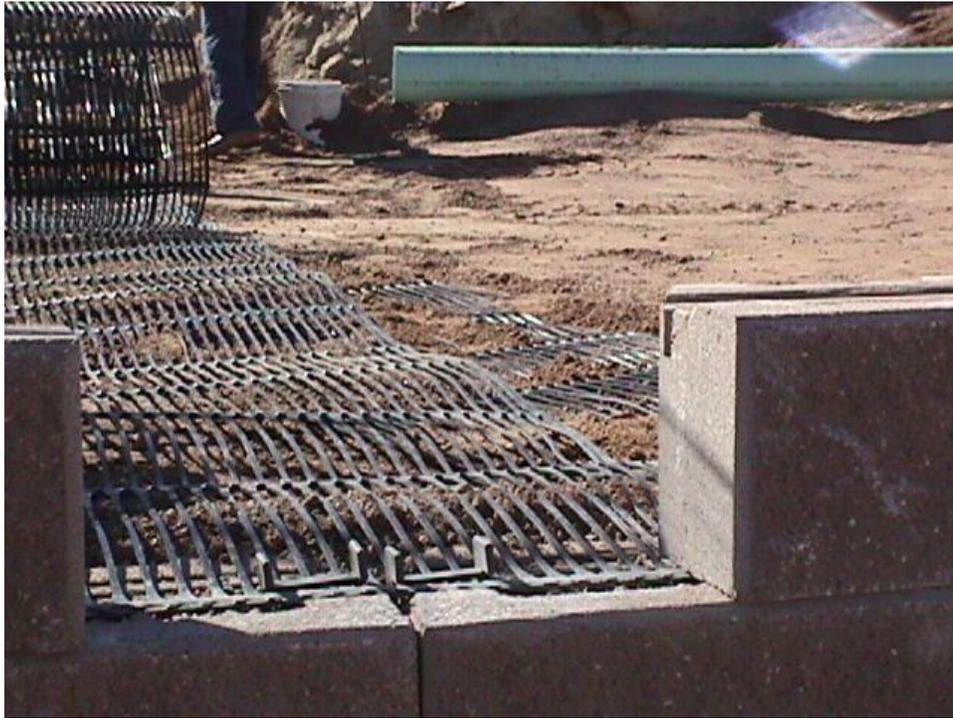
Figure B-11. The facing blocks are fastened to the geogrid by the use of Mesa Standard Connectors which fit into the grooves of the blocks.

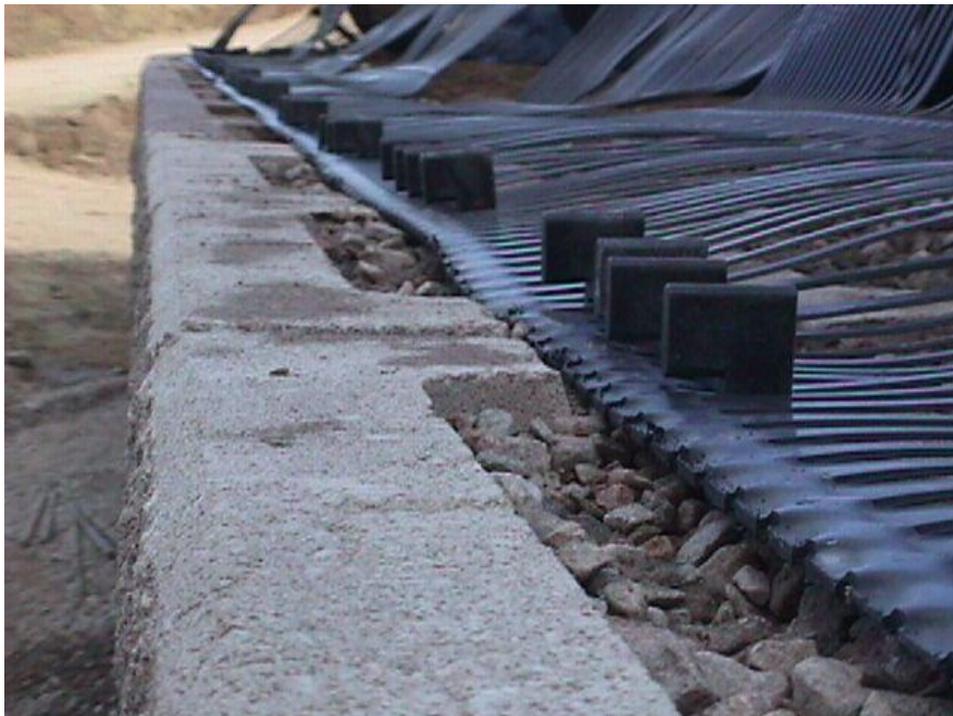
Figure B-12. The rear of the block (to the right of the picture under the geogrid) is lower than than the front to allow for the thickness of the grid.

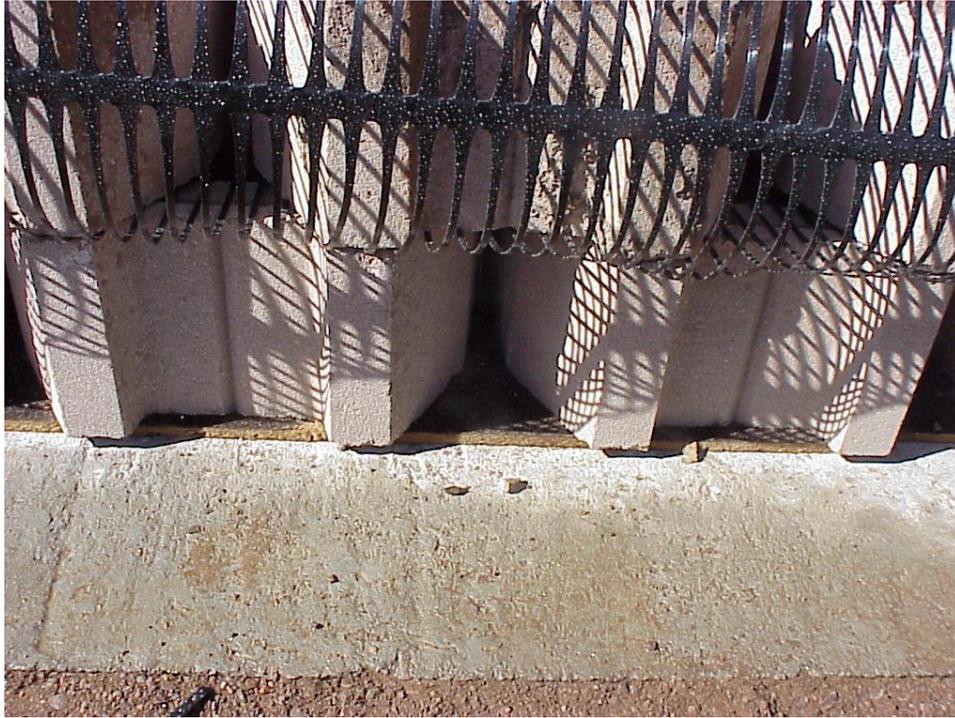
Figure B-13. Expansion joint material was placed between the leveling bed and the first row of blocks.

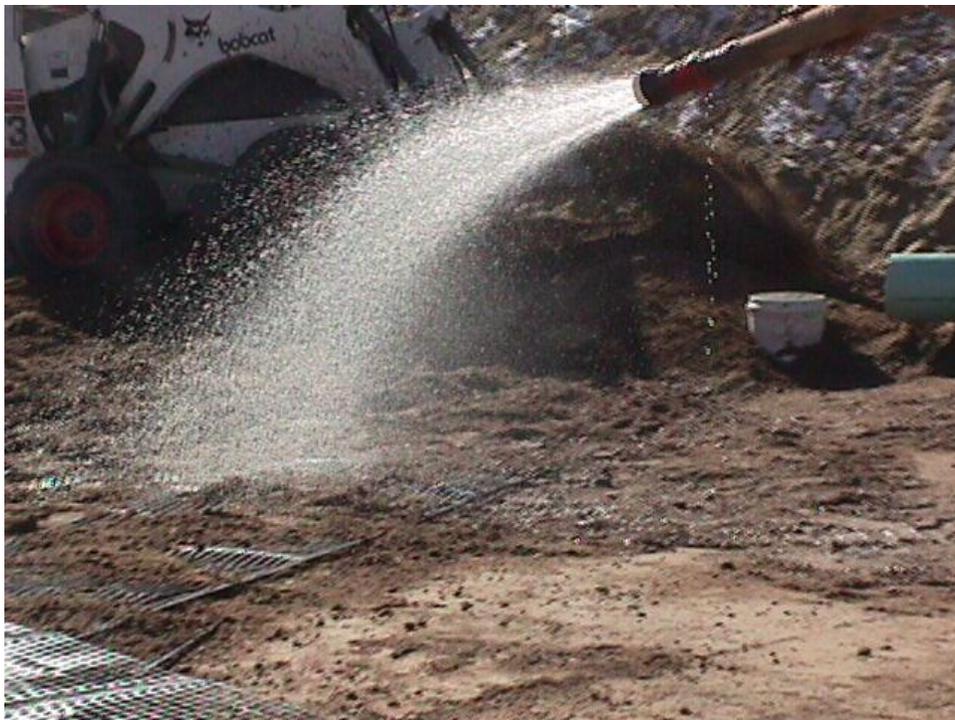
Figure B-14. Water was added before the fill was compacted.

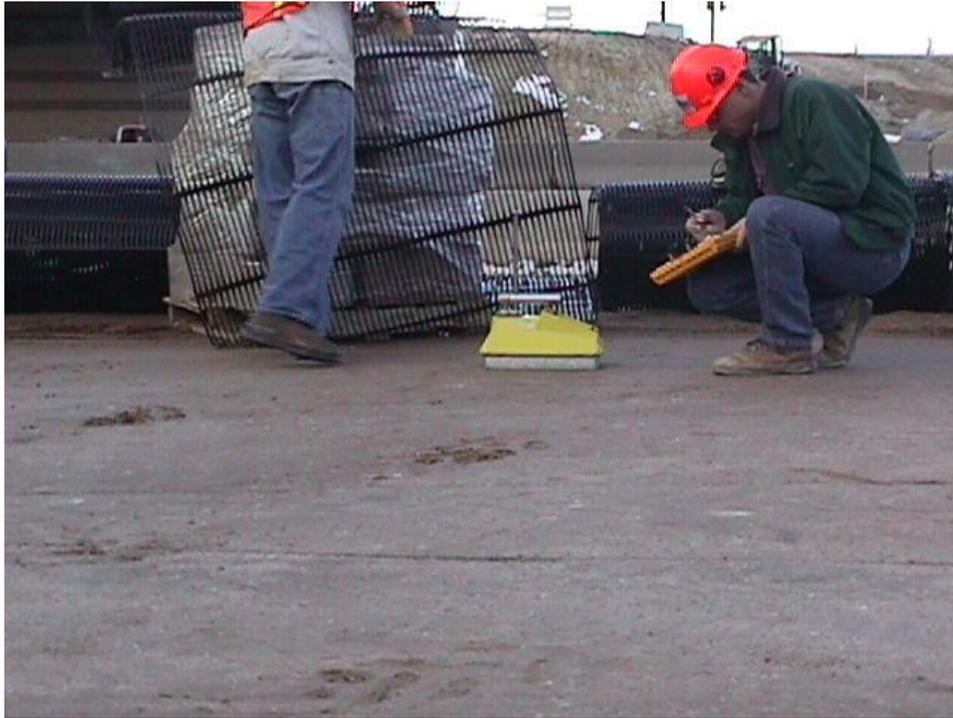
Figure B-15. Backfill levels of compaction were checked with a nuclear gage.

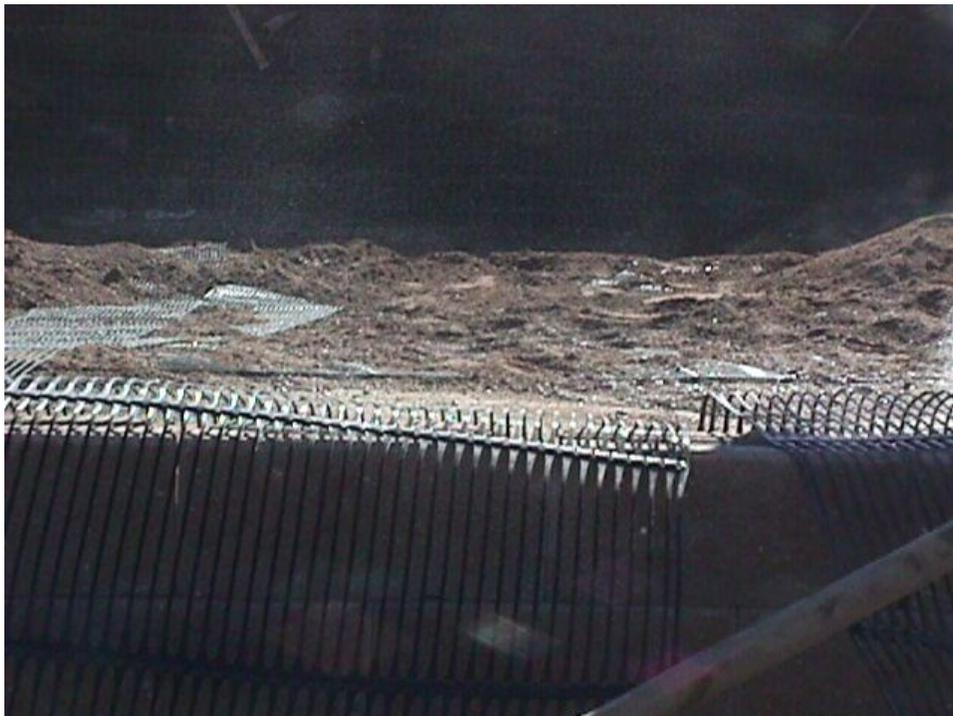
Figure B-16. Around the corners of the lower MSE walls, where geogrid from the front and side of the structure overlapped, a thin layer of fill material was placed between these geogrid layers to provide friction between them.

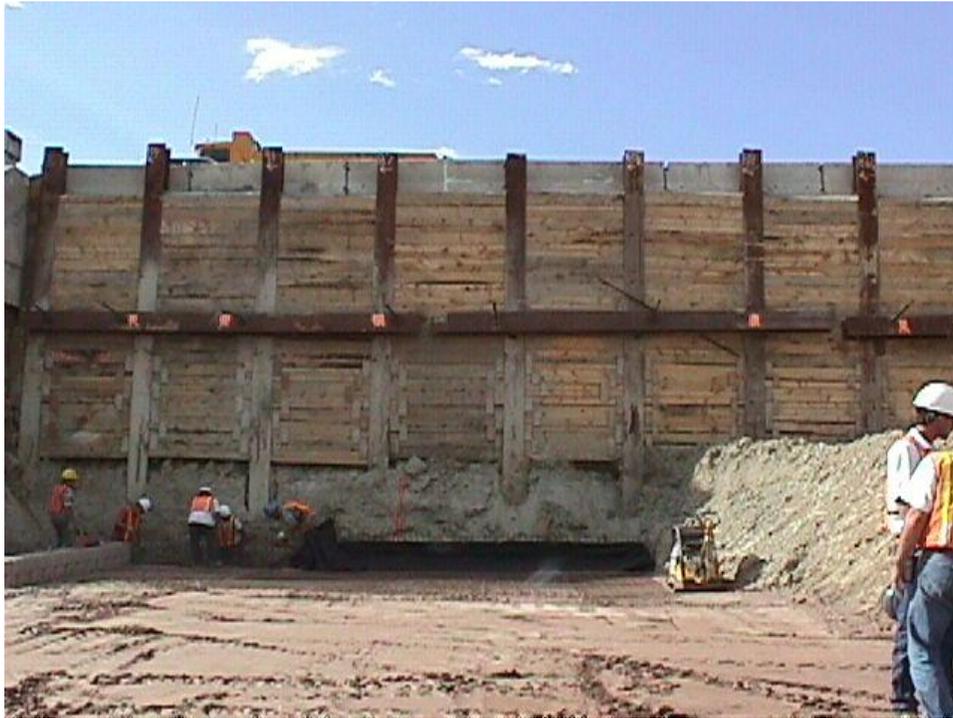
Figure B-17. The first layer of fill material at the east side of the Phase I Structure has been placed. In the background, H-beams and shoring support the approach to the old bridge during the construction of the Phase I Structure.

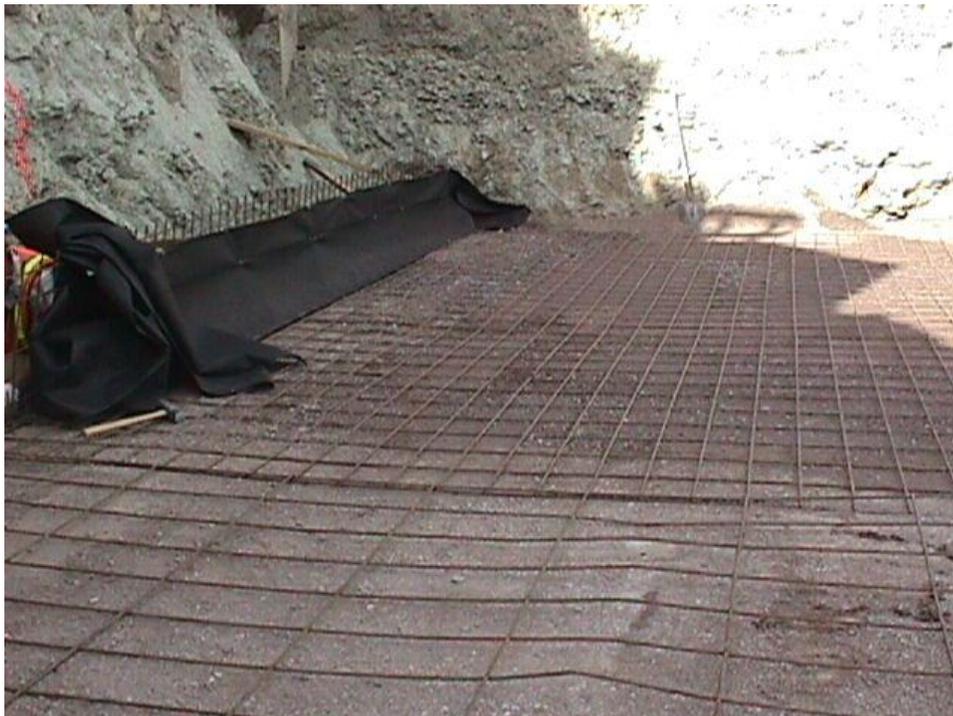
Figure B-18. The northern side of Phase I structure was internally stabilized with steel wire mesh. The steel extended past the edge of the wall and was tied to the geogrid placed to stabilize the front MSE wall.

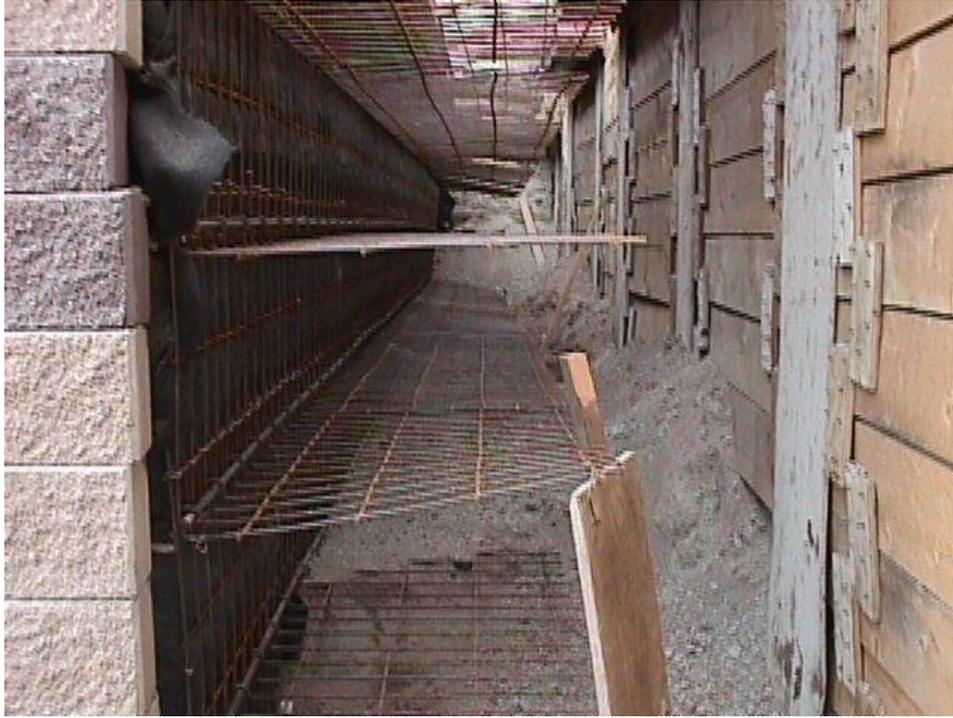
Figure B-19. Temporary wire mesh facing was used to support the northern face of the Phase I structure until the Phase II structure was built and tied to the Phase I structure. The backfill in between the wire mesh reinforcement was contained using wrapped fabric that also facilitated backfill drainage. To the right is a closer look at the shoring supporting the old bridge structure.

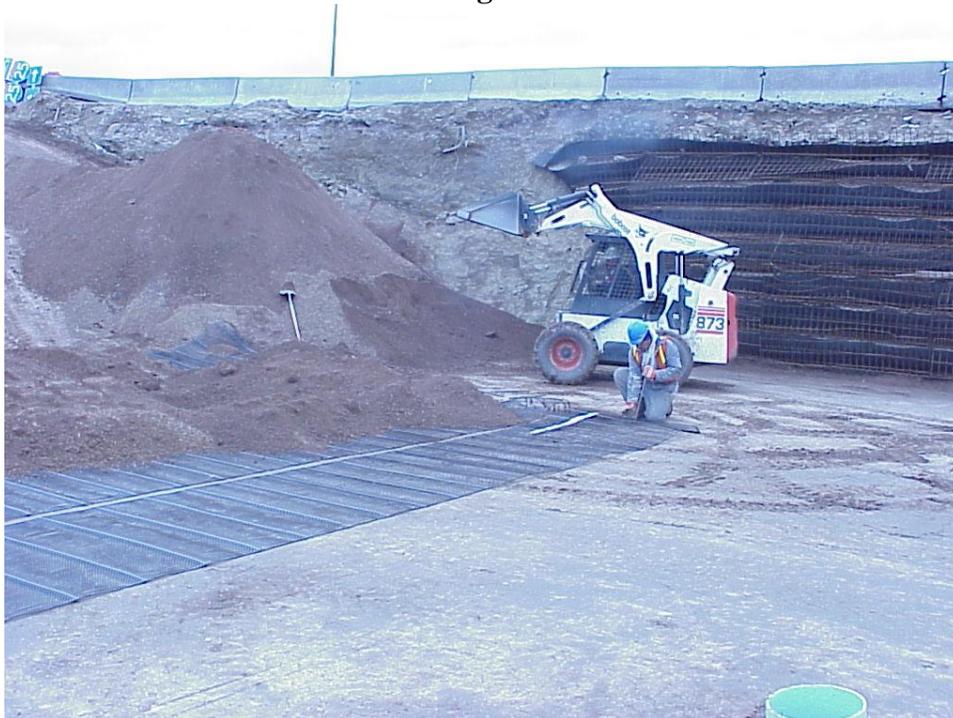
Figure B-20. The geogrid was connected at the wall end, rolled out, and then stretched by hand. The back end was staked to prevent geogrid movement while the fill was placed using a small loader. In the background is the steel reinforcement used to temporarily support the northern face of the Phase I structure.

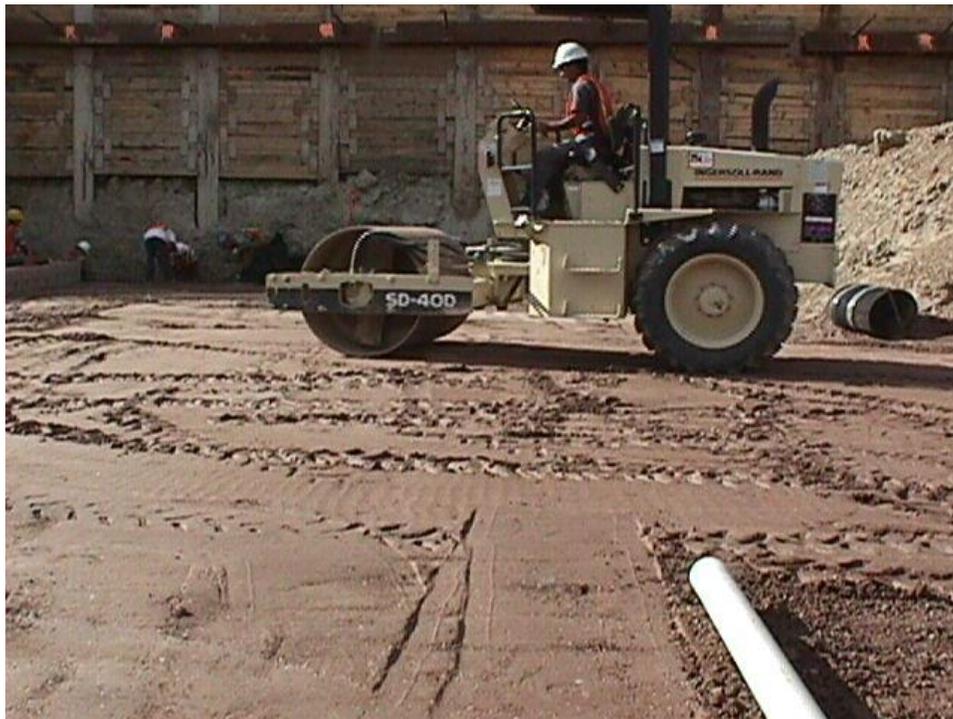
Figure B-21. A vibratory roller was used to compact the fill material.

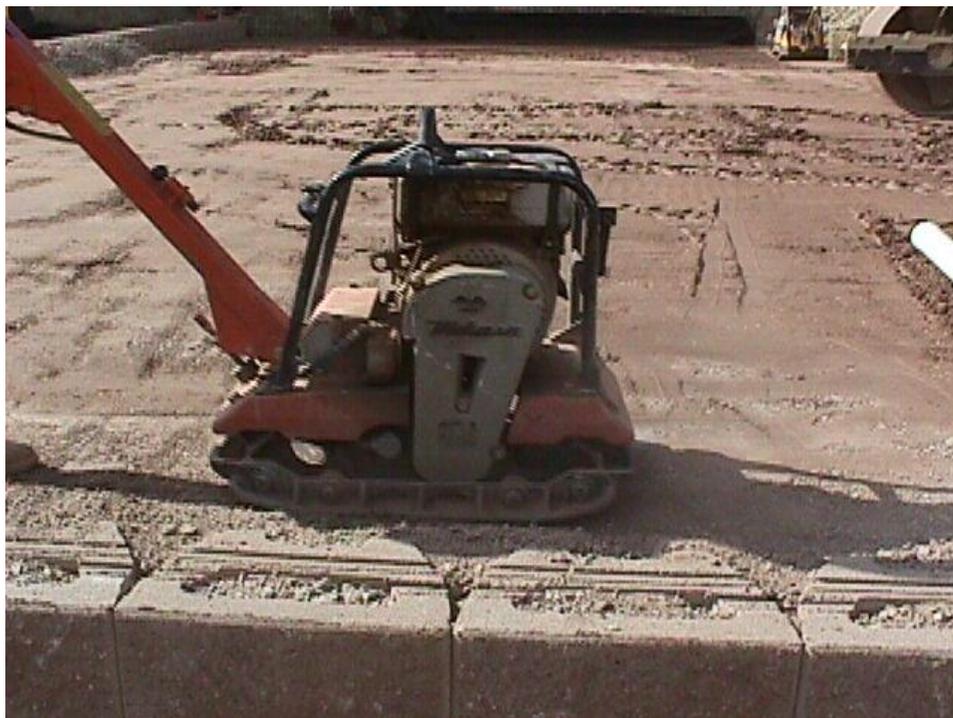
Figure B-22. Near the block facing, a small walk-behind compactor was used to prevent pushing the blocks out of position.

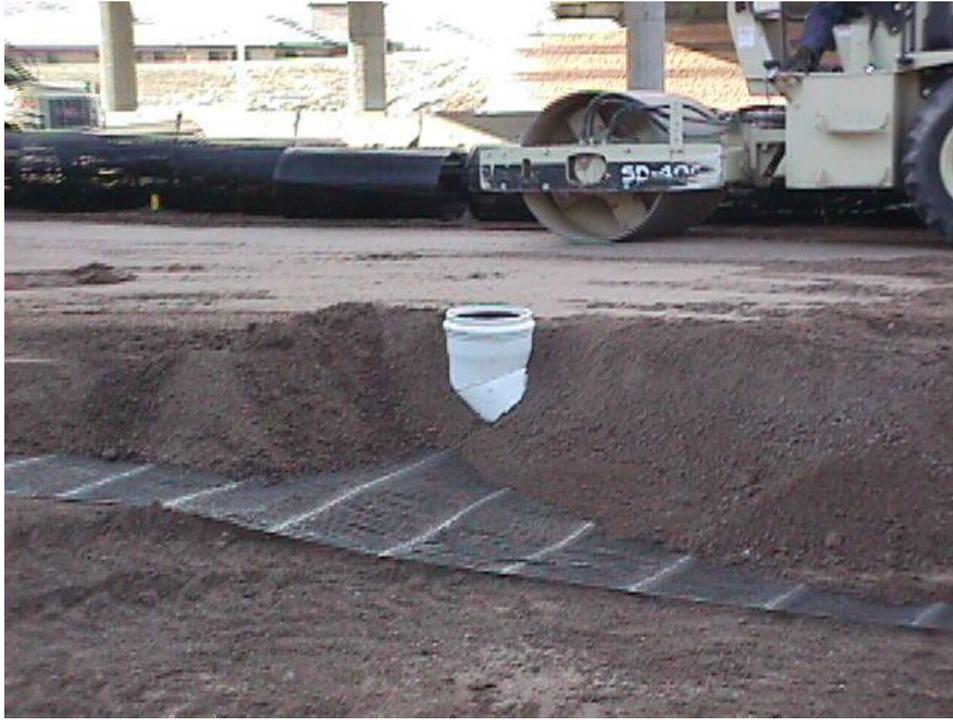
Figure B-23. A vertical drain pipe was installed inside the MSE Walls.

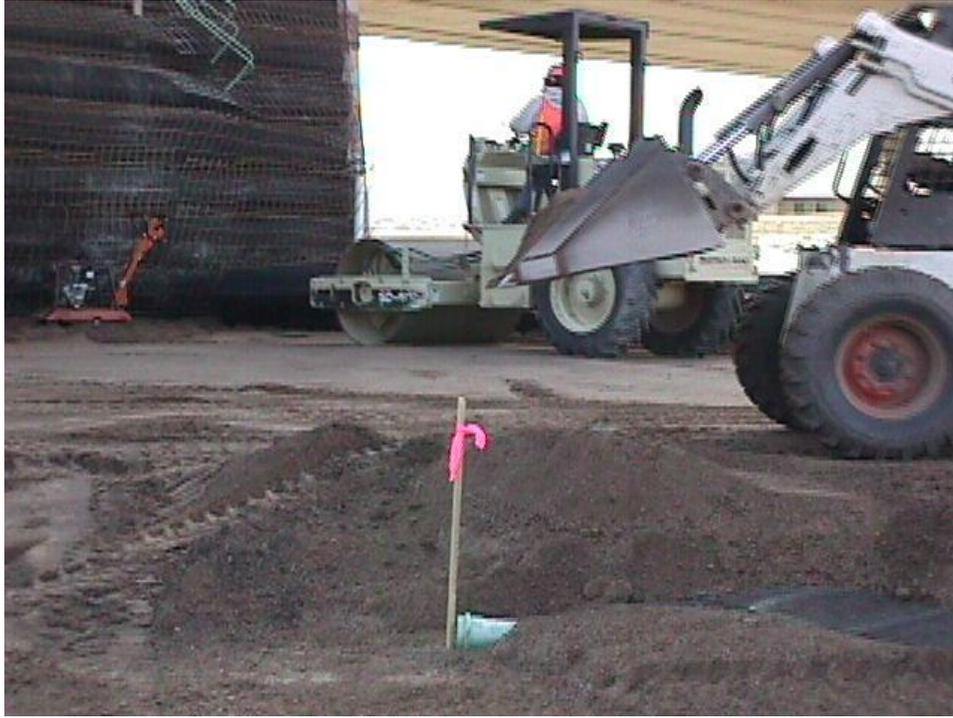
Figure B-25. The pipe used with the drainage blanket placed behind the reinforced backfill.

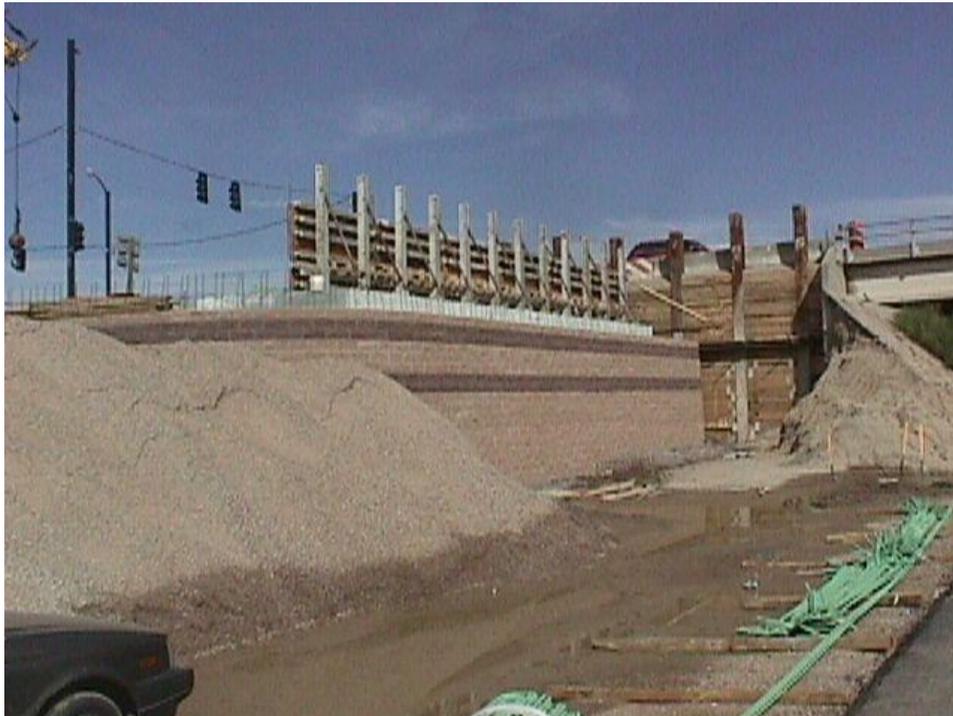
Figure B-26. The abutment wall footing has been poured and the forms are being set for the abutment wall.

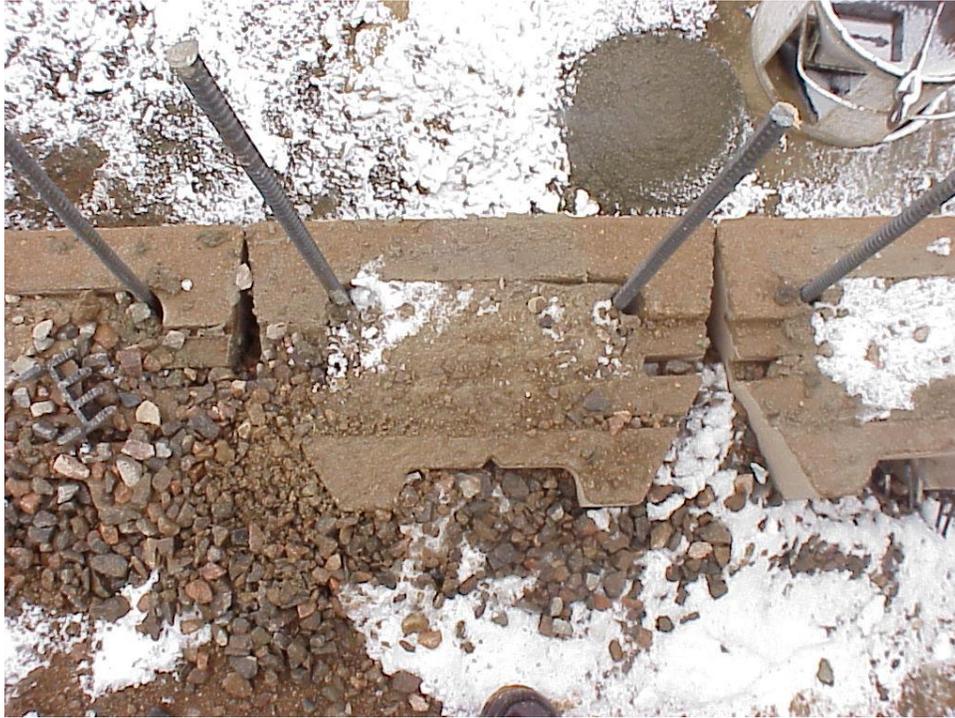
Figure B-27. The top two rows of blocks were filled with concrete. Steel rebar inserted in the plastic concrete were later bent over to tie the concrete cap at the top of the front MSE wall.

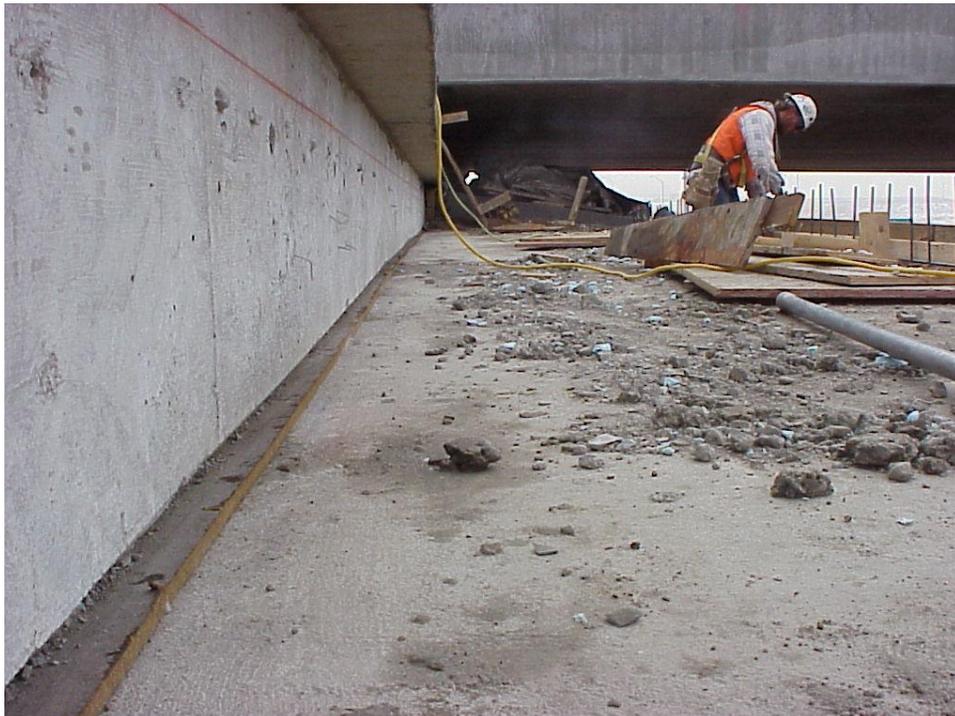
Figure B-28. Expansion joint material was installed below the sides of the abutment wall on top of the footing. In the center zone below the abutment wall on top of the footing, galvanized sheet metal centered on a bearing pad was placed (see figure 29).

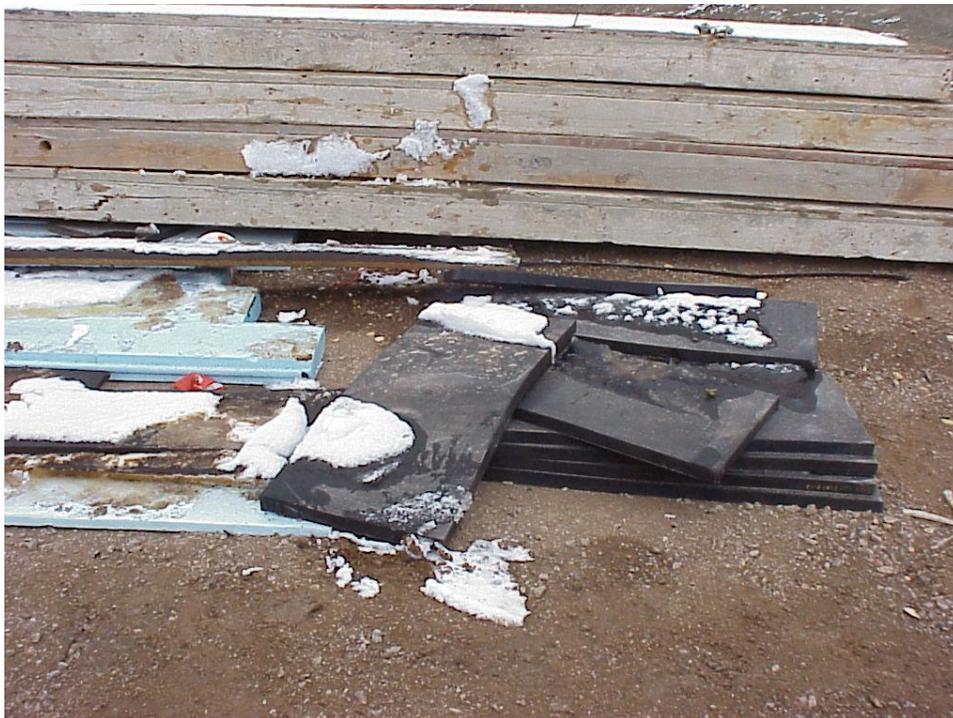
Figure B-30. These elastomeric bearing pads were installed on the abutment wall where the bridge girders are seated.

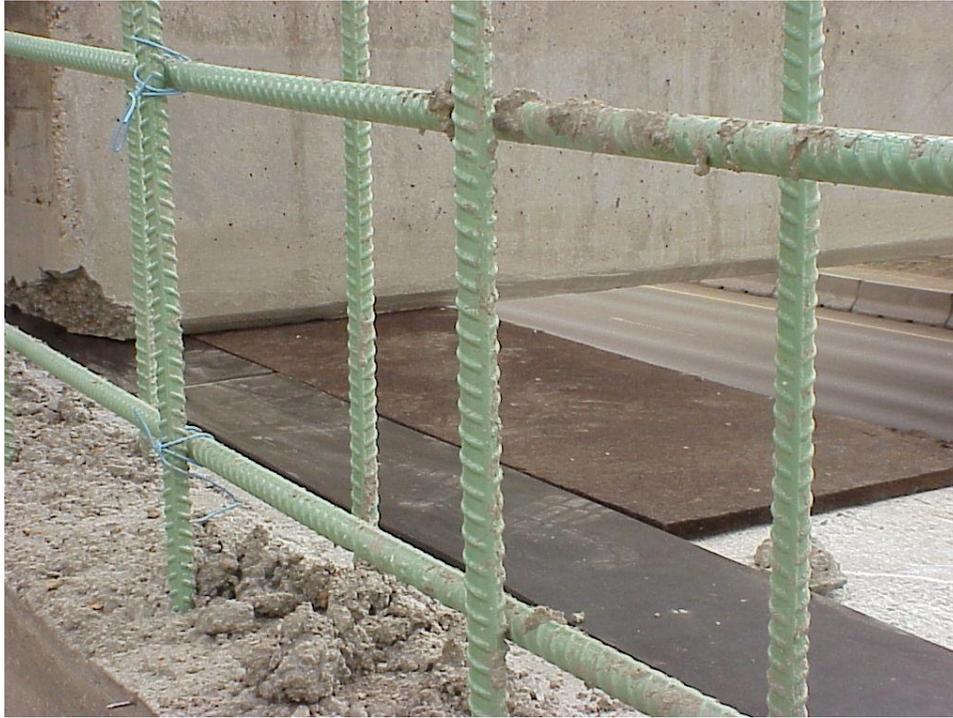
Figure B-31. The elastomeric bearing pad and expansion joints material placed on the abutment wall where girders will be seated.

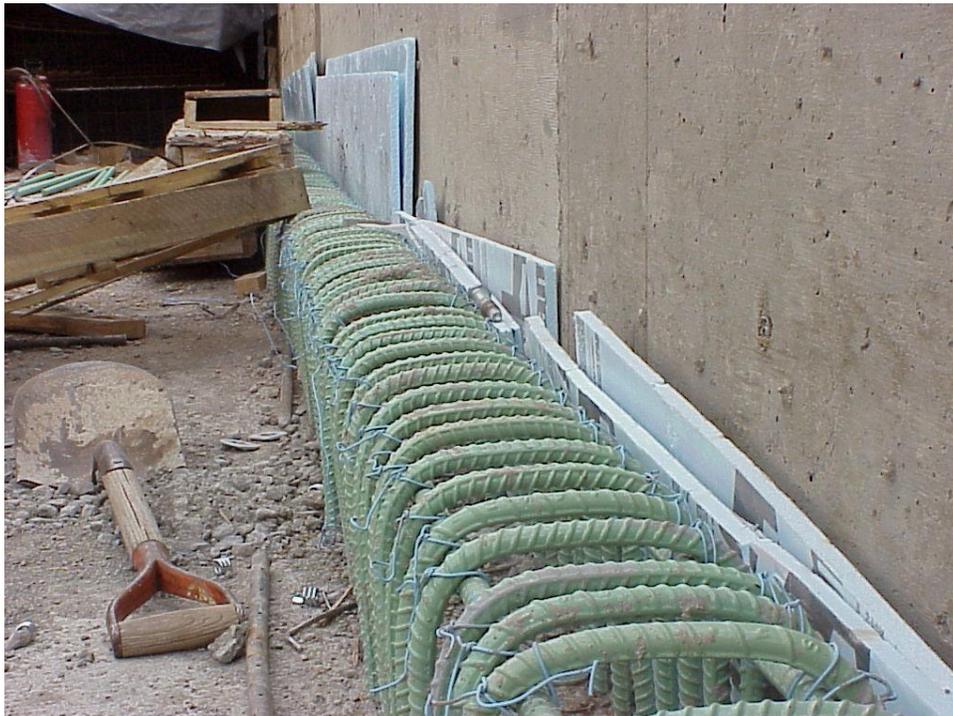
Figure B-32. A reinforced concrete “kicker” strongly attached to the bridge foundation was placed behind the bottom of the abutment wall. This kicker was placed to provide an extra bracing at the top of MSE wall for global stability.

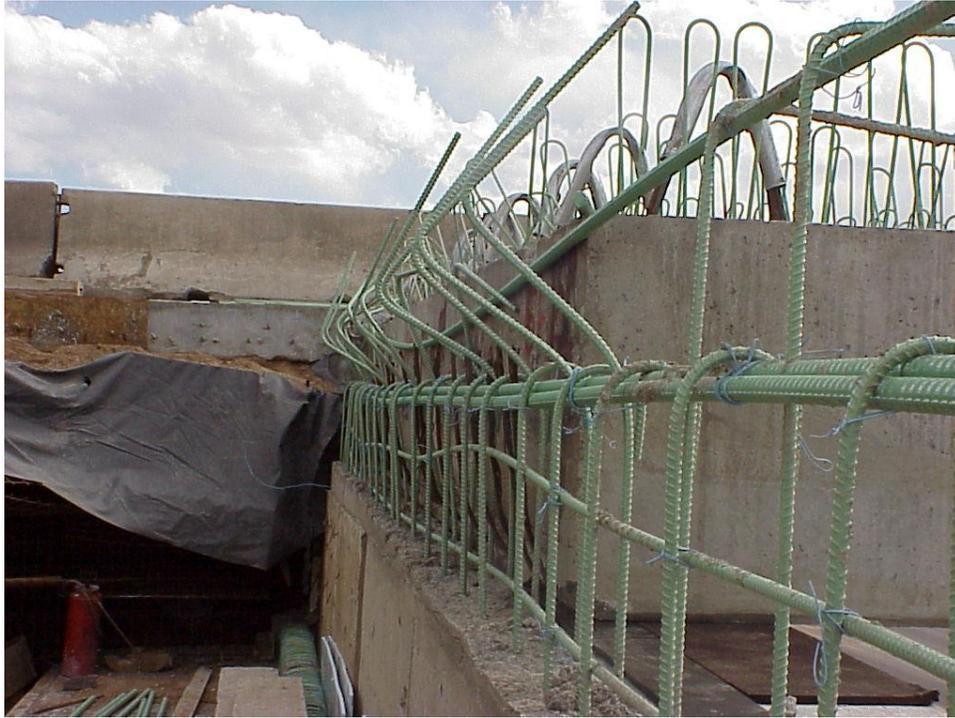
Figure B-33. Abutment wall and some girders. The stage that follows is pouring the concrete for the bridge deck and the rest of the abutment wall and girders. The overlapping steel from girders, abutment wall, and bridge deck will strongly attach the bridge superstructure to the abutment wall without any joint (integral abutment).

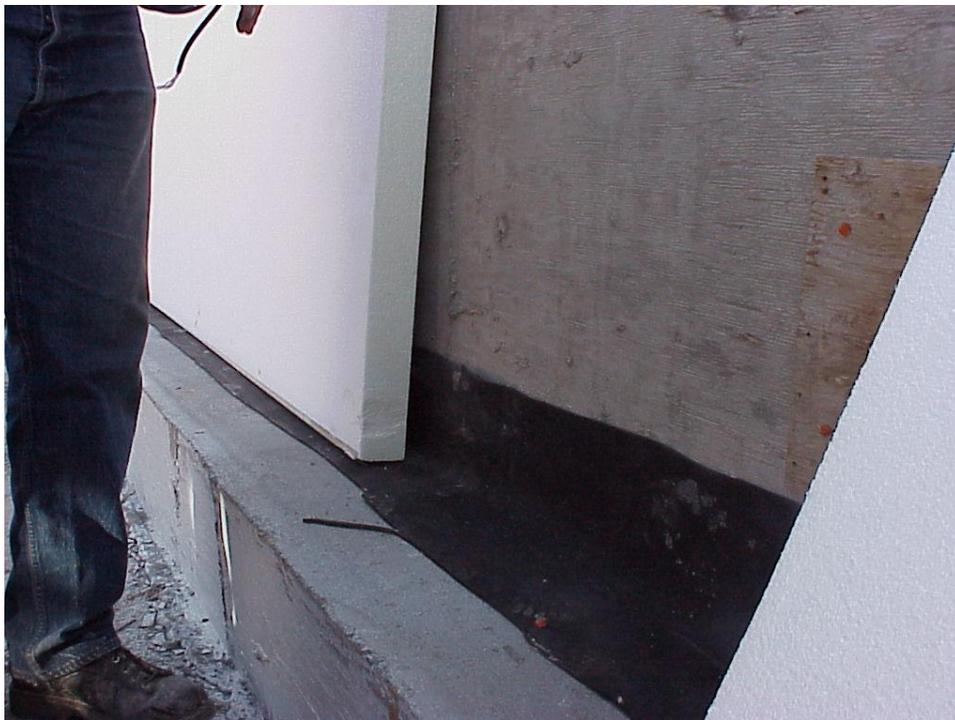
Figure B-34. A plastic sheet was placed between bridge abutment and bridge foundation to facilitate water drainage.

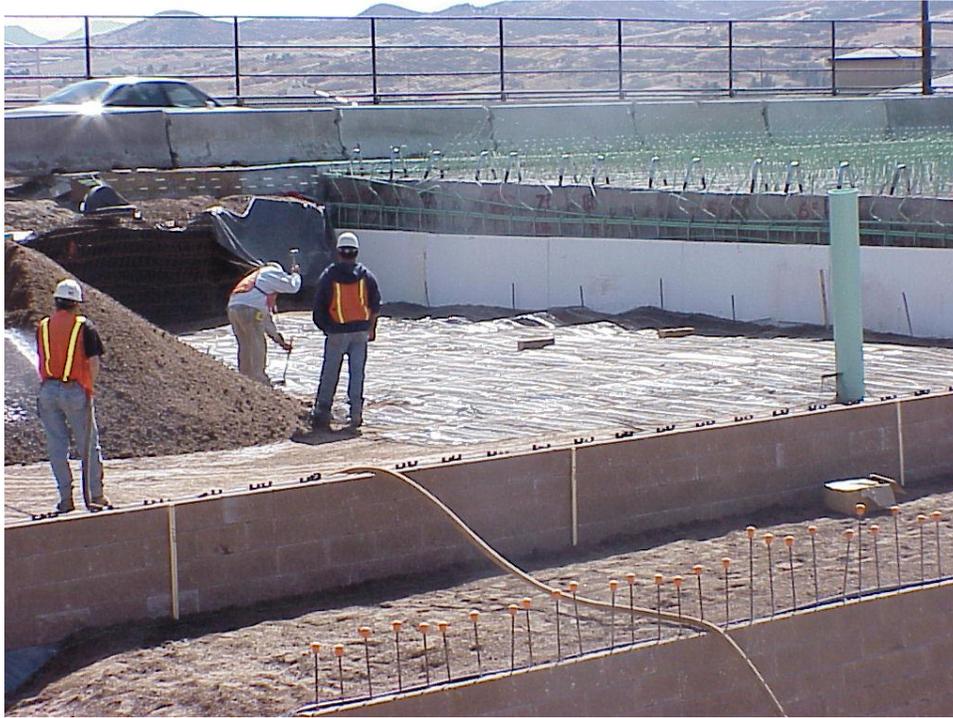
Figure B-35. After the girders were placed, 75 mm sheets of low-density expanded polystyrene were placed against the back of the abutment wall. The area in the foreground between the lower and upper MSE walls will be covered with a membrane and paved with concrete (referred to as slope paving in Fig. 40).

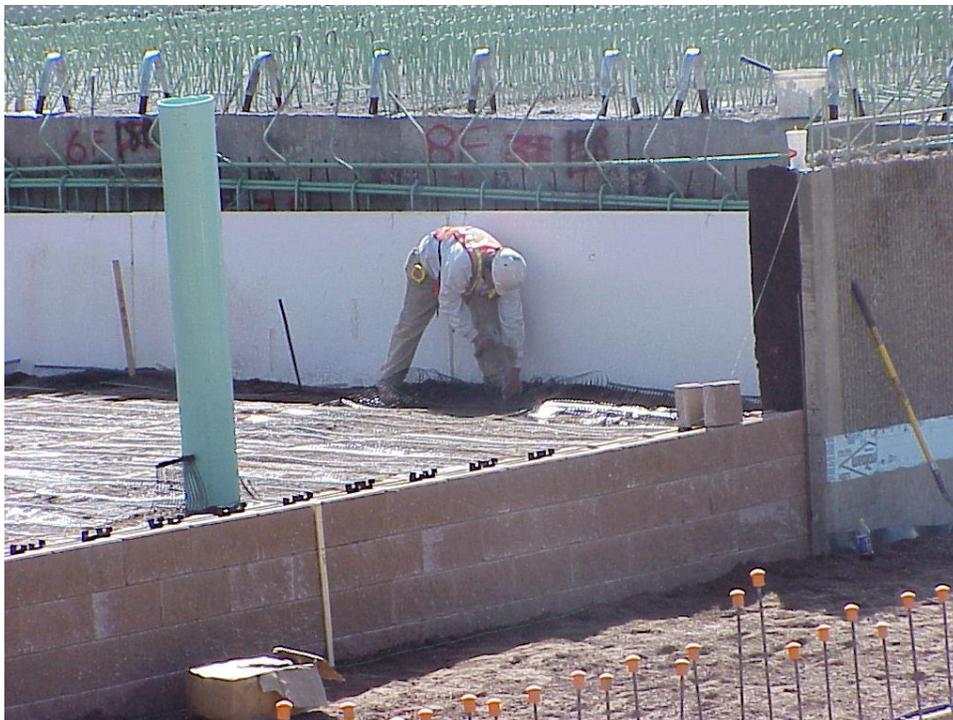
Figure B-36. The wrapped geogrid behind the abutment wall.
