Report No. CDOT-DTD-R-2000-5

PERFORMANCE OF GEOSYNTHETIC- REINFORCED WALLS SUPPORTING THE FOUNDERS/MEADOWS BRIDGE AND APPROACHING ROADWAY STRUCTURES

**REPORT 1: DESIGN, MATERIALS, CONSTRUCTION,
INSTRUMENTATION, AND PRELIMINARY RESULTS**

**COLORADO DEPARTMENT OF TRANSPORTATION
RESEARCH BRANCH**

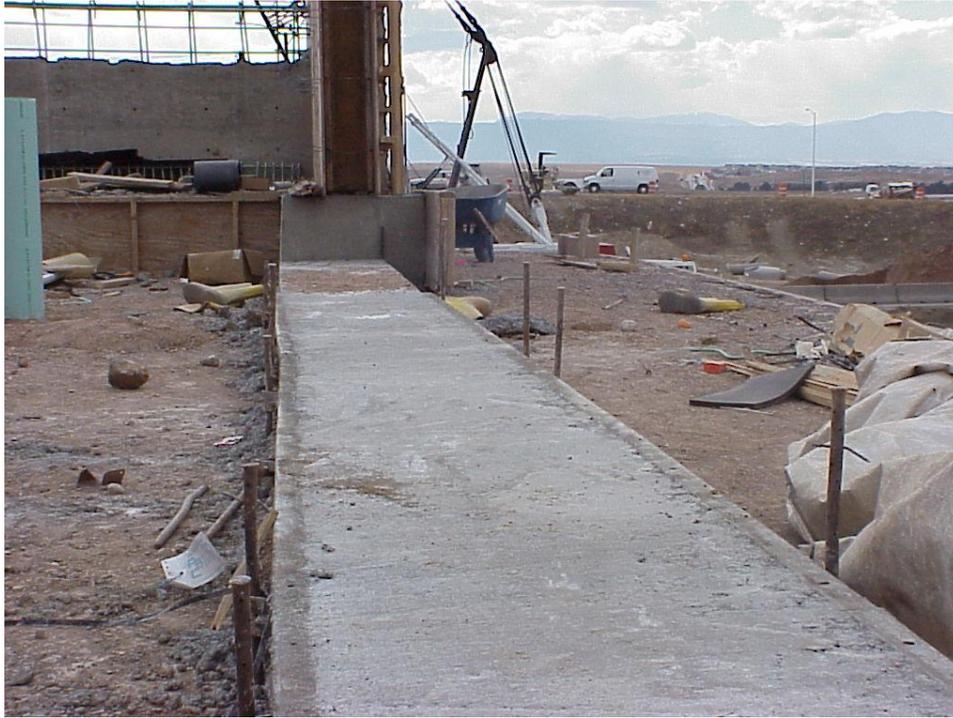
Figure B-37. Leveling pad for the upper MSE wall.

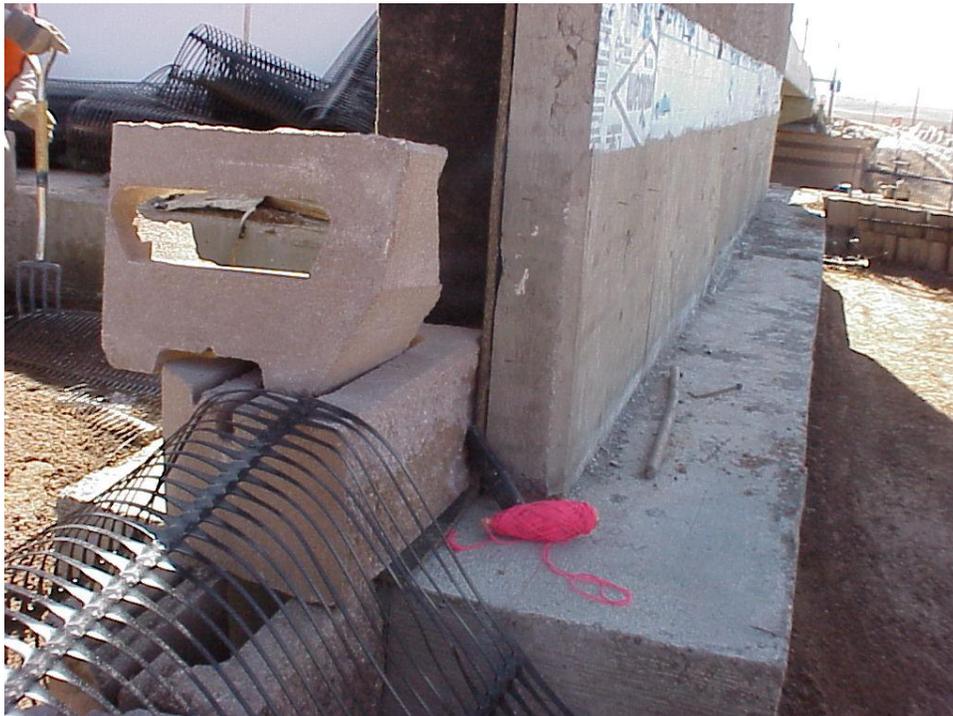
Figure B-38. The edge of the wing wall and upper MSE wall. Expansion joint material was placed between blocks and leveling pad and between blocks and the wing walls.

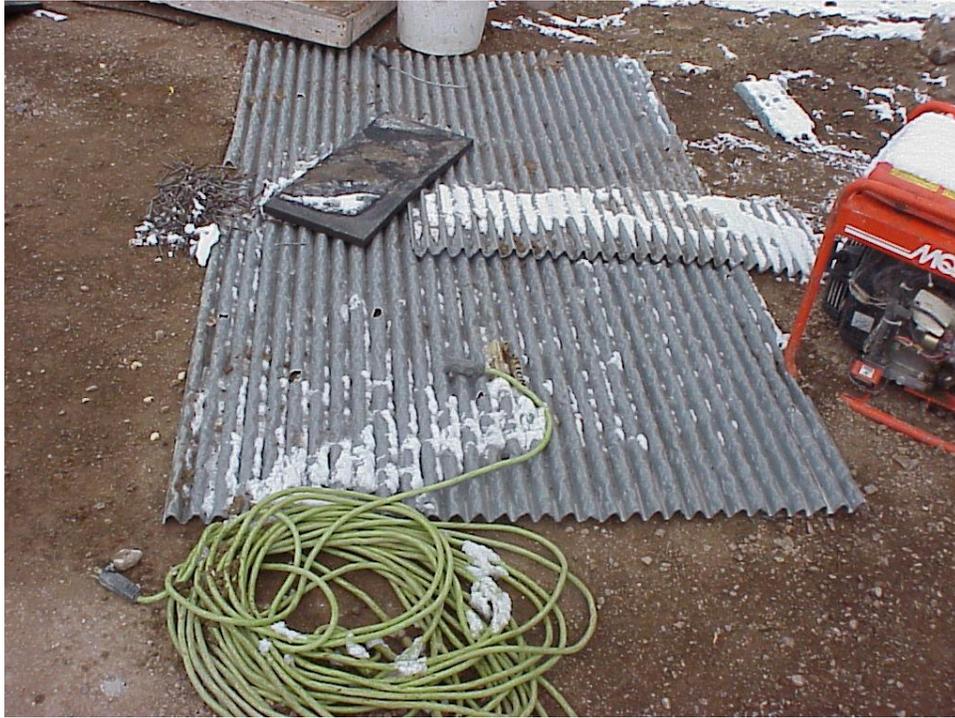
Figure B-39. This panel was used to give texture to the outside of surface of the concrete wing wall.

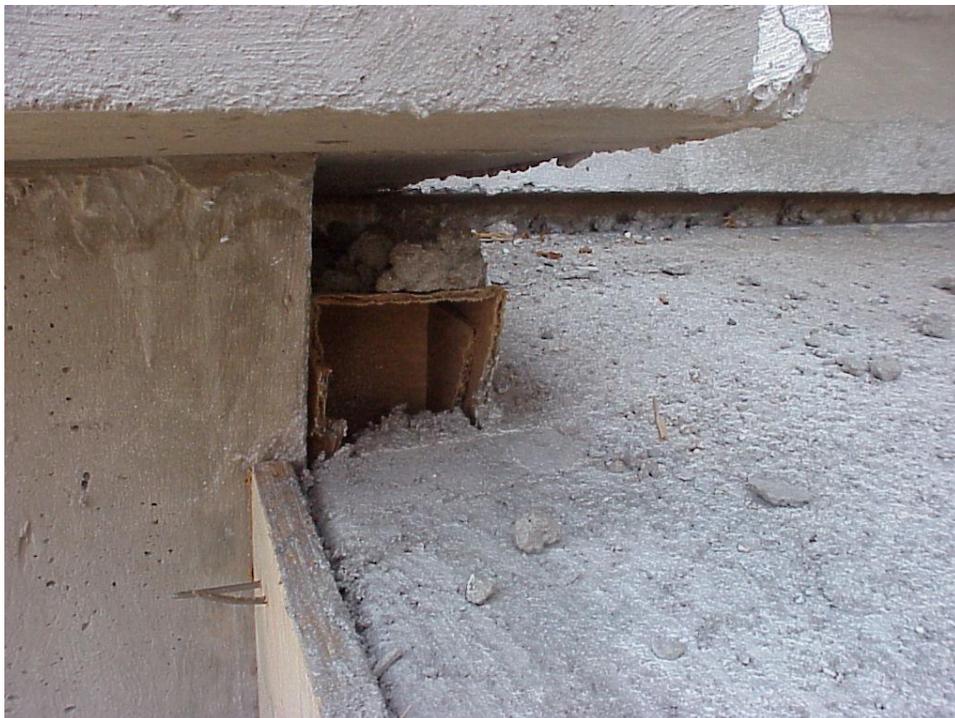
Figure B-40. Collapsible cardboard was placed in front of the bottom portion of the abutment wall behind slope paving (see figures 29 and 35).

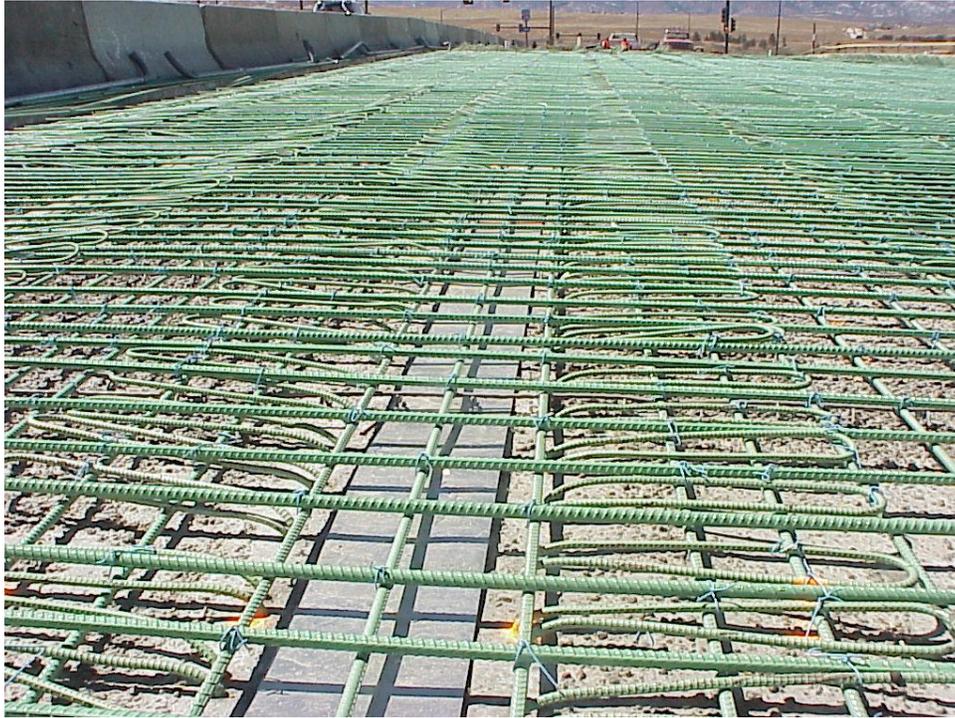
Figure B-41. Reinforcement Steel for the Bridge Deck

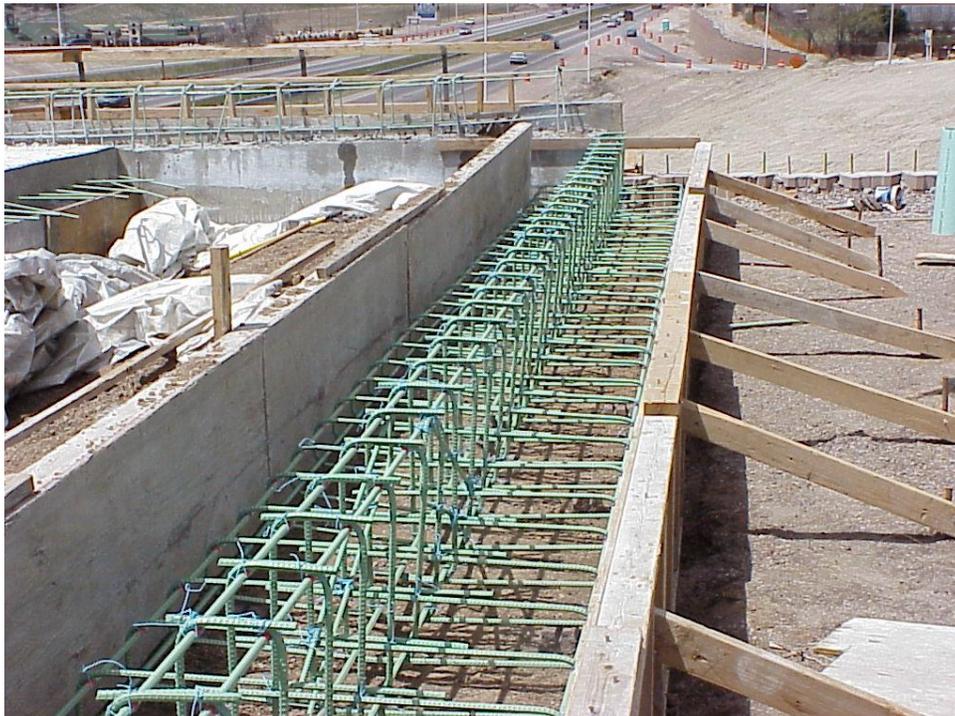
Figure B-42. The forms and reinforcing steel for the sleeper foundation supporting the approach slab.

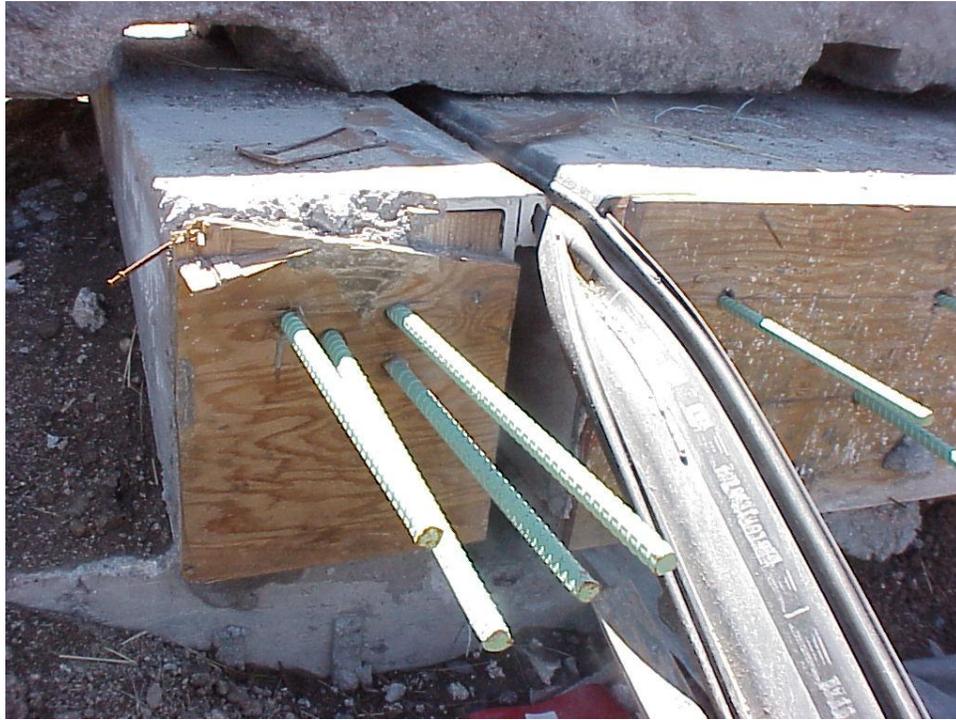
Figure B-43. The approach expansion device placed between the sleeper foundation and approach slab.
