SPECIAL PUBLICATION 46

**Geology of the 1994 South Canyon Fire Area,
and a Geomorphic Analysis of the September 1, 1994
Debris Flows, South Flank of Storm King Mountain,
Glenwood Springs, Colorado**

By Robert M. Kirkham, Mario Parise, and Susan H. Cannon

Colorado Geological Survey
Department of Natural Resources
Denver, Colorado
2000

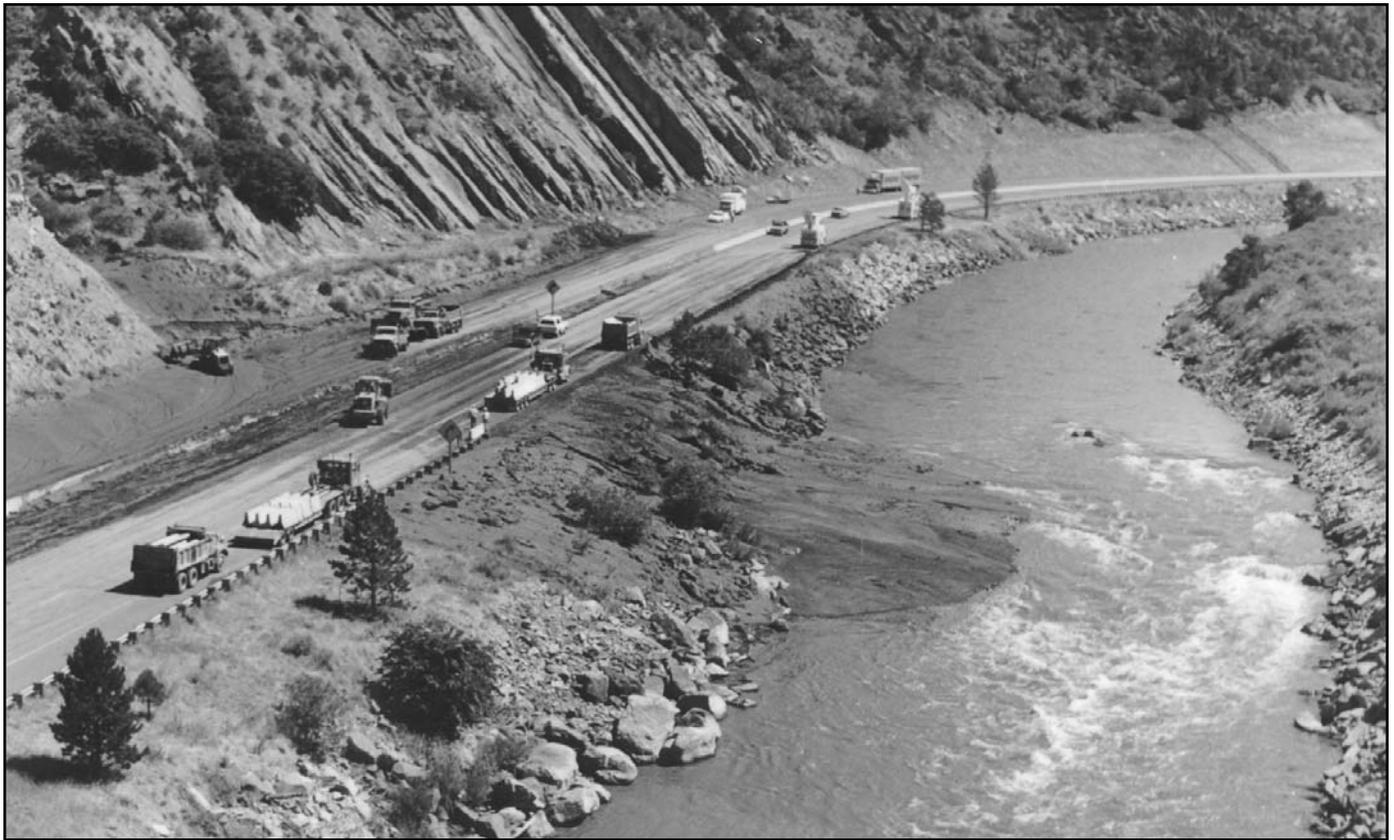
Figure 4. Photograph of debris-flow deposits at the mouth of drainage B. The debris-flow deposits were derived primarily from red soils, yet they are gray, a result of their high ash content. The debris-flow delta created by the 1994 events extended about half way across the river. Most of the fine-grained sediments in the delta have since been eroded away by the river, but large boulders from the deposits remain in the channel, creating a new section of whitewater for river rafters. The debris flows discharged from basin B carried at least two people into the river (see the eyewitness account by Kevin White in Appendix 1). Photograph by Jim Scheidt, BLM.

B is shown in Figure 4. The debris-flow deposits were derived primarily from red soils, yet they are gray, a result of their high ash and charcoal content. The debris-flow fan created by the 1994 events at the mouth of basin B extended about half-way across the river. Most of the fine-grained sediments in the fan have since been eroded away by the river, but large boulders in the fan deposits remain in the channel, creating new rapids for river rafters. The debris flows discharged from basin B carried at least two people into the river, as described in the eyewitness account by Kevin White contained in Appendix 1.

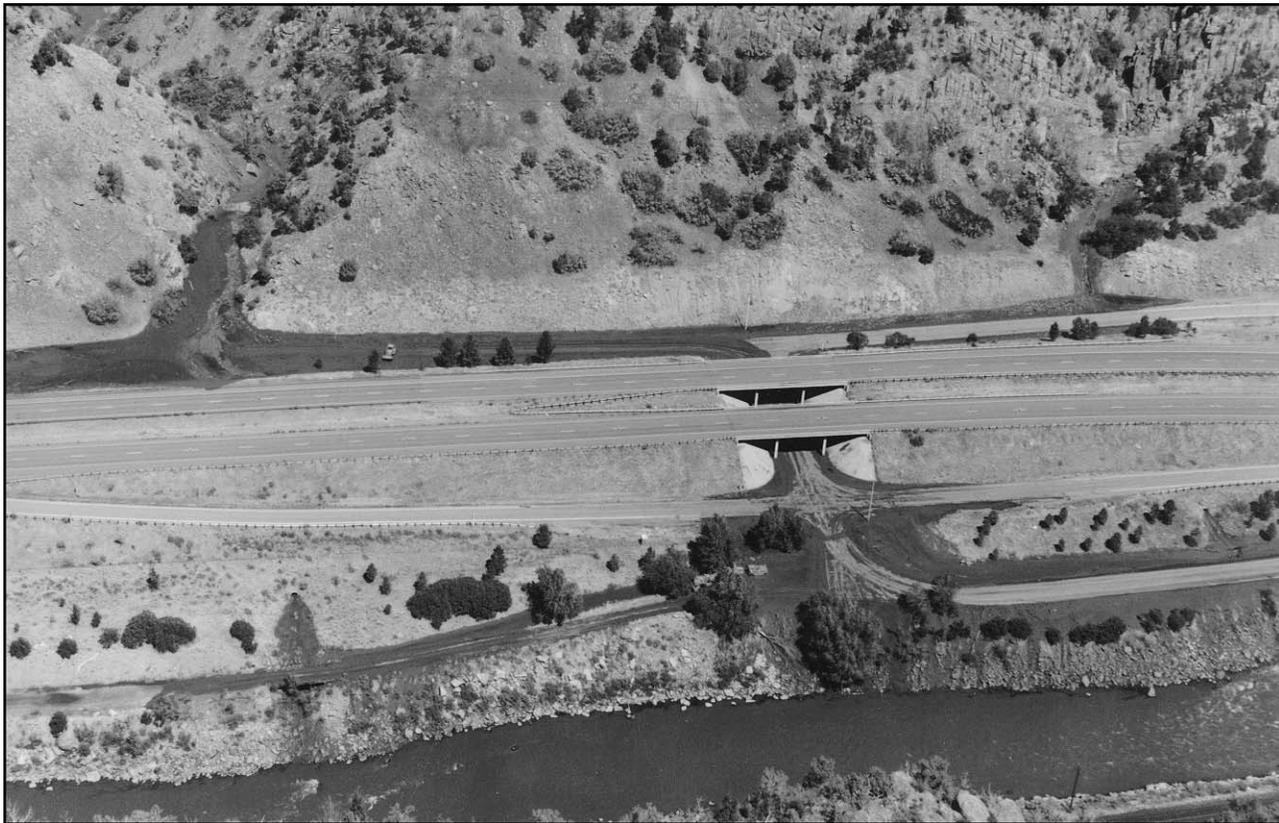
Figure 5. Photograph of debris-flow deposits that discharged from drainages C and D at the South Canyon Creek exit. Note the near vertical dip slope that forms the channel bed of basin D a short distance above the highway exit ramp. This steep slope likely created a waterfall effect for the debris flows discharging from basin D and caused the flows to violently cascade downward. None of the deposits flushed from basins C or D spilled onto the through-going traffic lanes of I-70. The South Canyon Creek highway interchange fortuitously served as a mitigative structure for the debris flows. Debris from basin C flowed eastward down the westbound entrance ramp, while debris from basin D ran westward down the westbound exit ramp. The deposits then flowed beneath the traffic lanes of the highway through the underpass, illustrating how diversion structures, even unintended ones, can mitigate debris-flow hazards to highways. Photograph by Christopher Tomlinson, Daily Sentinel.

Debris-flow deposits flushed out of basins C (channel on left side of photograph) and D (right side) are shown in Figure 5. Note the near-vertical, bedrock dip slope that forms the channel bed of basin D a short

distance above the highway exit ramp. This steep slope likely created a waterfall effect or extreme turbulence in the debris flows discharging from basin D, causing the flows to violently cascade downslope. None of the material flushed from basins C or D spilled onto the traffic lanes of I-70, because the South Canyon Creek highway interchange fortuitously served as a mitigative structure for the debris flows. Debris from basin C flowed eastward down the westbound entrance ramp, while debris from basin D ran westward down the westbound exit ramp. The deposits then flowed beneath the traffic lanes of the highway by way of the underpass, illustrating how diversion structures, even unintended ones, can mitigate debris-flow hazards to highways.

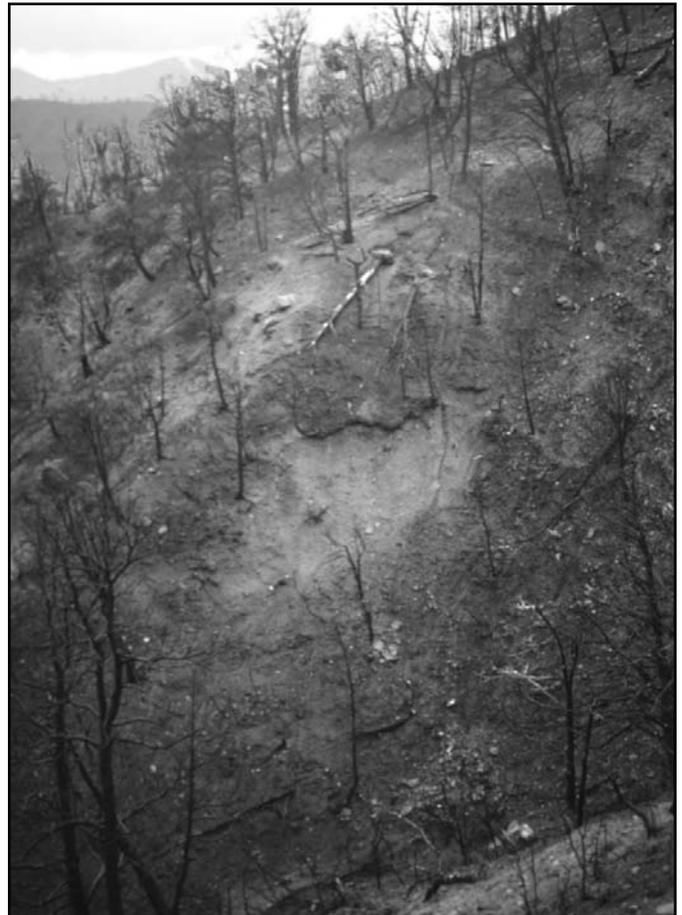
Figure 6. Photograph of a soil-slip scar developed in older landslide deposits in basin F. Note the absence of burned soil in the soil-slip scar, indicating the slip occurred after the wildfire. Note also that the material removed from the scar is not present on the slope below the scar and that the hillslope below the scar was little affected by the downslope transport of the material removed by the soil slip. Photograph by Robert Kirkham.

Scars left by the evacuation of thin, areally small, translational landslides, herein called soil slips, are common on steeper slopes in the area. Figure 6 is a photograph of a typical soil-slip scar developed in older landslide deposits. Material mobilized from the soil slips appears to have been very fluid in that only a few traces of the deposits from soil slips were observed on the hillsides downslope from the scars. This is in contrast with the debris flows in the main channels, which left nearly continuous, up to one-inch thick veneers of mud on the channel banks. Most material from the soil slips apparently traveled over the hillsides and into adjacent channels. No significant deposits from the soil slips were observed in the channels. The soil exposed in the soil-slip scars was not burned, indicating that the soil slips occurred after the fire. When coupled with the observation that most material derived from the soil slips was not preserved

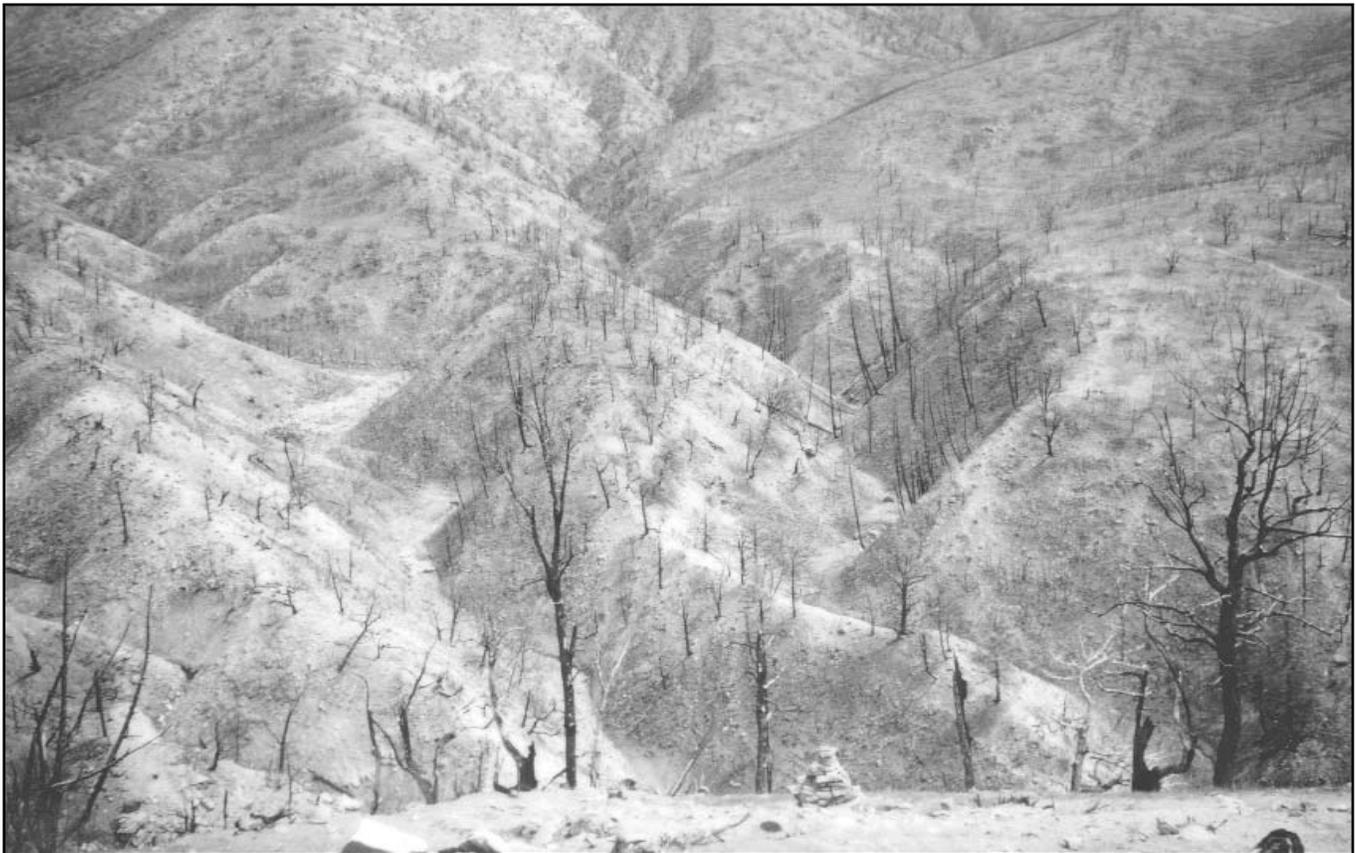
Figure 8. Photograph of older colluvium and sheetwash deposits in basin B taken in May, 1995. Remnants of the original depositional surface of the deposit are preserved on the right (east) side of the photograph. Erosion caused by the 1994 events and deposits left by it can be seen in both of the major tributaries to basin B. Hillslopes where thin veneers of soil were removed during the flood are visible in the lower left and center of the photograph. Trees burned by the South Canyon fire stand as stark reminders of the intensity of the fire. At the time of the photograph stands of grasses and forbs were beginning to be established on the flatter slopes in this basin, but were much less well established on the steep slopes. Photograph by Robert Kirkham.

A photograph taken in May 1995 of deeply dissected older colluvium and sheetwash deposits in basin B (Figure 8) shows remnants of the original depositional surface of the deposit preserved on the right (east). Erosion caused by and deposits left by the 1994 events can be seen in both of the major tributaries to basin B. Hillslopes where thin veneers of soil were removed during the rainstorm are visible in the lower left and center of the photograph. Trees burned by the South Canyon fire stand as stark reminders of the intensity of the fire. At the time of the photograph stands of grasses and forbs were beginning to establish on the

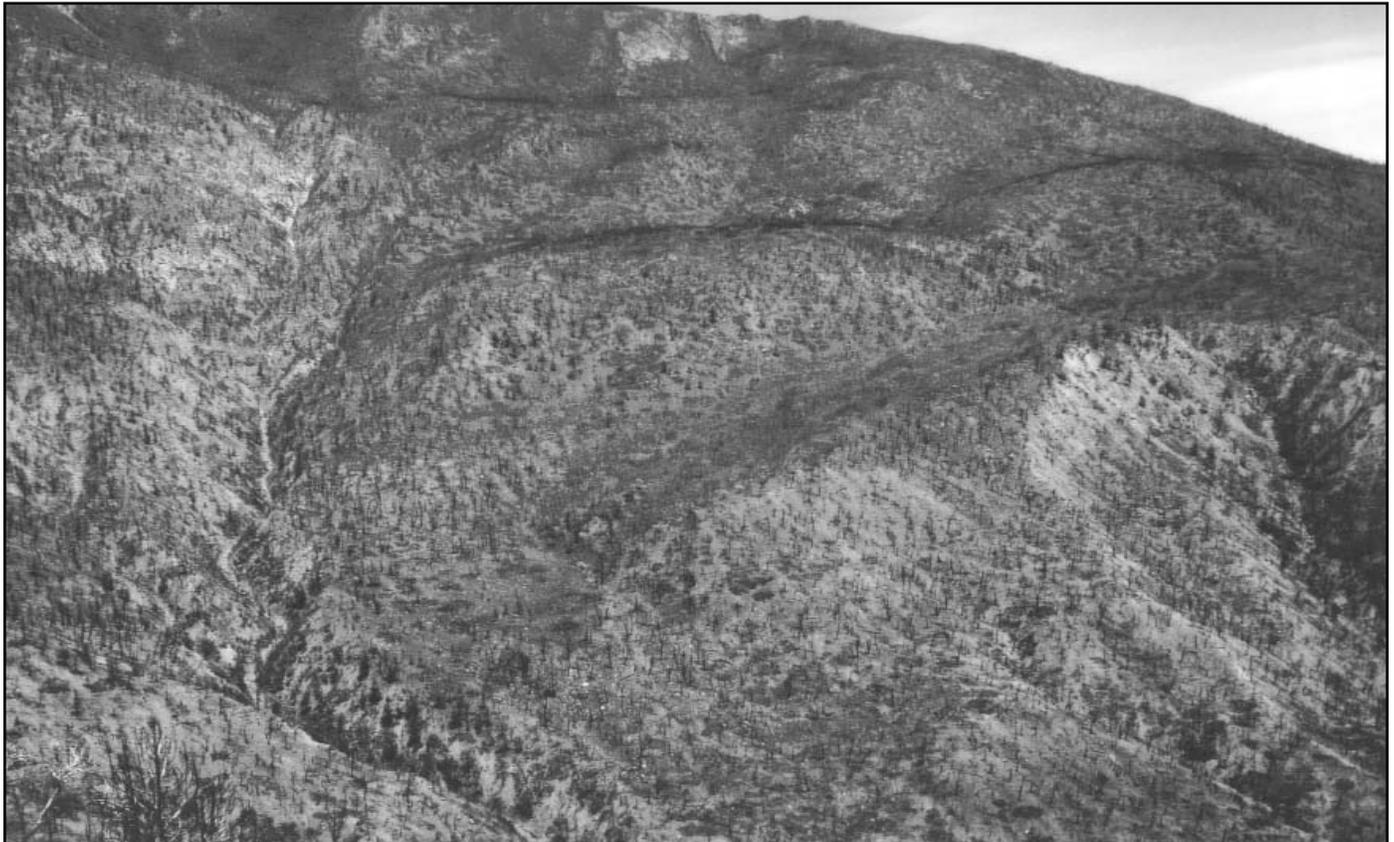
Figure 15. Photograph of older landslide deposits on the south flank of Storm King Mountain taken in May, 1995. Note the prominent, transverse ridges and swales that extend across the landslide. Excellent stands of

One of the original concerns following the 1994 debris flows was the effect of the fire and debris flows on the stability of large landslides recognized on the south flank of Storm King Mountain by Soule and Stover (1985) and Fairer and others (1993). If destabilized, these landslides, by continuing to slide into and block drainages, could become major sediment sources for future debris flows. Figure 15 is a photograph of some of the older landslide deposits where prominent, transverse ridges and swales extend across the landslide. During our field work we observed no evidence to indicate that these large landslides have been reactivated to any large extent. Because of their apparent age relative to other landslides in the study area, we have mapped these large landslides as older landslide deposits (Q_{lso}) on Plate 1.
