Re: Colorado State Capitol

Dome
Bi-Annual Review
Project #200014.027

Re: Colorado State Capitol Dome
WJE No. 2008.0718

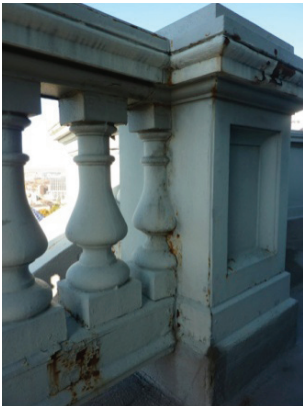
IMAGE UW006

A detail of the separation and rusting at the balustrade railing cap shows increased separation since 2008. Photo above shows a rusted fastener.

This area is shown above in detail.

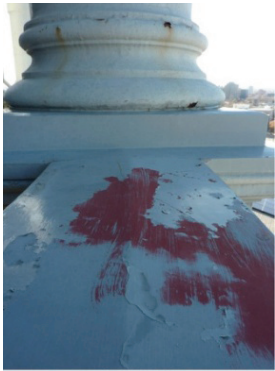
IMAGE L W006

A vertical crack is visible along the side of this column base.

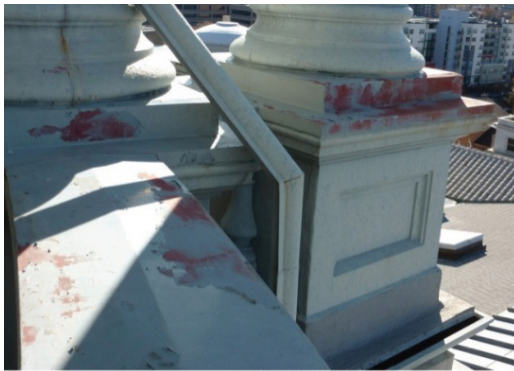
IMAGE LS001

Shown above is additional evidence of the areas where coating is missing and peeling. Leaving the metal unprotected will subject it to further oxidation.

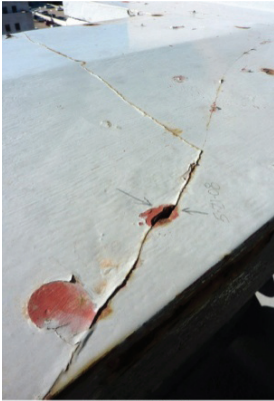
IMAGE LE001

The crack in the column base has gotten bigger since March 2009. The cracks and rusting on the balustrade top rail has expanded as well.

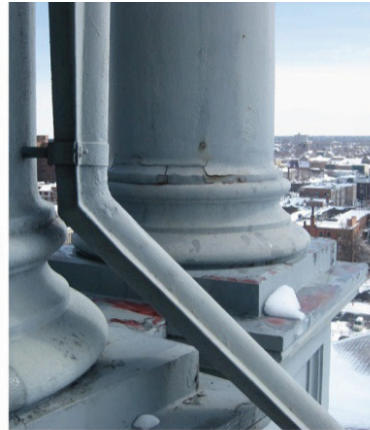
This column has been rusting for a long time and is getting worse and is reaching the point where the metal coating is cracking and releasing water collecting in the column. The moisture is also trapped against the metal in many areas.

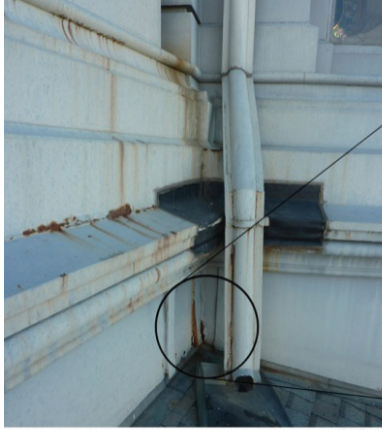
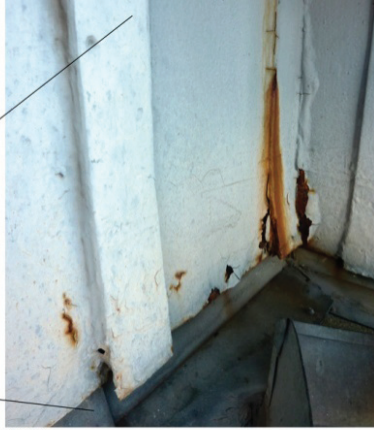
IMAGE DN001A

Continuing staining and water infiltration behind the drum battens. Note that the battens are separating from the drum wall. Rusting and staining at the drum base cap. The rusty areas seen to the left of the dark patch will soon be rusted through and require the same kind patch.
