**Report No. CDOT-2011-10**  
**Final Report**

# **INVESTIGATING CRACK SEALANT PERFORMANCE AND CAUSES OF BUMPS IN NEW HOT MIX ASPHALT OVERLAYS OVER CRACK SEALANTS**

**Scott Shuler**

**COLORADO DEPARTMENT OF TRANSPORTATION  
DTD APPLIED RESEARCH AND INNOVATION BRANCH**

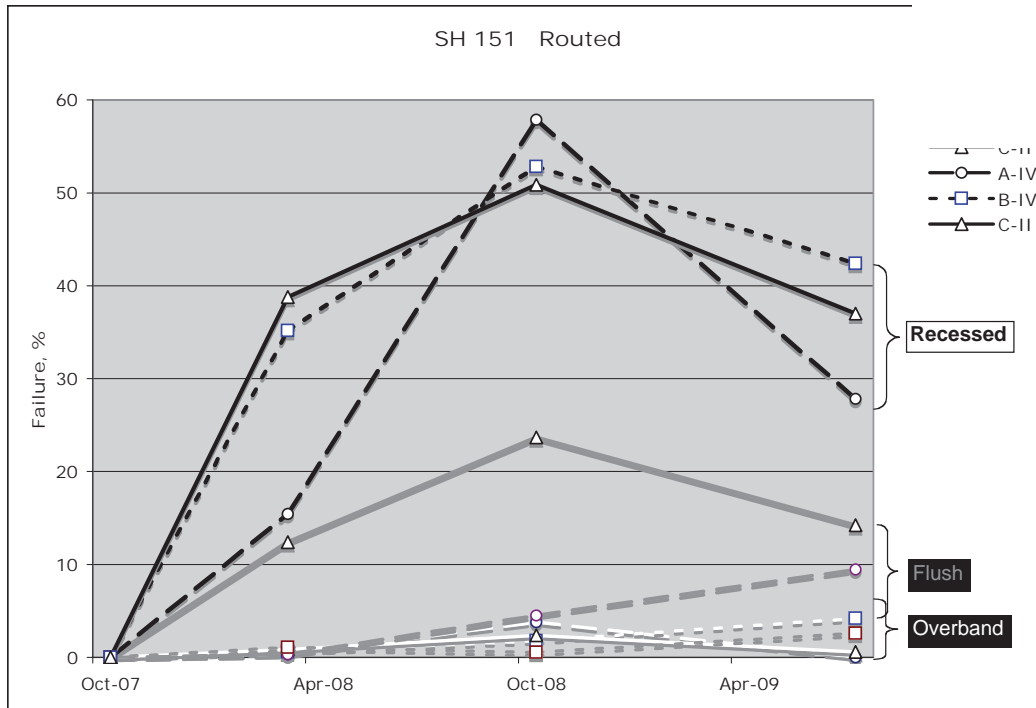
Figure 3. Sealant Performance on S.H. 151-Cracks Prepared by Routing

Figures 3, 4, and 5 are the results from S.H. 151 for routed, overbanded, and air blown cracks, respectively. Figures 6, 7 and 8 are the results from US 285 for routed, overbanded and air blown cracks, respectively. Figures 9, 10, and 11 are the results from US 350 for routed, overbanded, and air blown cracks, respectively.
