QUICK RESPONSE REPORT

VULNERABILITY OF REINFORCED CONCRETE FRAME BUILDINGS AND THEIR OCCUPANTS IN THE 2009 L'AQUILA, ITALY EARTHQUAKE

Abbie B. Liel¹

Kathryn P. Lynch²

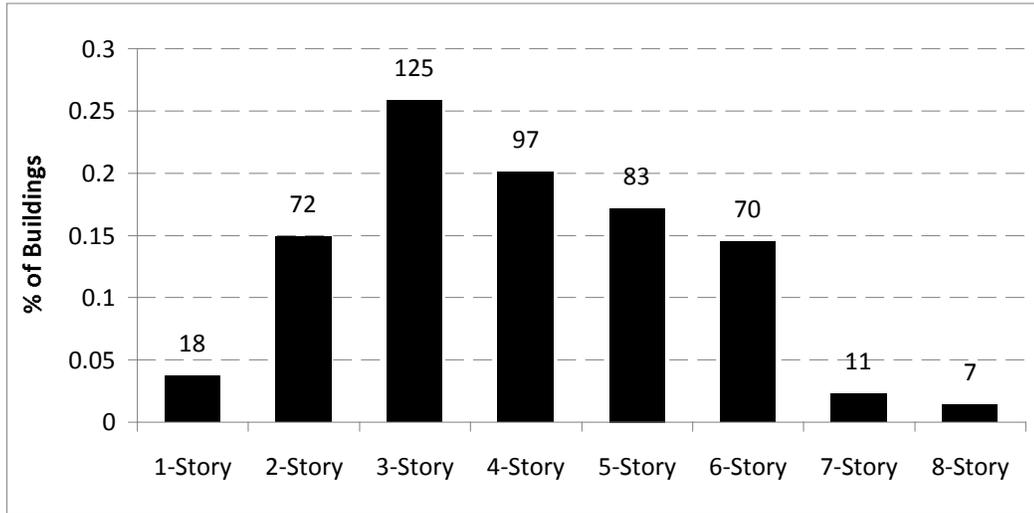
Figure 1a. Distribution of Database L’Aquila Buildings by Building Height (average of 3.9 stories) Data labels show the number in each group

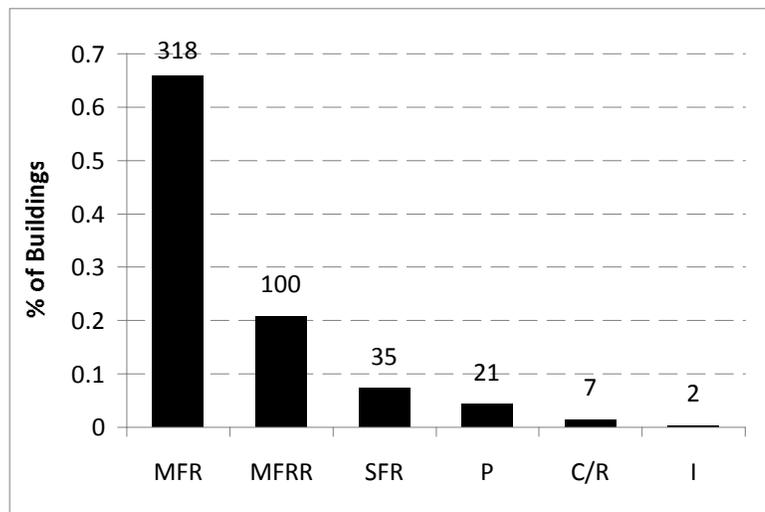
Figure 1b. Distribution of Database L’Aquila Buildings by Building Function

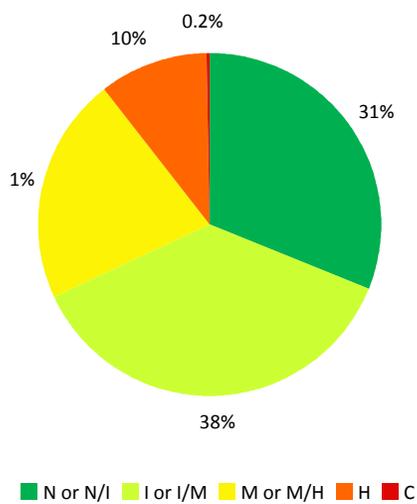
Figure 4a. Damage State

Damage assessments for the L'Aquila RC buildings are summarized in Figure 4 on the next page. The majority (68%) of buildings are classified as having negligible or insignificant damage, requiring only cosmetic repairs. Only one of the 483 buildings had collapsed (a collapse rate of 0.2%). The average damage state of 2.2 is slightly above insignificant ($DS=2$). Figure 4 also illustrates the outcome of the functionality of the assessment. Most of the RC buildings (55%) fell into Grade *C*, meaning the structures had fairly limited damage (corresponding to negligible or insignificant damage states), but were unoccupied and retail and commercial activity was not open. Fourteen percent of the database buildings were occupied by residents or had open shops at the time of inspection, approximately three weeks after the earthquake. At this time, many of these structures were awaiting inspection by the Protezione Civile Nazionale and reentry was not officially allowed (Bazzurro et al. 2009). However, most were not cordoned off and electricity, water, and other utilities were operational—after minor repairs—within a day

Figure 4. Damage state (a) and loss of functionality (b) assessments for database RC buildings.

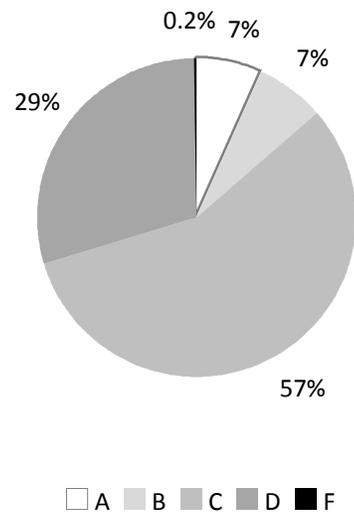
Figure 4b. Loss of Functionality

by the loss of functionality assessment. Six buildings were undergoing earthquake-related repairs at the time of inspection. These assessments, shown in Figure 4, are not consistent with an April 18 government statement, which stated that 57 percent of housing was accessible at that time, 19 percent would be accessible in a few days to a month, with the remaining homes being unusable (Corriere della Serra 2009b).

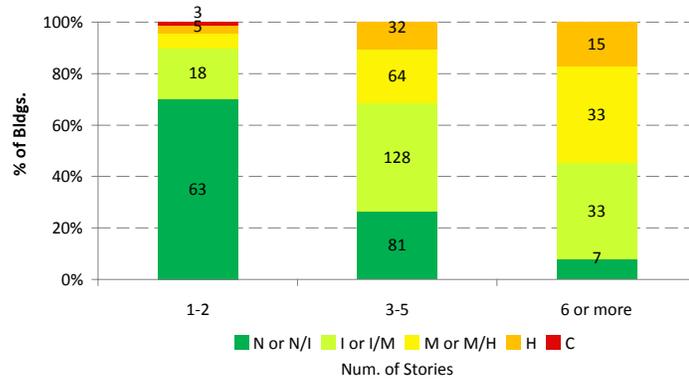
Figure 8a.

Database building characteristics, such as height, function, and the presence of plan or elevation irregularities, are correlated with damage and loss of functionality assessments. As illustrated in Figure 8a, the damage assessment tends to increase with building height, such that only 45 percent of buildings with six or more stories assessed were in the lowest two damage states (negligible or insignificant) compared to 90 percent of one- and two-story buildings. Assigning each damage state a numerical value between 1 and 5 (see Table 1), statistical analyses show that the mean damage state is 1.5 (N/I) for buildings with two or fewer stories, 2.3 (between I and I/M) for buildings with three to five stories and 2.8 (I/M to M) for the tallest buildings (six stories or more). These differences in mean damage state are statistically significant at the 5 percent level according to T-tests of the distributions.³ The increase in damage with building height is consistent with post-earthquake studies of RC frame buildings following the 1999 Chi-Chi, Taiwan (Tu et al. 2009) and Duzce, Turkey (Gur et al. 2009; Hassan and Sozen 1997; Sucuoglu et al. 2007) earthquakes. In L'Aquila, we hypothesize that damage increases in taller buildings because these

Figure 8. Relationship between building height and (a) damage state and (b) loss of functionality assessment.

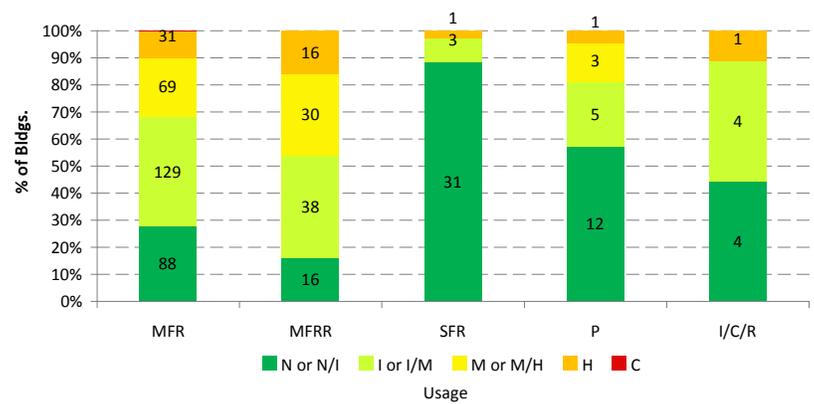
Figure 9a.

Damage states and functionality assessments are compared in Figure 9 for different building usage types. The single-family residential (SFR) structures were much more likely to have negligible damage than other types of structures (Figure 9a). In addition, a notable 51 percent of the database SFR

Figure 9. Relationship between building usage and (a) damage state and (b) loss of functionality rating.

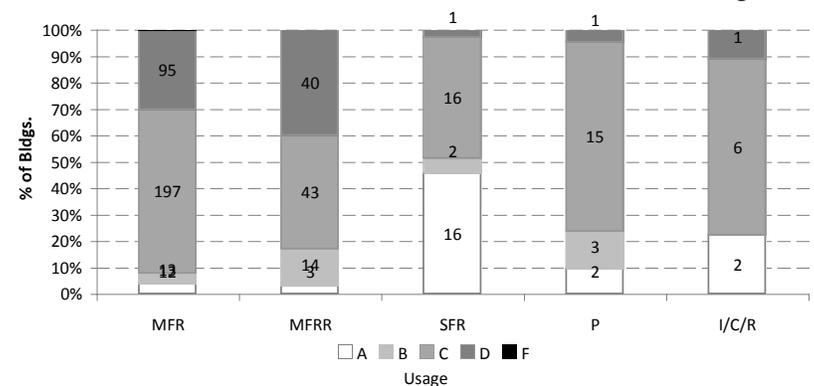
Figure 9b.

were occupied or partially occupied at the time of inspection (Grades A or B), a much higher percentage than other structures (Figure 9b). Of the multi-family residential structures, those with retail (MFRR) had higher damage ratings than those without (MFR) (with mean damage states of 2.5 for MFRR and 2.2 for MFR). The structural and nonstructural systems in these buildings are very similar with retail or garage in the first story.

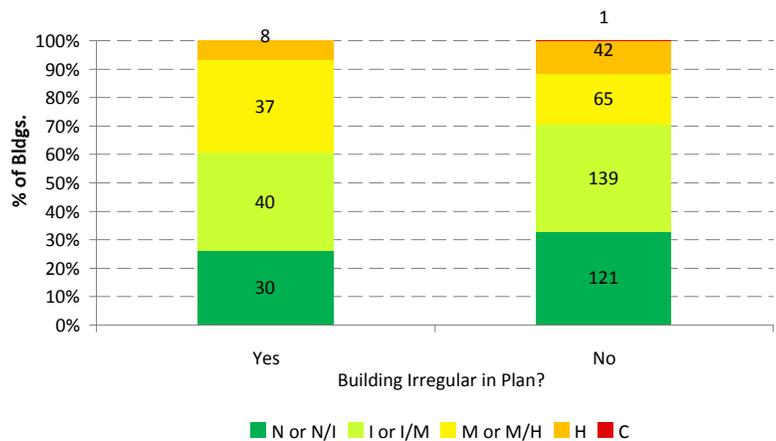
Figure 11a. Structural irregularities in plan.

Figure 11. Relationship between identified structural irregularities in plan/elevation and damage state.

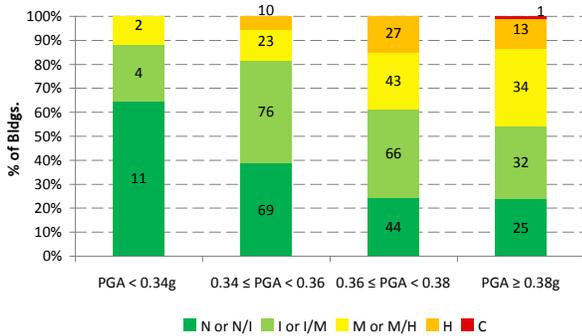
Figure 12a. Damage state.

Figure 12. Relationship between estimated ground motion intensity (PGA) and damage state and loss

Based on this approach, the average PGA at the database building sites is estimated at 0.36g. Figure 12 clearly shows higher damage rates in structures subjected to larger estimated PGA. T-tests show that the ground motion bins are statistically significant. The relationship between PGA and building damage is summarized in the fragility curves illustrated in Figure 13, which show the probability of being in or exceeding a given damage state. Fragility functions are assumed lognormal and fitted according to the criteria suggested by Porter et al. (2007). The median values are: insignificant damage—0.33g ($\sigma_{ln} = 0.17$), moderate damage—0.39g ($\sigma_{ln} = 0.12$), heavy damage—0.45g ($\sigma_{ln} = 0.17$), and collapse 3.6g ($\sigma_{ln} = 1.1$). The collapse fragility curve is limited by insufficient data (and is not shown in Figure 12). Given the similarity in construction practices throughout much of Italy these fragility curves are expected to be applicable to RC frames buildings in many cities.

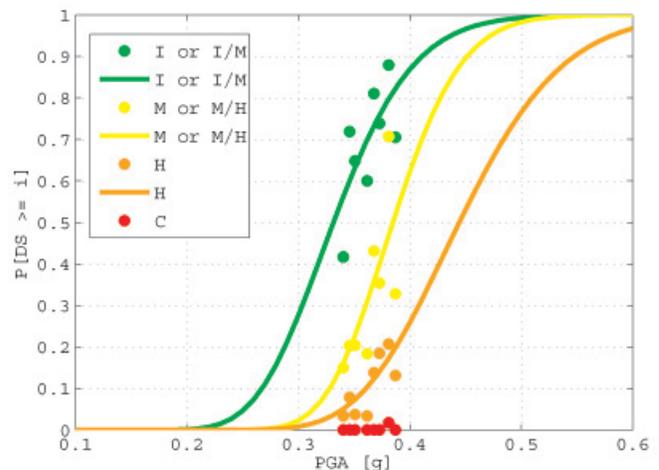
Figure 13. Fragility functions predicting the probability of exceeding a specified damage state as a function of ground motion intensity for L’Aquila RC buildings.

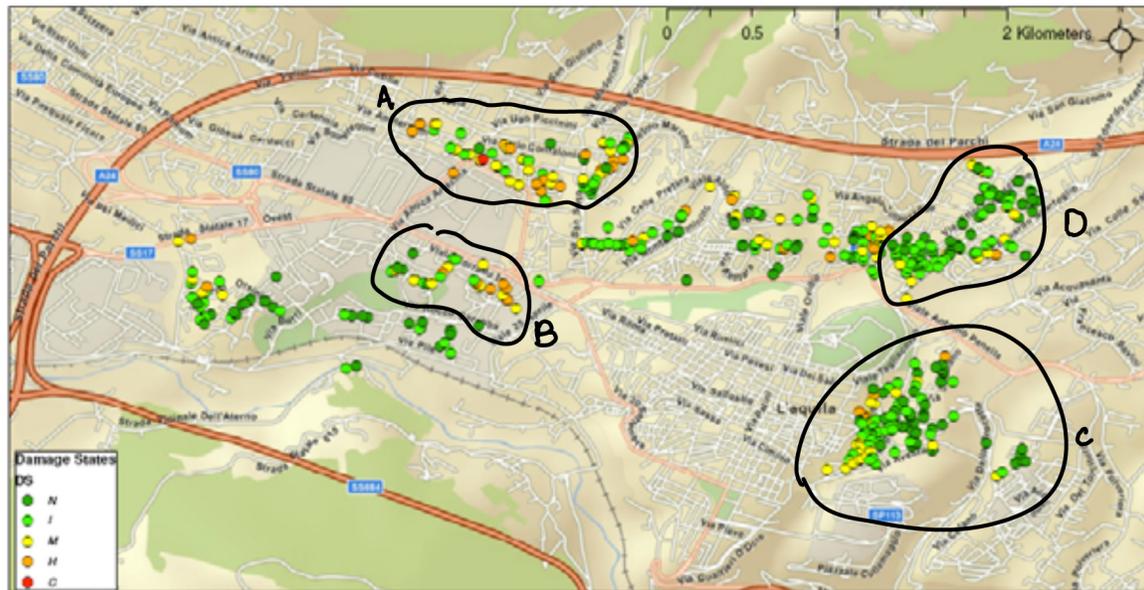
The spatial distribution of damage in database buildings is illustrated in Figure 14. There are concentrations of moderate and severely damaged buildings in the area north of Via Raffaele Paolucci, marked A on the map, and between Viale Corrado IV and Viale 25 Aprile (area B). Areas A and B correspond loosely to locations with the highest esti-

Figure 14. Damage patterns observed in database buildings in the newer areas surrounding the historic city core (shown in the center of the map). The city core was closed at the time of fieldwork.

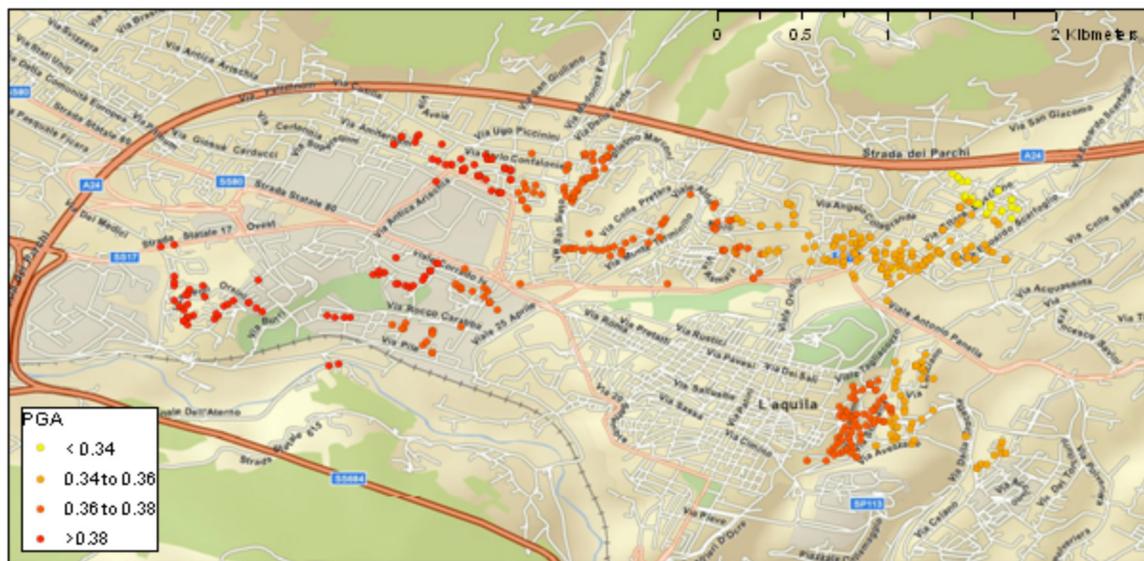
Figure 15. PGA estimates at database sites.

ground shaking, as shown in Figure 15. Inspected areas to the east (around Via Strinella and north-east of Via Antonio Panella, areas C and D) experienced relatively less damage. These areas were also more likely to have occupied residential buildings or open retail.

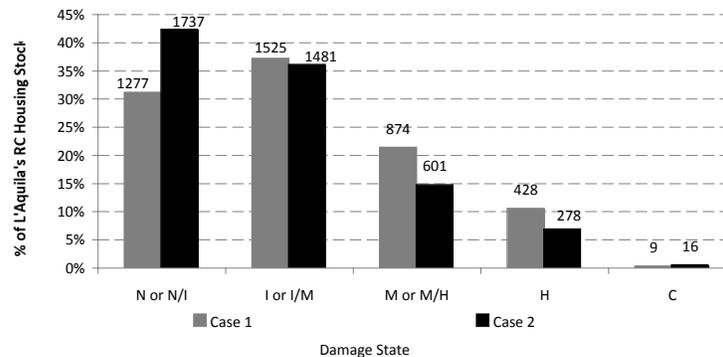
Fieldwork data for RC buildings collected in this study suggest that between 601 and 874 residential buildings are estimated to be moderately damaged and 278 to 428 buildings are estimated to be heavily damaged. These damage states require significant repairs (moderate) and building replacement in some cases (particularly in the cases of heavily damaged buildings). Since these buildings include 22-32 percent of RC buildings in L'Aquila and six to nine percent of the total number of residential buildings, these vulnerabilities could have a significant effect on the city's recovery; severely disrupting lives and commercial activities in these building. The impact on local businesses is likely to be critical because of the prevalence of retail and commercial activity, especially in the taller, more damaged buildings. These types of structures house a variety of services, including shops, doctors' offices, and government agencies.

Figure 17. Estimated damage state for all RC residential buildings in L'Aquila. Cases reflect different assumptions about distribution of buildings by height.
